Airworthiness Directives; Robinson Helicopter Company Model R22 Series Helicopters

SUMMARY: This amendment supersedes an existing airworthiness directive (AD), applicable to Robinson Helicopter Company Model R22 series helicopters, that currently requires an inspection and repetitive visual checks for slippage of the tail rotor (T/R) drive and replacement of the T/R gearbox, if necessary. This amendment requires disassembly of the T/R gearbox to verify the installation of the input and output shaft keys (keys) between the input and output pinions and their respective shafts. This amendment is prompted by two incidents in which the key was not installed between the output shaft and

AD 95-23-05 Robinson Helicopter Company: Amendment 39-9425. Docket No. 95-SW-06-AD. Supersedes AD 94-17-07, Amendment 39-9059.

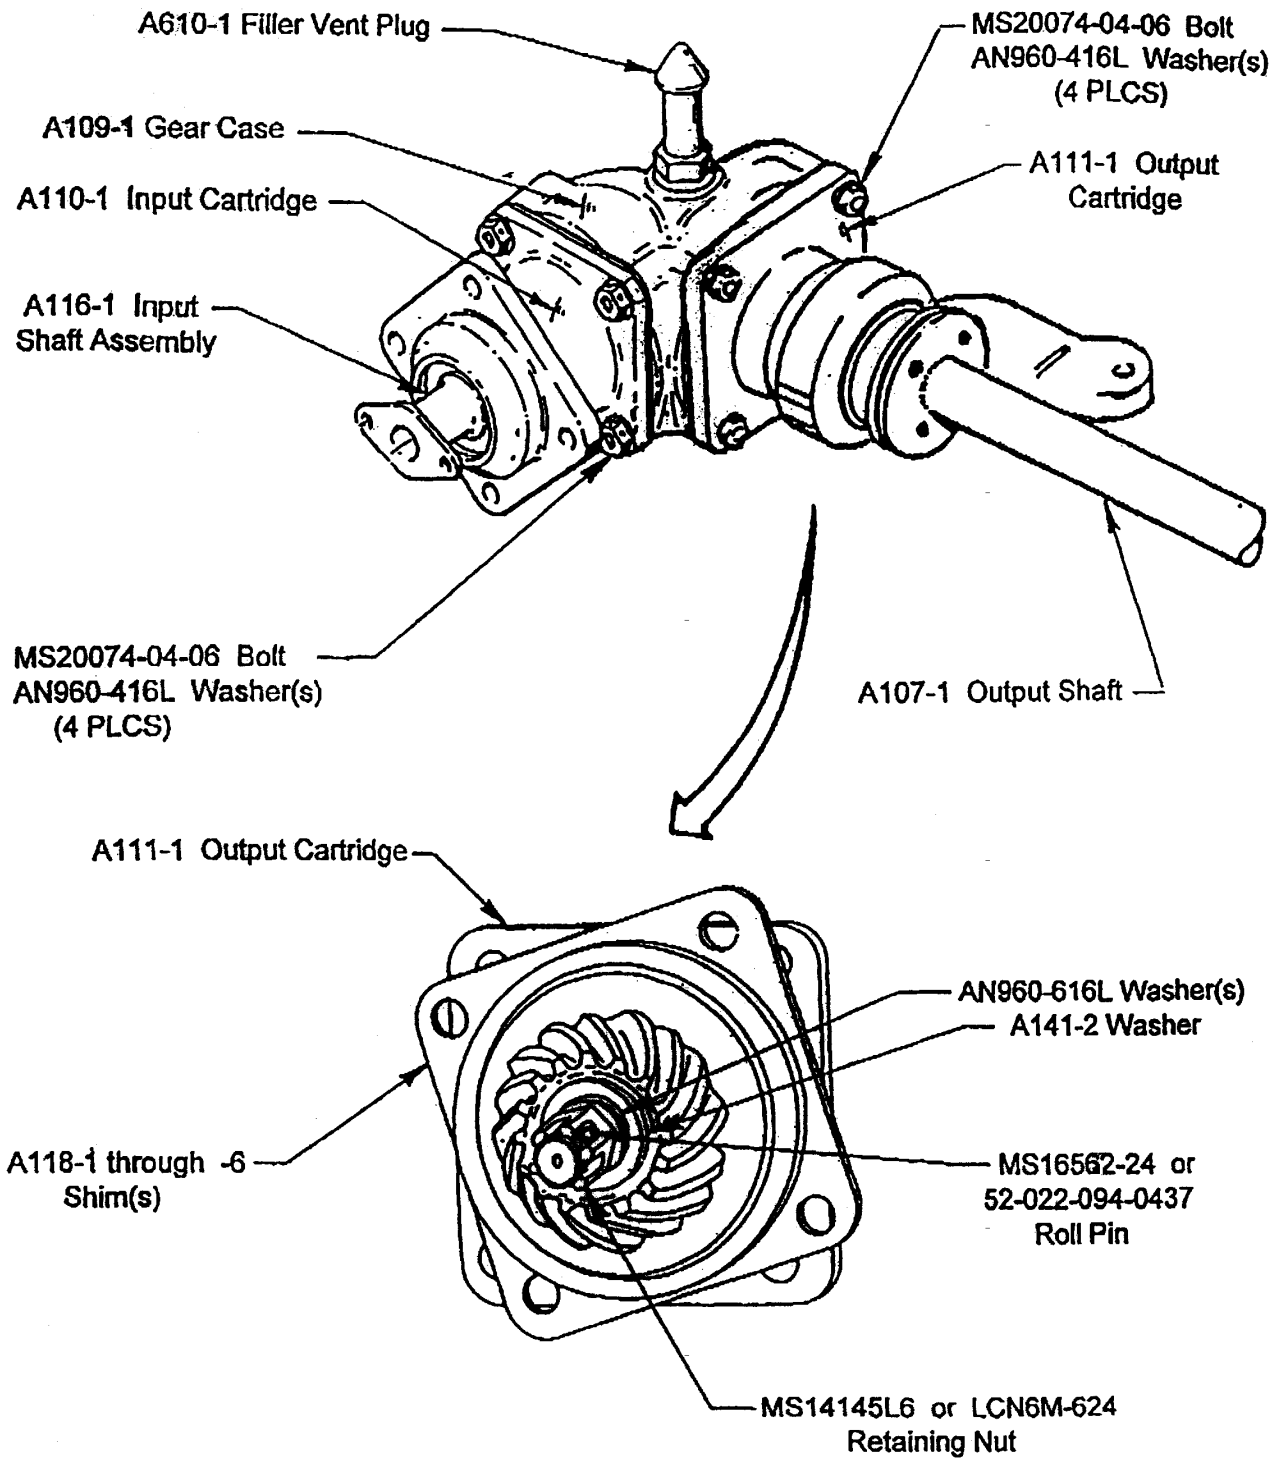
Figure 1

Note: The safety wire has been removed for clarity

(4) Remove and disassemble the output cartridge, P/N A111-1, from the T/R gearbox case, P/N A109-1 (see figure 1) as follows:

output cartridge from the gear case (see figure 1).

(ii) Cut and remove the safety wire around the four MS20074-04-06 bolts securing the input cartridge to the gear case. Remove each of the four bolts and their associated AN960-416L washer(s), noting the washer stacks for reassembly. Separate the input cartridge from the gear case (see figure 1).

(iii) Secure the input cartridge to a block of wood through the two bolt holes in the input shaft assembly, P/N A116-1 (see figure 1). Place the block of wood in a vise. Remove and discard the safety wire, roll pin, and retaining nut. Remove the AN960-616L washer(s), and washer, P/N A141-1, noting the washer(s) location for reassembly. Do not damage the input shaft or shim(s), P/N A118-1 through -6, located next to the flange of the input cartridge.

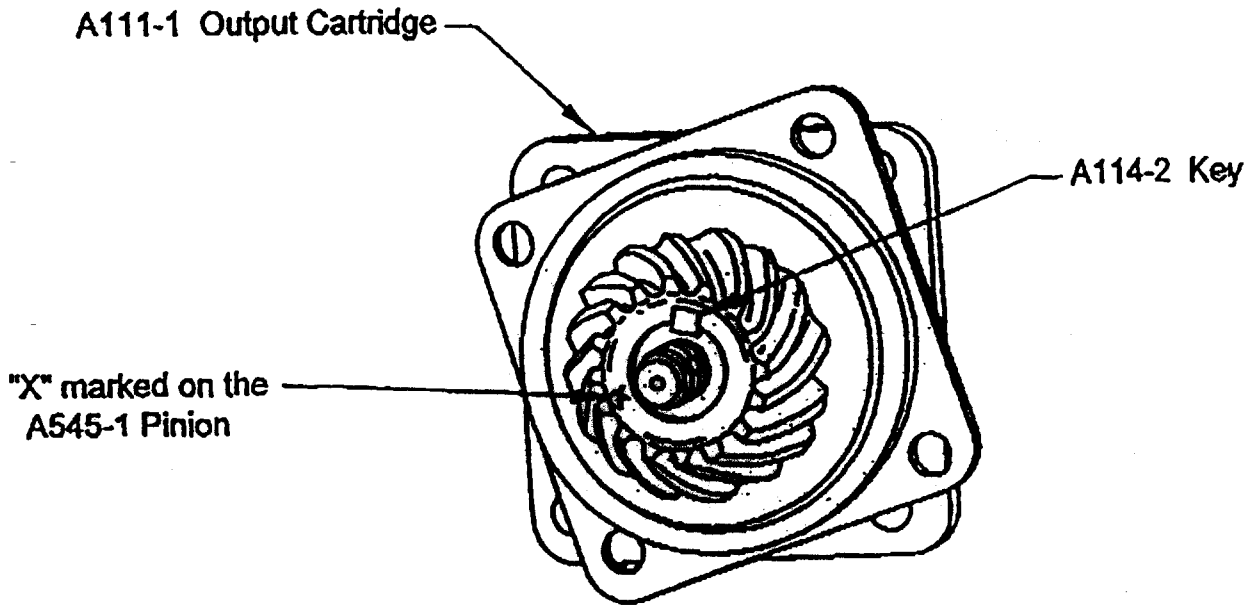
Figure 2

(iv) Visually inspect for the presence of the output shaft key, P/N A114-2, between the pinion gear, P/N A545-1, and the output shaft (see figure 2).

(iv) Visually inspect for the presence of the input shaft key, P/N A114-1, between the gear, P/N A545-2, and the input shaft (see Note on figure 2).

Note: The A114-1 Key for the A110-1 Input Cartridge is located similar to the A111-1 Output Cartridge depicted above

(v) If the output shaft key is missing, replace the T/R gearbox with an airworthy gearbox that has been determined to have the output key installed. Report any T/R gearbox that has a missing key within 10 days after the inspection to the Manager, Los Angeles Manufacturing Inspection Office, FAA, Northwest Mountain Region, 3960 Paramount Blvd., Lakewood, California 90712, telephone (310) 627-5290, fax (310) 627-5293. Reporting requirements have been approved by the Office of Management and Budget and assigned OMB control number 2120-0056.

(v) If the input shaft key is missing, replace the T/R gearbox with an airworthy gearbox that has been determined to have the input key installed. Report any T/R gearbox that has a missing key within 10 days after the inspection to the Manager, Los Angeles Manufacturing Inspection District Office, FAA, Northwest Mountain Region, 3960
