[Docket No. 94–CE–28–AD; Amendment 39–9472; AD 95–26–13]

#### **Airworthiness Directives; The New Piper Aircraft, Inc. (Formerly Piper Aircraft Corporation) PA28 and PA32 Series Airplanes**

**ACTION:** Final rule.

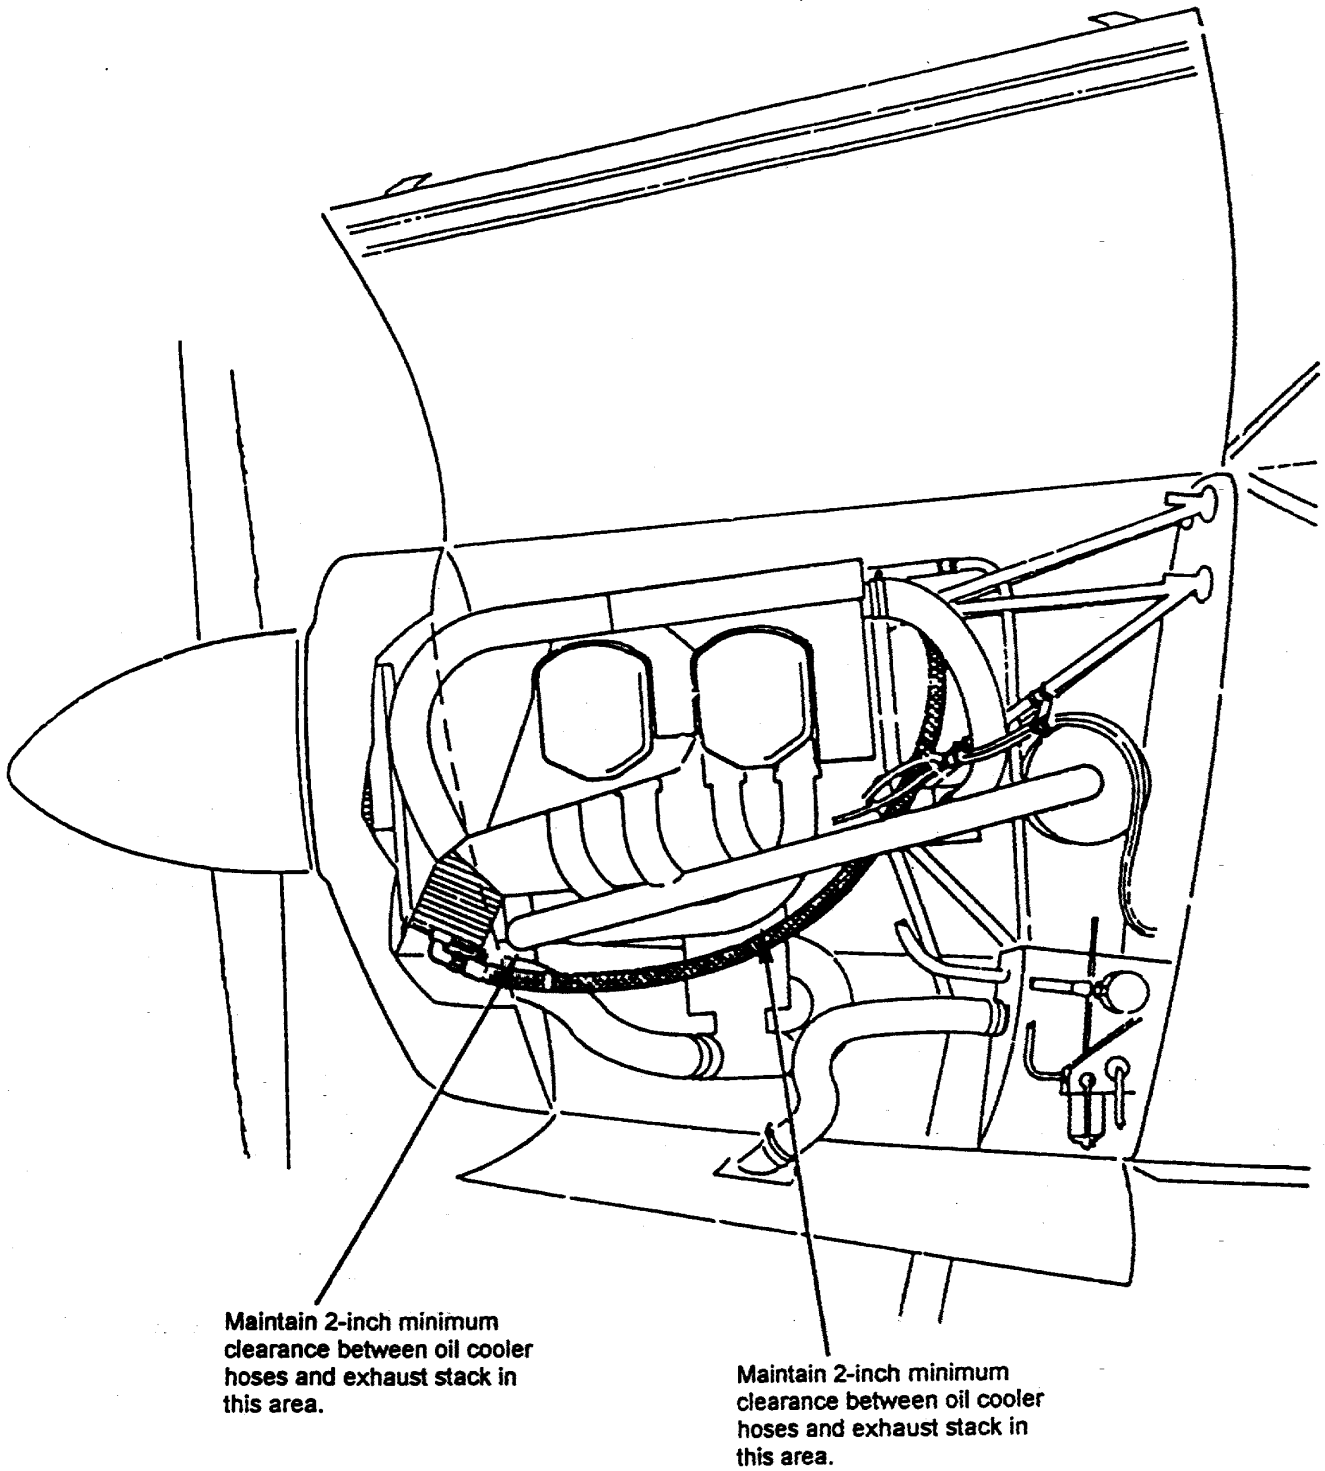
(i) The hose passes underneath and behind the electrical ground cable and in front of the lower of the two engine mount struts when the hose is routed to the rear of the engine; and

(ii) The hose is tied to the engine mount strut and a clearance of at least 2 inches exists between the oil hose and exhaust stack.

Note 2: Figure 1 of this AD relates to the conditions specified in paragraphs (a)(2)(i) and (a)(2)(ii) of this AD.

(2) Replace each oil cooler hose assembly with an approved TSO-C53a, Type D, hose assembly ensuring that there is a minimum of 2 inches between the oil cooler hoses and exhaust stacks (as applicable) upon installation. Ensure that there is a minimum bend radius of 6.5 inches on oil cooler assemblies incorporating 0.75-inch outer diameter hoses.
