Airworthiness Directives; Bell Helicopter Textron (Bell) Model 204B, 205A, and 205A-1 Helicopters

AD 97-18-11 Bell Helicopter Textron: Amendment 39-10520. Docket No. 97-SW-32-AD.

Applicability: Model 204B, 205A, and 205A-1 helicopters, with tailboom vertical fin spar, part number (P/N) 205-032-899, 205-030-846, or 205-032-851, all dash numbers, installed, certificated in any category.

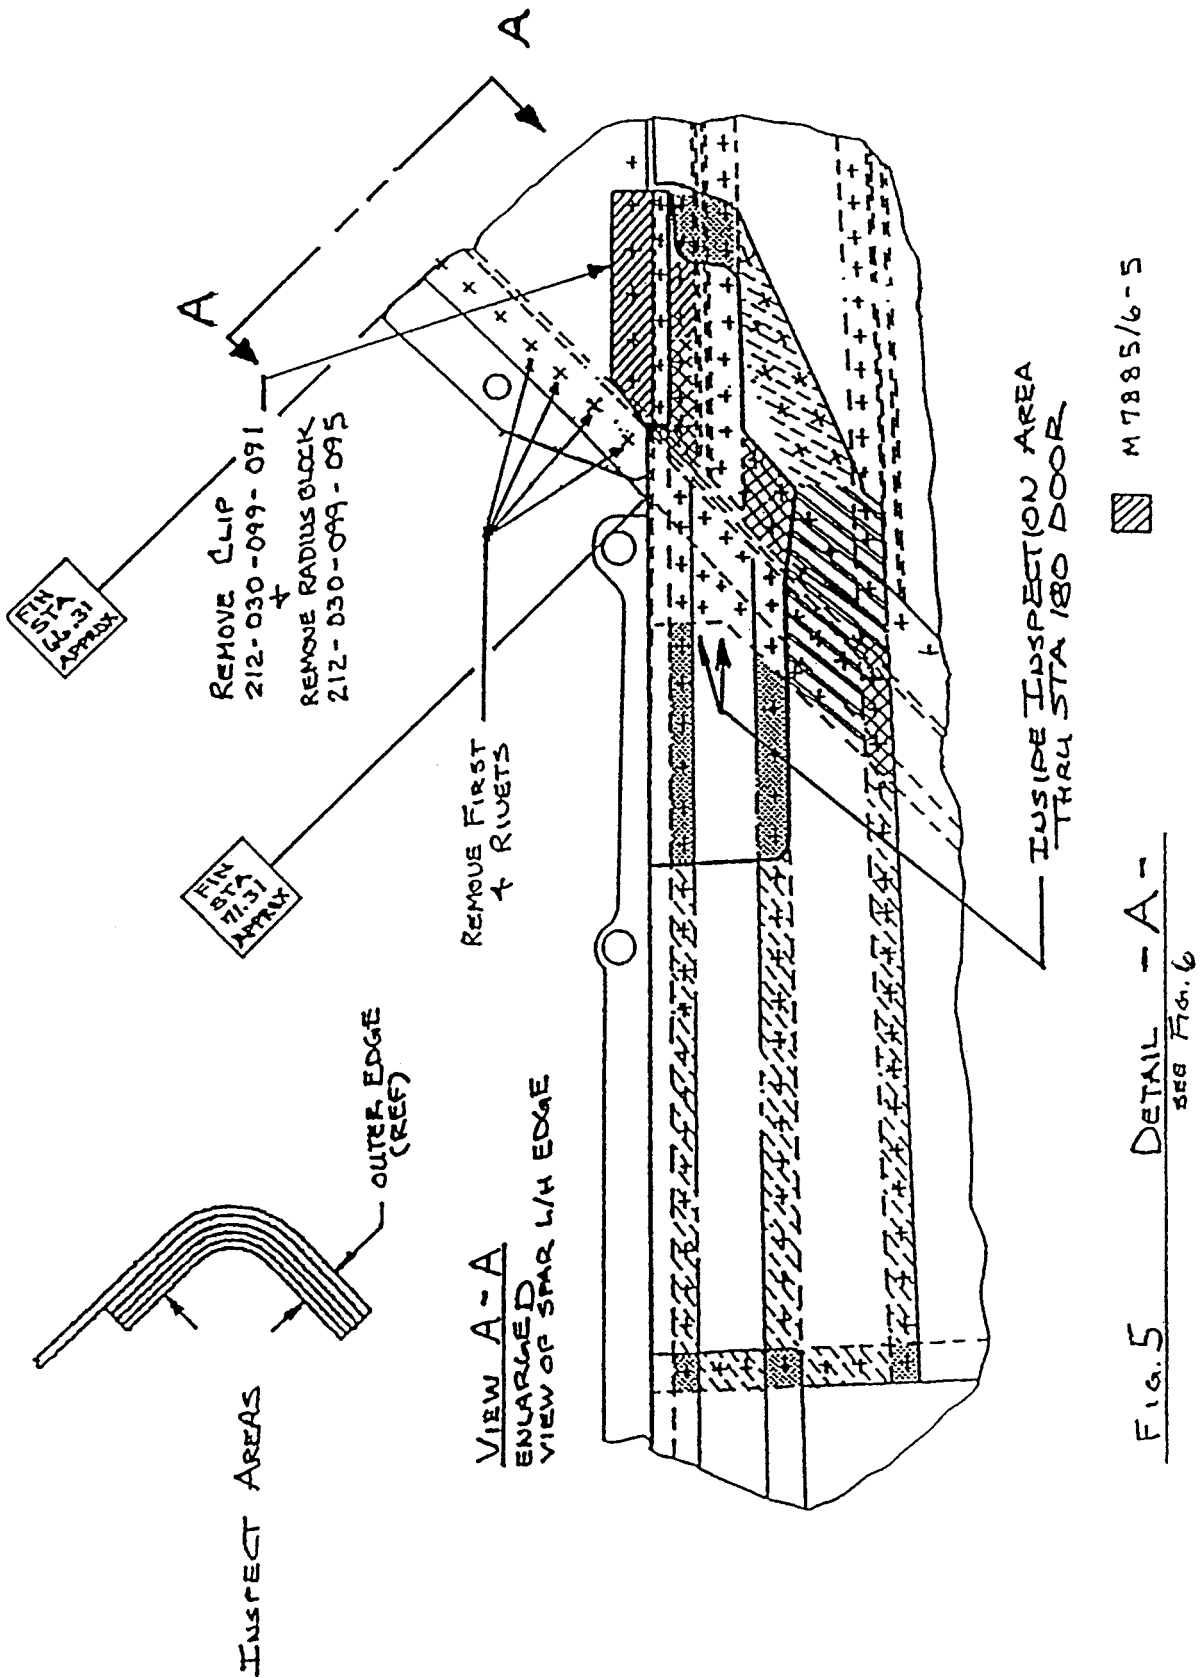
(iii) Through the lower aft tailboom inspection door, using a bright light and an inspection mirror, inspect the vertical fin spar assembly adjacent to the tailboom top skin on the forward side, paying special attention to the left-hand edge and the adjacent surfaces (see Figure 5).

(iv) In a ventilated work area, clean all surfaces to be inspected with a cloth dampened with aliphatic naphtha or an equivalent cleaning solvent. Using a bright light and a 10x magnifying glass, inspect the vertical fin spar assembly adjacent to the tailboom top-skin on the in-board and out-board sides, the vertical edge, and the two open rivet holes. Using a bright light and a mirror, inspect the aft side of the vertical fin spar in the same area. Special attention must be given to the left-hand edge of the vertical fin spar and any adjacent surfaces between fin stations 66.31 and 71.31 (see Figure 5).

(iv) In a ventilated work area, clean all surfaces to be inspected with a cloth dampened with aliphatic naphtha or an equivalent cleaning solvent. Using a bright light and a 10x magnifying glass, inspect the vertical fin spar assembly adjacent to the tailboom top-skin on the in-board and out-board sides, the vertical edge and the two open rivet holes. Using a bright light and a mirror, inspect the aft side of the vertical fin spar in the same area. Special attention must be given to the left-hand edge of the vertical fin spar and any adjacent surfaces between fin stations 66.31 and 71.31 (see Figure 5).

(i) Remove the clip, P/N 212-030-099-091, and the radius block, P/N 212-030-099-095, (see Figures 5 and 6).

(ii) Remove the first four rivets from the vertical fin spar, located at the bottom of the vertical fin spar left-hand side at the tailboom and vertical fin spar junction as shown (see Figure 5). CAUTION: Extreme care must be taken when drilling and removing rivets from the side of vertical fin spar to ensure the vertical fin spar assembly is not damaged.

(vi) Reinstall the clip and radius block with M 7885/6-5 rivets (see Figure 5).
