[Docket No. 97-SW-35-AD; Amendment 39-10521; AD 97-20-09]

**Airworthiness Directives; Bell Helicopter Textron (Bell)-manufactured Model HH-1K, TH-1F, TH-1L, UH-1A, UH-1B, UH-1E, UH-1F, UH-1H, UH-1L, and UH-1P Helicopters; and Southwest Florida Aviation SW204, SW204HP, SW205, and SW205A-1 Helicopters**

**AD 97-20-09 California Department of Forestry; Firefly Aviation Helicopter Services (Previously Erickson Air Crane Co.); Garlick Helicopters, Inc.; Hawkins and Powers Aviation, Inc.; International Helicopters, Inc.; Ranger Helicopter Services; Robinson Airplane; Scott Paper Co.; Smith Helicopters; Southern Helicopter; Southwest Florida Aviation; Utah State University; Western International Aviation, Inc.; UNC Helicopters; and U.S. Helicopter, Inc.:** Amendment 39-10521. Docket No. 97-SW-35-AD. Supersedes priority letter AD 97-20-09.

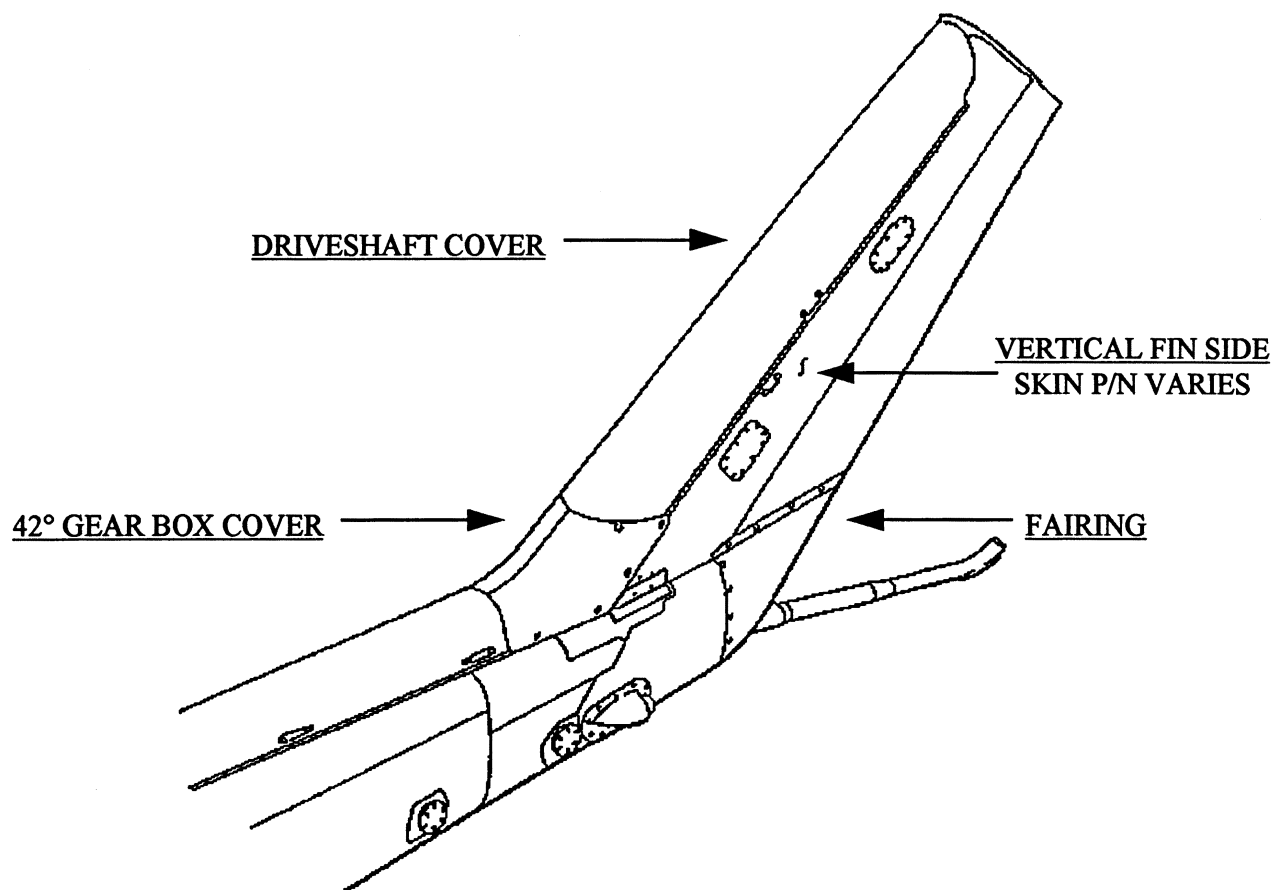
Figure 1

(1) Remove the 42° gearbox cover and open the drive shaft cover on the vertical fin spar assembly (see Figure 1).

(2) Remove the 42° gearbox cover and open the drive shaft cover on the vertical fin (see Figure 1).

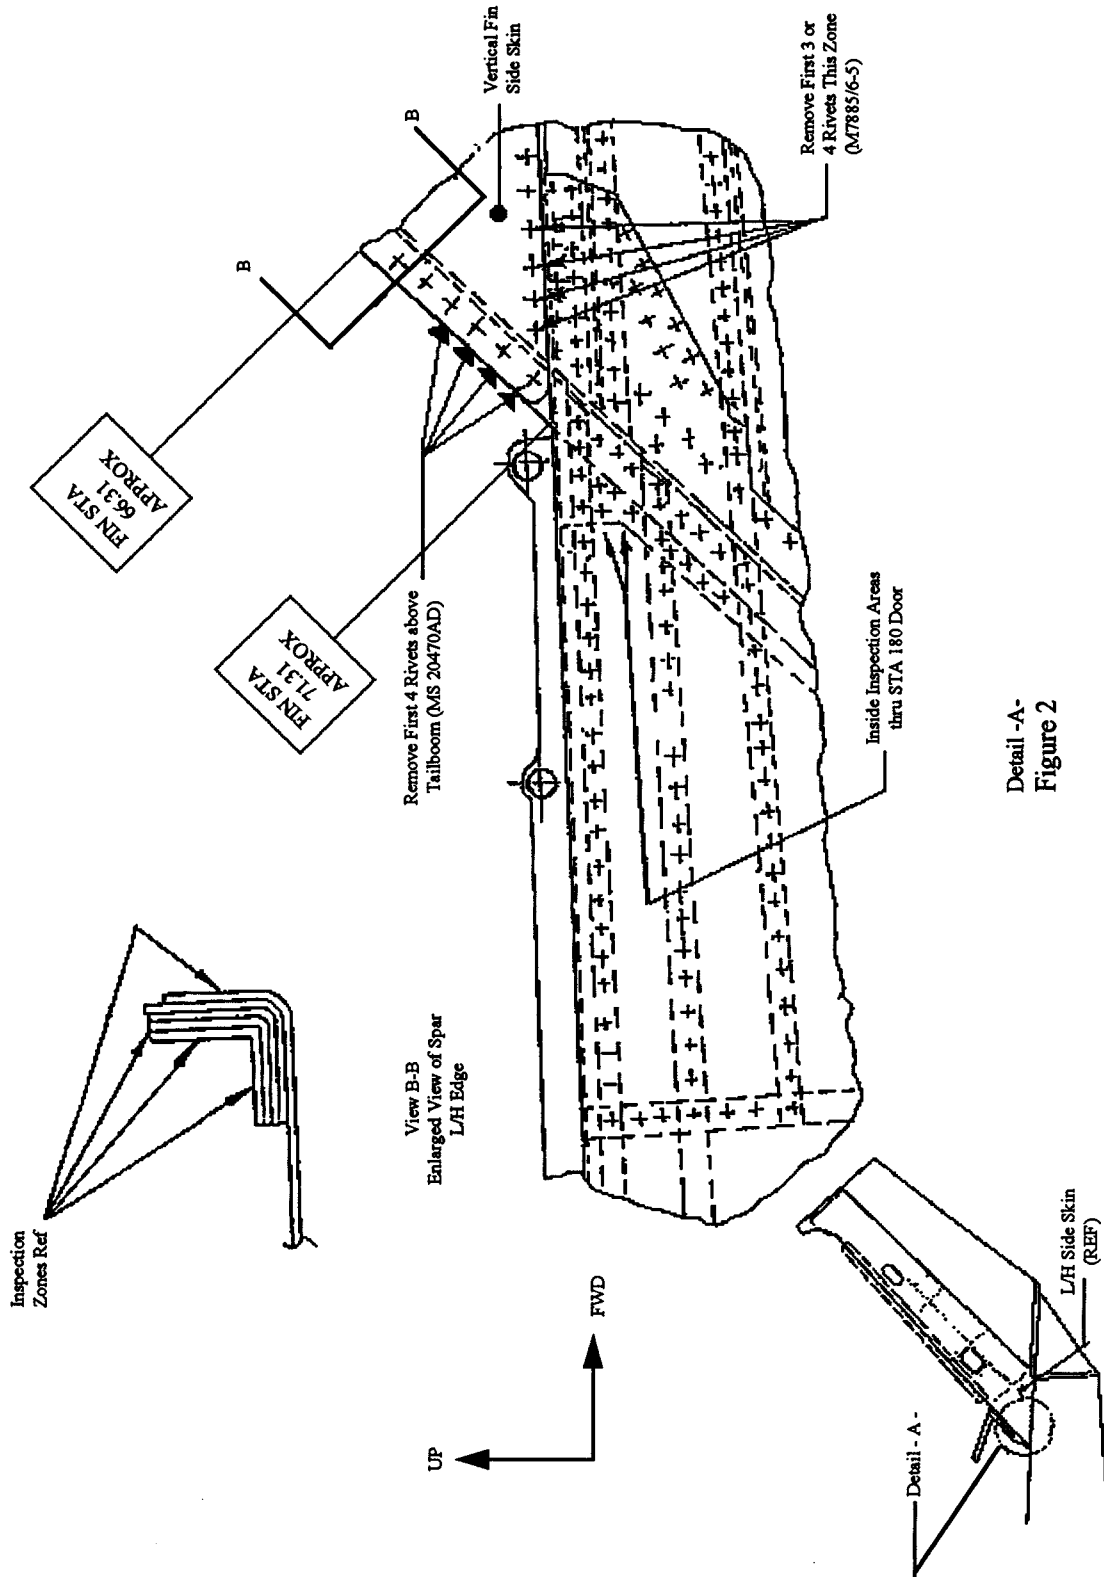
Detail - A-  
Figure 2

(2) Remove the first four rivets from the vertical fin spar located at the bottom of the vertical fin spar left-hand side at the tailboom and vertical fin spar junction, and the first four rivets aft of the junction along the lower

edge of the vertical fin spar side-skin as shown (see Figure 2).

(3) Through the lower aft tailboom inspection door, using a bright light and an inspection mirror, inspect the vertical fin spar assembly adjacent to the tailboom top skin on the forward side, paying special attention to the left-hand edge and the adjacent surfaces (see Figure 2).

(4) In a ventilated work area, clean all surfaces to be inspected with a cloth dampened with aliphatic naphtha or an equivalent cleaning solvent. Using a bright light and a 10x magnifying glass, inspect the vertical fin spar assembly adjacent to the tailboom top-skin on the in-board and out-board sides, the vertical edge, and the two open rivet holes. Using a bright light and a mirror, inspect the aft side of the vertical fin spar in the same area. Special attention must be given to the left-hand edge of the vertical fin spar and any adjacent surfaces between fin stations 66.31 and 71.31 (see Figure 2).

(c) If any crack is discovered on the vertical fin spar as a result of the inspection specified in paragraphs (b)(3) or (b)(4) of this AD,

(6) Reinstall the vertical fin spar skin lower edge rivets using M 7885/6-5 rivets (see Figure 2).

replace the vertical fin spar assembly with an airworthy vertical fin spar assembly before further flight.

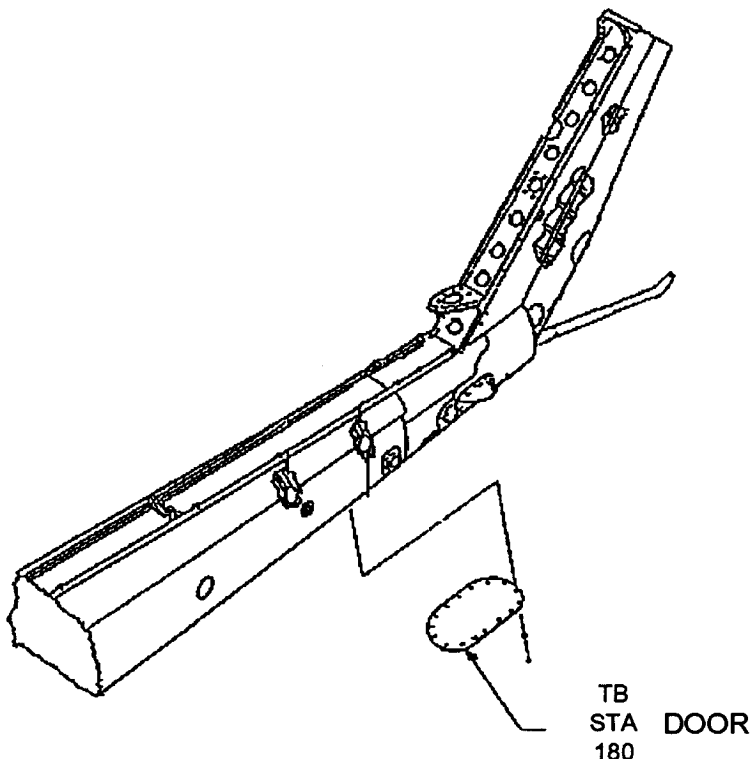
Figure 4

(1) Remove the lower aft tailboom inspection door, located at tailboom station 180 (see Figure 4).
