[Docket No. 97-SW-65-AD; Amendment 39-10619; AD 98-13-28]

**Airworthiness Directives; Agusta S.p.A. Model A109C and A109K2 Helicopters**

**AD 98-13-28 AGUSTA S.p.A.:** Amendment 39-10619. Docket No. 97-SW-65-AD.

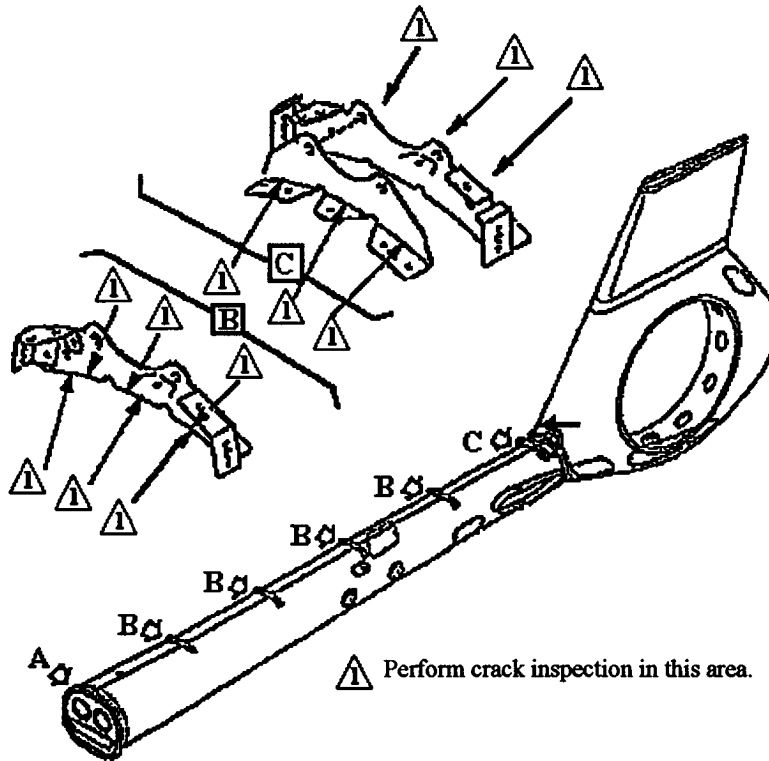
Inspection of Bearing Supports  
Figure 1

(1) Inspect each bearing attaching lock plate that was installed with the Fenestron

(2) Inspect for broken or missing slippage marks that may indicate looseness or rotation of attaching hardware.

(3) If a lock plate tab is bent open on bearing supports A, B, or C (shown in Figure 1), or if slippage marks are broken or missing, contact the Manager, Rotorcraft Standards Staff.

(c) Before further flight, and thereafter at intervals not to exceed 15 hours TIS, using a 6-power or higher magnifying glass and a bright light, visually inspect bearing supports B and C as shown in Figure 1 for cracks. If a crack is found, replace the bearing support with an airworthy bearing support.

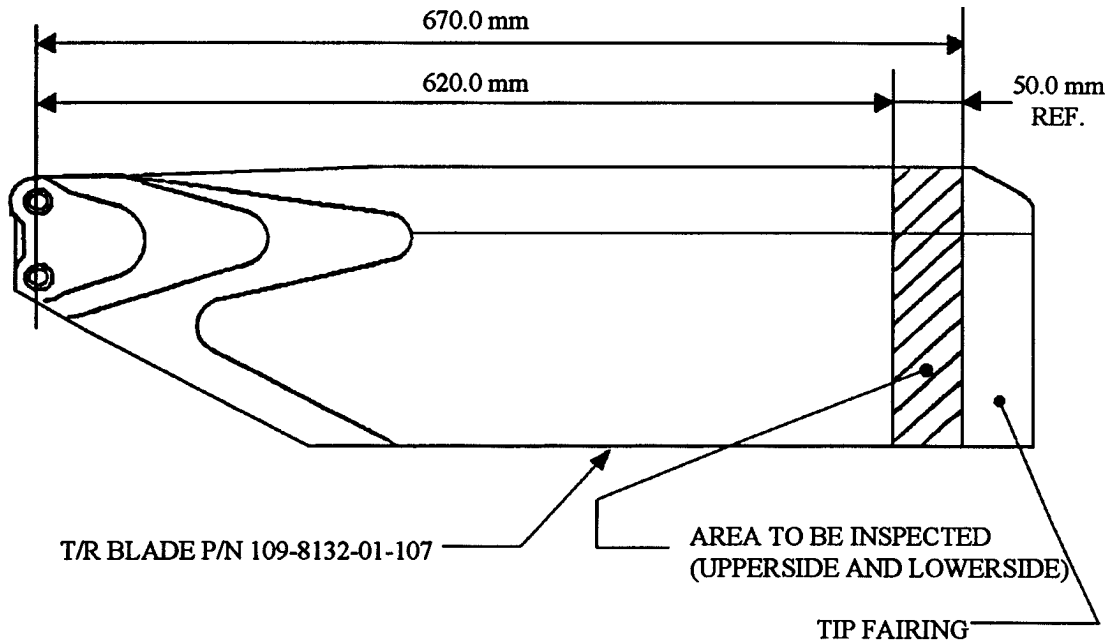
Figure 1

inspected is located in a spanwise band from 620.0 mm to 670.0 mm (24.4 to 26.4 inches), as measured outboard from the blade retention bolt centerline. Inspect the entire blade surface on both sides of each blade within this band (see Figure 1).

(b) Perform a tapping inspection to detect debonds within the blade surface area identified in paragraph (a) of this AD, using an aluminum hammer, P/N 109-3101-58-2, or equivalent. The presence of paint cracks on the tail rotor blade upper or lower surface in the tip fairing area at the 670.0 mm spanwise location (see Figure 1) may indicate that debonds exist.

(c) Any blade that does not meet the allowable debond criteria specified in the applicable maintenance manual must be replaced with an airworthy blade before further flight.
