[Docket No. 97-SW-14-AD]

Airworthiness Directives; Eurocopter France Model SA. 315B, SA. 316B, SA. 316C, SA. 319B, and SE. 3160 Helicopters

ACTION: Notice of proposed rulemaking (NPRM).

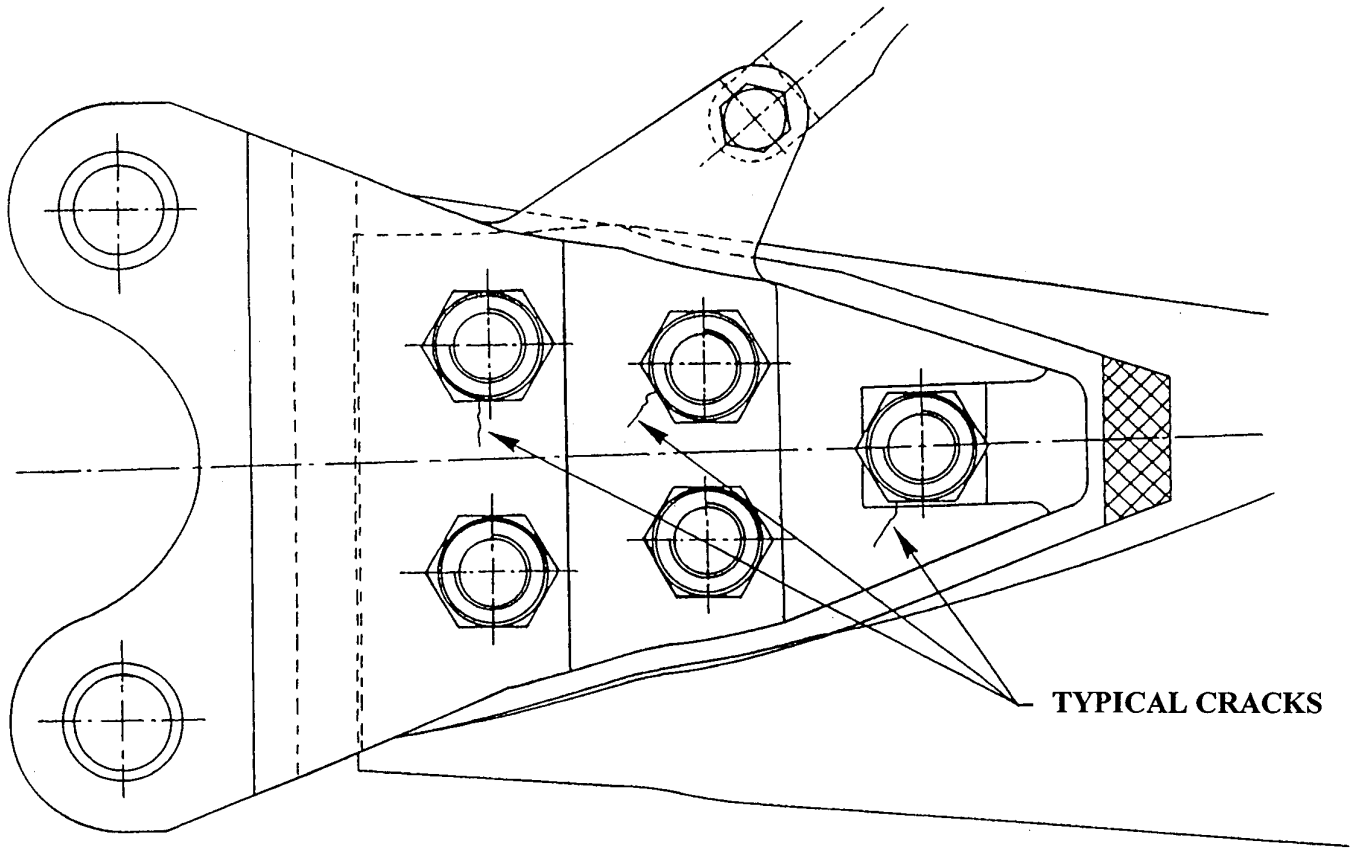
Figure 1

(a) Inspect both upper and lower blade surfaces of each blade cuff for cracks (see Figure 1) as follows:

(2) Inspect the blade cuff for cracks, paying particular attention to the area around the attaching bolts, using a 10-power or higher magnifying glass.

(3) If a crack is suspected, remove any paint and clean the area under inspection using a Naptha-type solvent or equivalent, and conduct a dye penetrant inspection. Completely isolate the area under inspection with self-adhesive aluminum tape to prevent solvent or penetrating dye seepage into the other areas of the blade.

(b) If a crack is detected, remove the blade and replace it with an airworthy blade.
