[Docket No. 98-SW-45-AD; Amendment 39-10908; AD 98-21-09]

#### Airworthiness Directives; Robinson Helicopter Company Model R22 Helicopters

**98-21-09 Robinson Helicopter Company:**  
Amendment 39-10908. Docket No. 98-WW-45-AD.

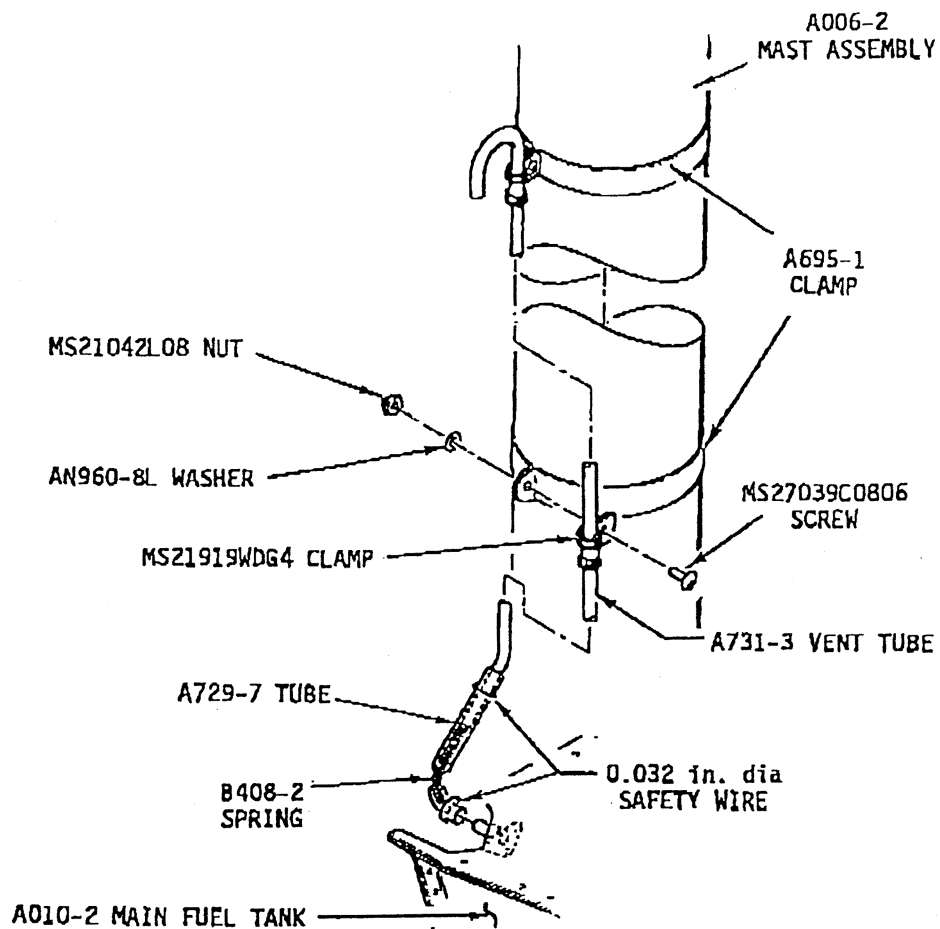
FIGURE 1

# HELICOPTER WITHOUT AUXILIARY FUEL TANK

(1) For helicopters without an auxiliary fuel tank installed, remove the existing vent tube, P/N A731-1, and install an airworthy vent tube, P/N A731-3, with flexible tube, P/N A729-7, using an MS27039C0806 screw and AN960-8L washer (alternate P/N NAS1149FN816P) at the lower clamp, P/N A695-1 (see Figure 1).

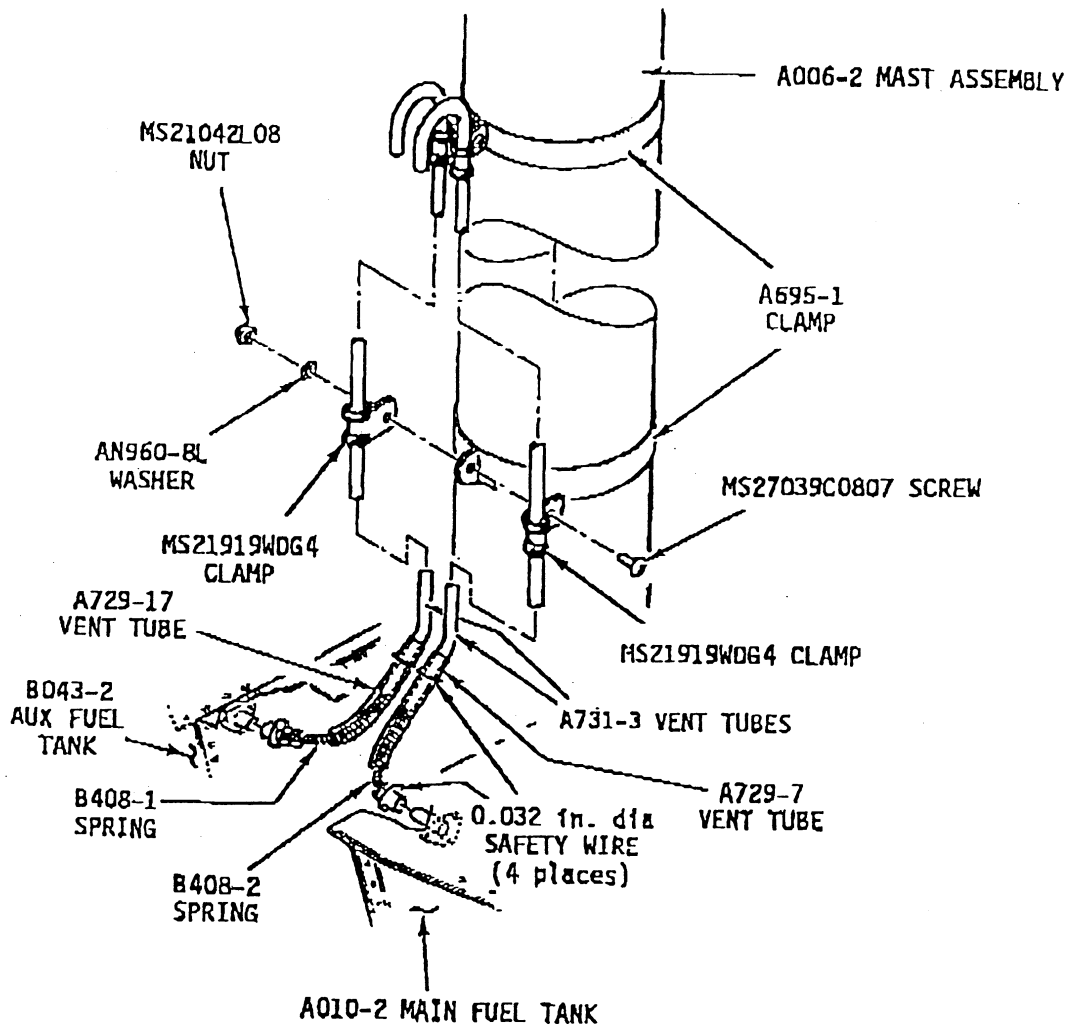
FIGURE 2

## HELICOPTER WITH AUXILIARY FUEL TANK

(2) For helicopters with an auxiliary fuel tank installed, remove the existing main fuel tank vent tube, P/N A731-1, and auxiliary fuel tank vent tube, P/N A731-2, and install airworthy vent tubes, P/N A731-3, with flexible tube, P/N A729-7, for main tank and flexible tube, P/N A729-17, for auxiliary tank using MS27039C0807 screw and AN960-8L washer (alternate P/N NAS1149FN816P) at lower clamp, P/N A695-1 (see Figure 2).
