[Docket No. 98-NM-323-AD]

Airworthiness Directives; Boeing Model 757-200, -200PF, and -200CB Series Airplanes Powered by Rolls-Royce RB211-535C/E4/E4B Turbofan Engines

ACTION: Notice of proposed rulemaking (NPRM).

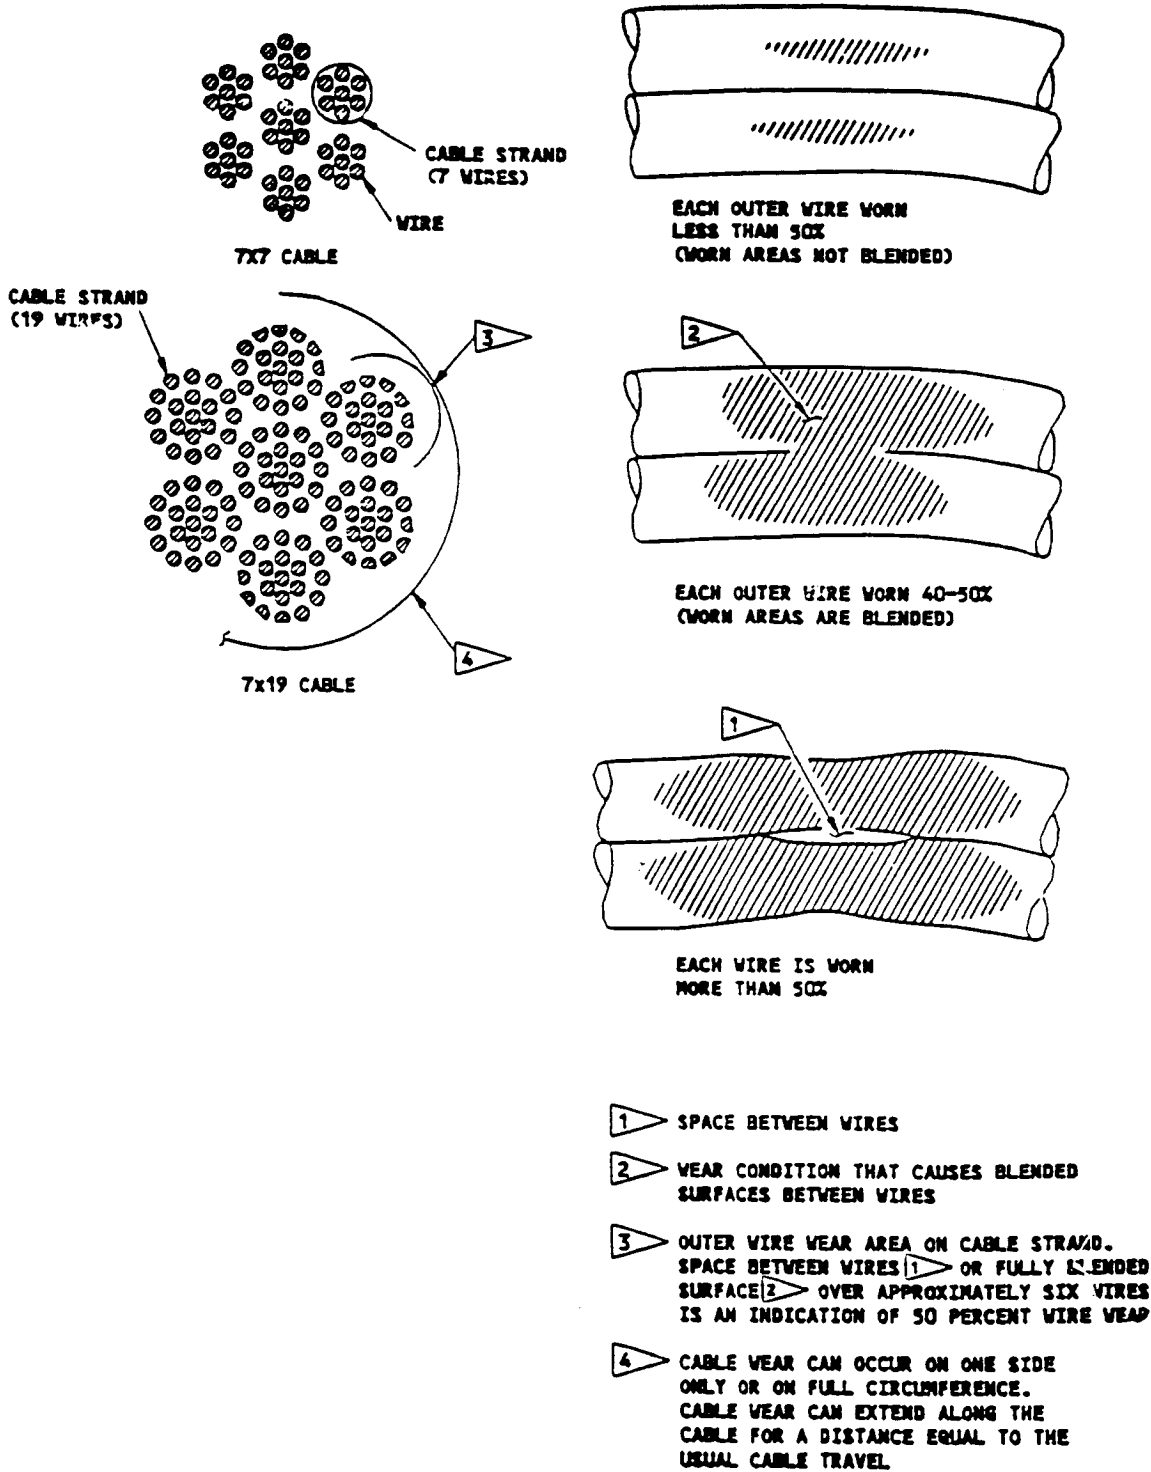
Figure 1.

(1) If one cable strand has worn wires where one wire cross section is decreased by 40 percent or more in an area that goes over a pulley, through a pressure seal, or through a fairlead (see Figure 1).

B. Visually examine the pulley wear pattern (see Figure 2).

(1) An unusual pulley wear pattern.

CABLE TENSION TOO HIGH

PULLEY NOT ALIGNED CORRECTLY

PULLEY TOO LARGE FOR CABLE

CABLE NOT ALIGNED CORRECTLY

PULLEY WILL NOT TURN

Pulley Wear Patterns

C. Remove the control cable from the airplane when you find one of these conditions:

F. Remove the pulley from the airplane when you find one of these conditions:
