[Docket No. 98-SW-46-AD; Amendment 39-11084; AD 99-07-02]

Airworthiness Directives; Eurocopter France Model AS 332C, L, L1, and L2 Helicopters and Model SA 330F, G, and J Helicopters

AD 99-07-02 Eurocopter France:

Amendment 39-11084. Docket No. 98-SW-46-AD.

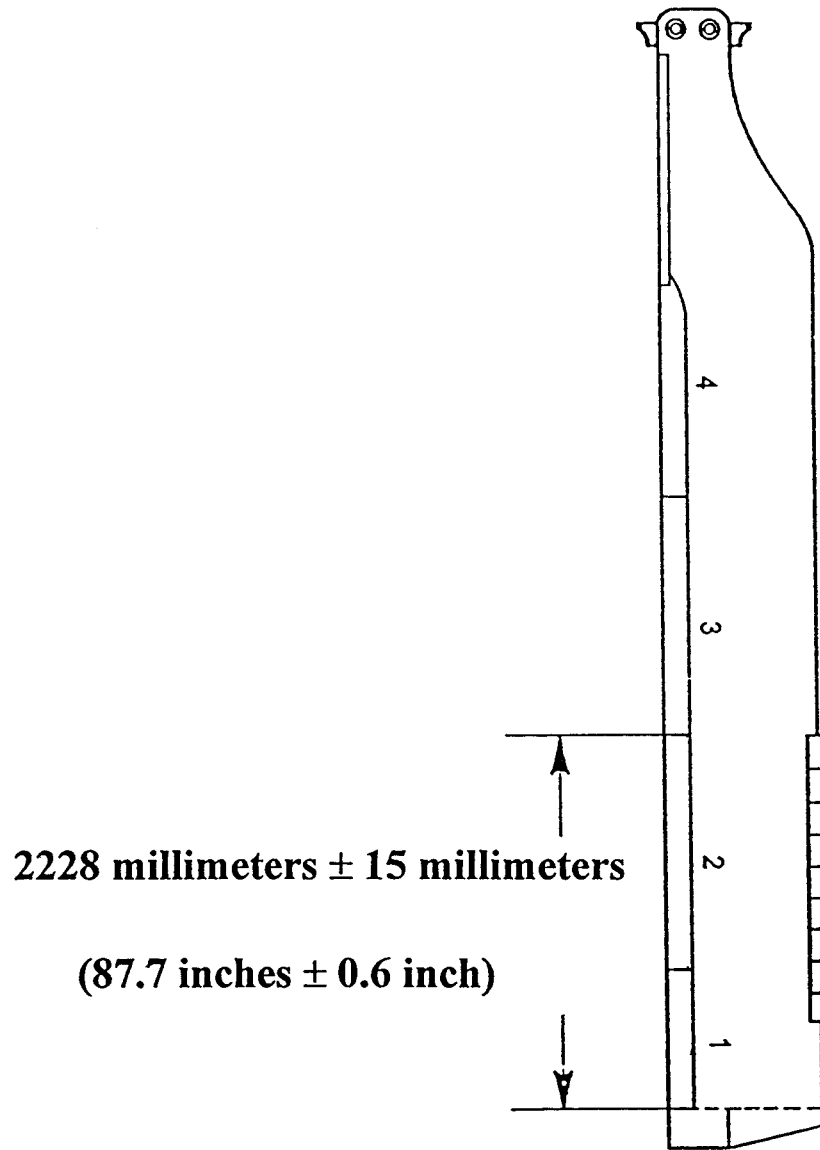
Figure 1

To detect a mislocated or improperly bonded main rotor blade (blade) leading edge stainless steel protective strip (strip), which could result in failure of the blade and subsequent loss of control of the helicopter, accomplish the following:

(2) Inspect the blade strips for correct positioning on each main rotor blade by measuring the distance from the tip cap-blade junction as shown in Figure 1. This distance must be 2228 mm plus or minus 15 mm (87.7 inches plus or minus 0.6 inch). If the strip is incorrectly positioned, remove the blade and replace it with an airworthy blade within 100 hours TIS (see Figure 1).

(b) Within 100 hours TIS, and thereafter at intervals not to exceed 100 hours TIS, inspect the strips for correct bonding using a bonding check by sound (tapping test). If a defect is found that is outside the tolerance limits, remove the blade and replace it with an airworthy blade.
