Airworthiness Directives; Boeing Model 767 Series Airplanes Powered by Pratt & Whitney JT9D-7R4 Series Turbofan Engines or General Electric CF6-80A Series Turbofan Engines

ACTION: Notice of proposed rulemaking (NPRM).

Boeing: Docket 98-NM-363-AD.

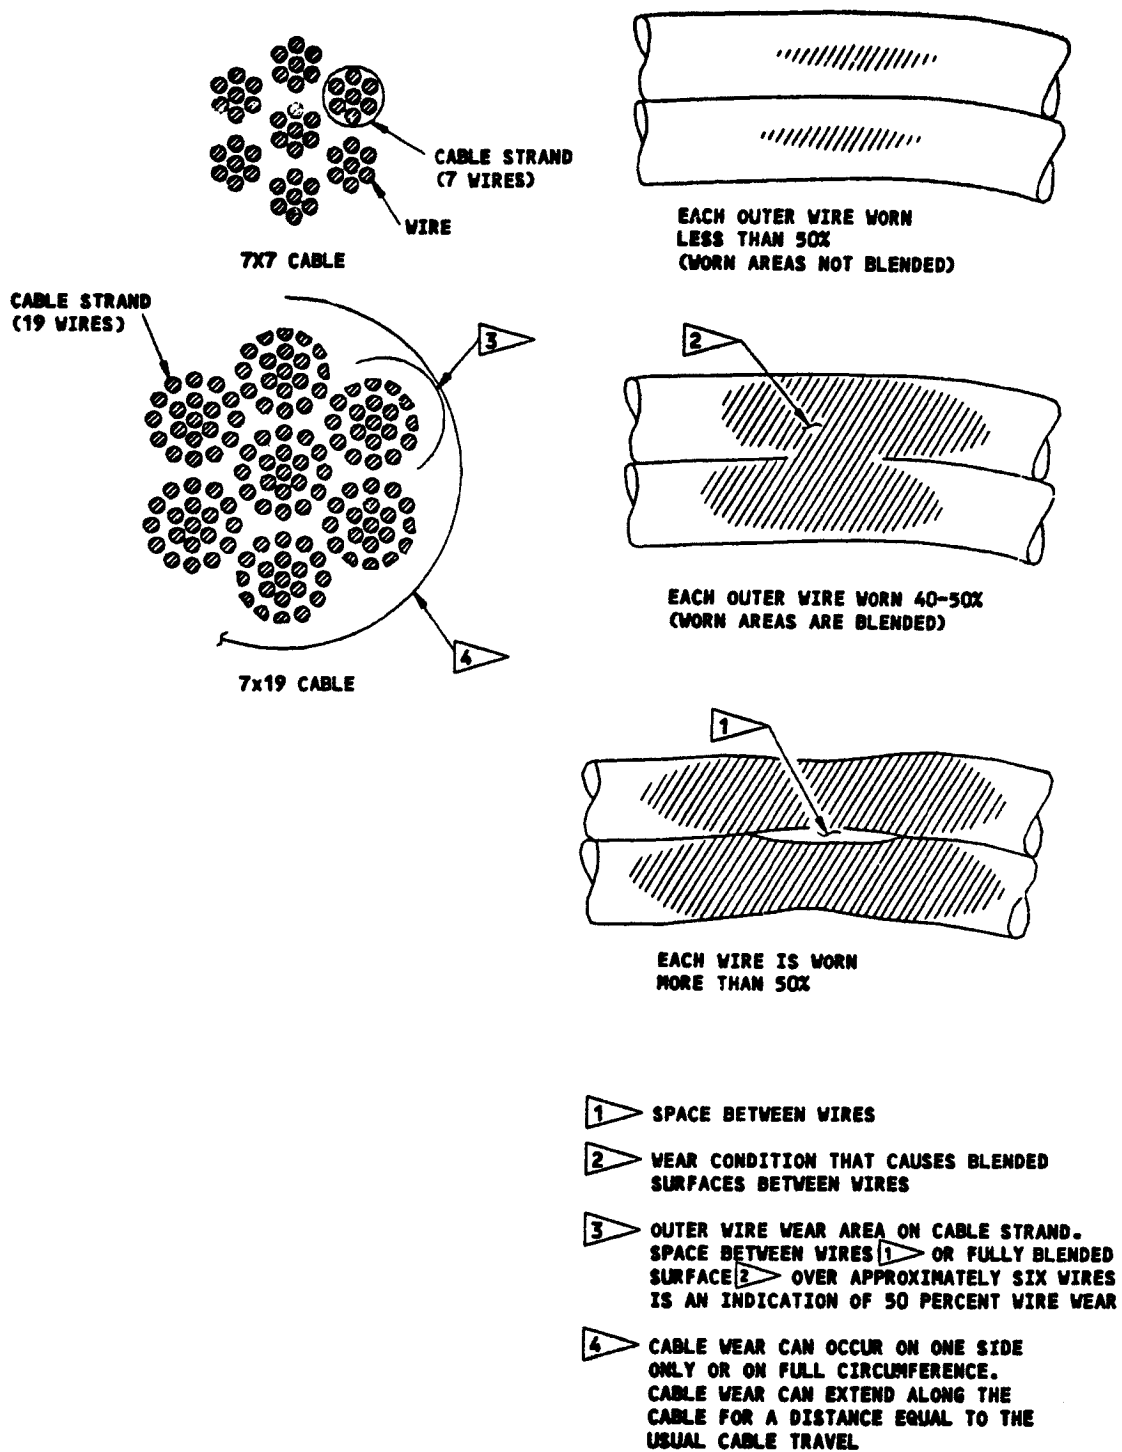
Figure 1

- (1) Two or more broken wires.
- (2) If one cable strand has worn wires where one wire cross section is decreased by 40 percent or more (see Figure 1).
- (3) For cables not in the pressurized area, replace a worn cable where you cannot identify the wire strands on the worn side.
- (4) A broken wire in the area that goes over a pulley, through a pressure seal, or through a fairlead.

C. Replace the control cable when you find one of these conditions:

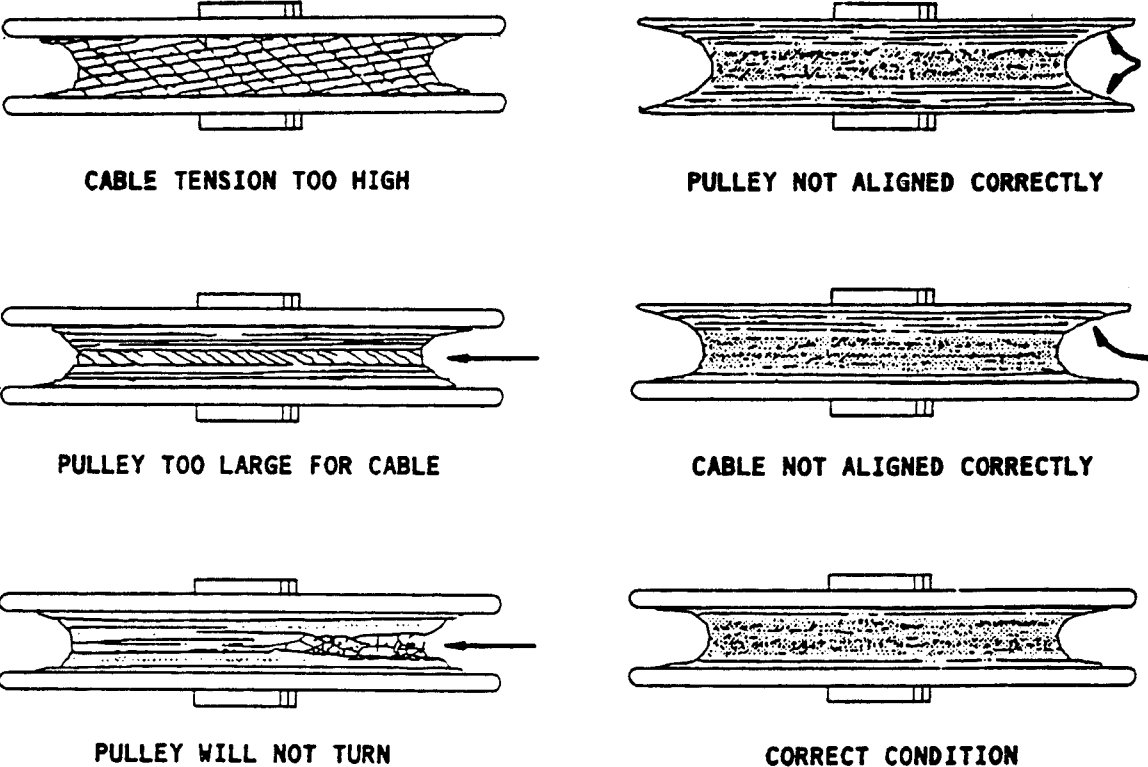
Pulley Wear Patterns

B. Visually examine the pulley wear pattern (see Figure 2).

- (1) An unusual pulley wear pattern.
- (2) Too much pulley wobble.
- (3) The pulley does not turn freely and smoothly.

F. Replace the pulley when you find one of these conditions:
