## DEPARTMENT OF TRANSPORTATION

#### 14 CFR Part 39

[Docket No. 98–NM–300–AD]

#### Airworthiness Directives; Mitsubishi Model YS–11 and YS–11A Series Airplanes

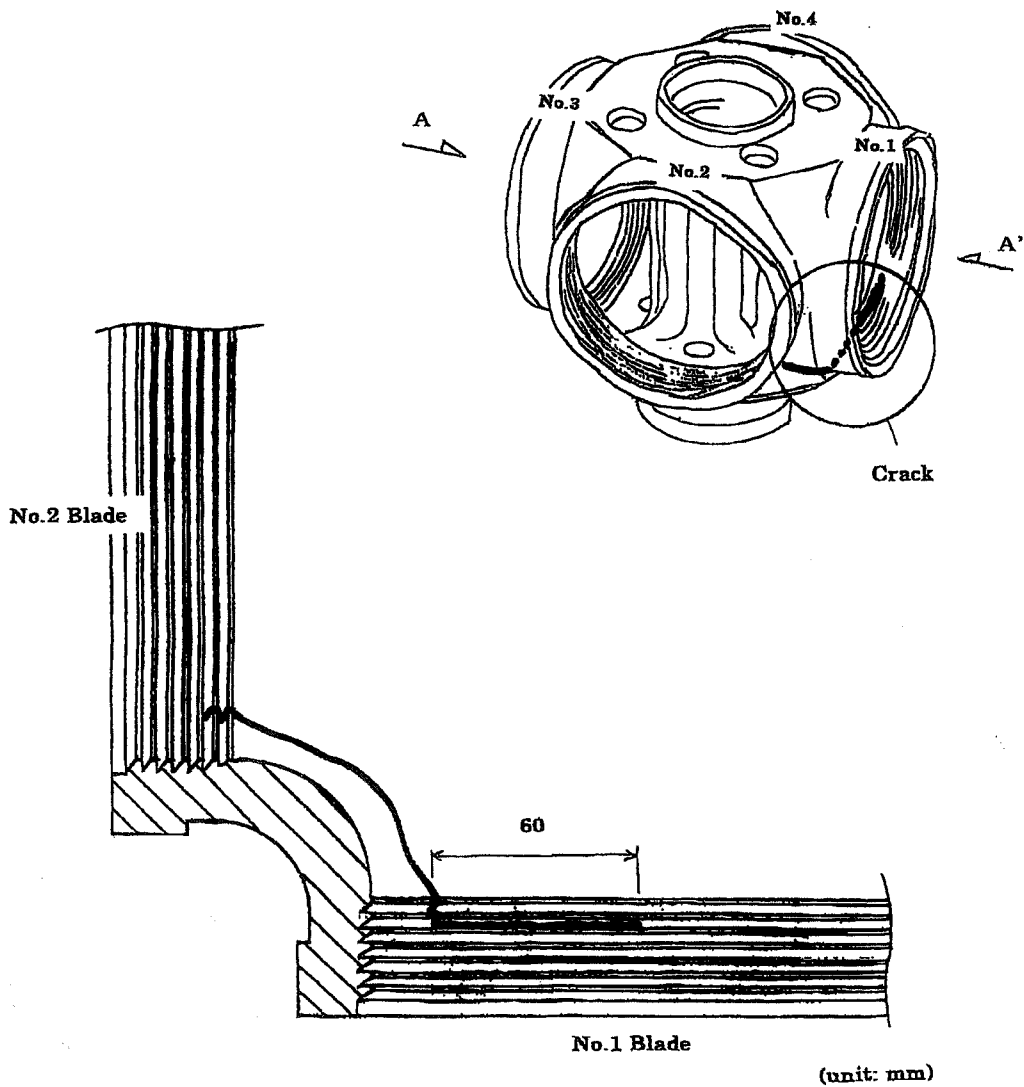
Figure 1 (Sheet 1 of 2)

The Japan Civil Aviation Bureau (JCAB), which is the airworthiness authority for Japan, notified the FAA that an unsafe condition may exist on all Mitsubishi YS-11 and YS-11A series airplanes. The JCAB advises that cracking has been found on propeller hubs. This cracking has been attributed to material fatigue. This condition, if not corrected, could result in the loss of the propeller.

(a) Within 25 flight hours or 30 days after the effective date of this AD, whichever occurs first, remove the spinner and perform a detailed visual inspection for cracking of the propeller hub in the crack area shown in Figure 1 of this AD.

**HUB CRACK - VIEW FROM TOP**

(Cut A - A')

(2) If any crack is detected, prior to further flight, replace the hub with a new hub. Repeat the actions required by paragraph (a) of this AD thereafter at intervals not to exceed 25 flight hours.

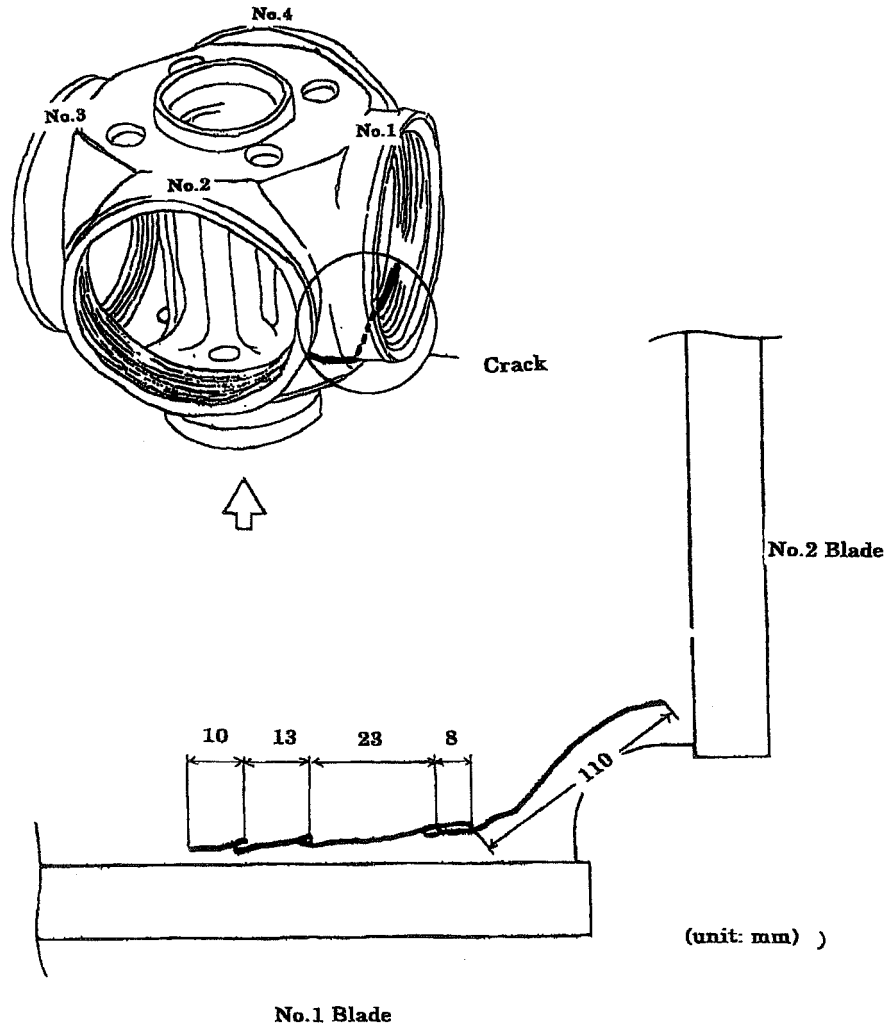
Figure 1 (Sheet 2 of 2)

**HUB CRACK - VIEW FROM BOTTOM**
