[Docket No. 2000-SW-29-AD; Amendment 39-11894; AD 2000-18-09]

Airworthiness Directives; Bell Helicopter Textron, Inc. Model 412, 412EP, and 412CF Helicopters

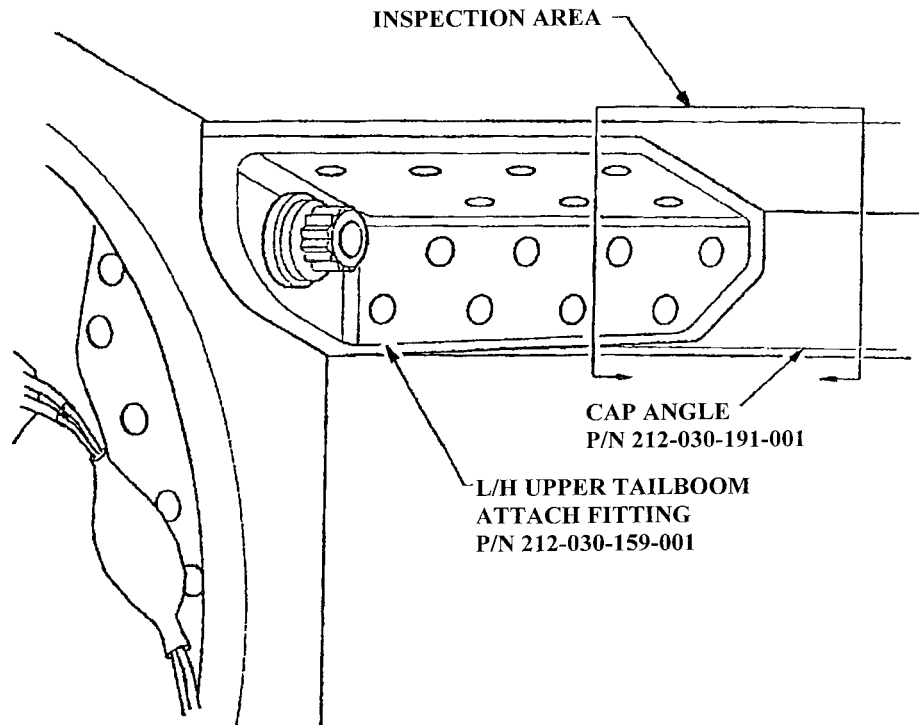
Figure 1 Fuselage Tailboom Attachment Inspection

This AD is prompted by a report of a fatigue crack in a tailboom attachment cap angle. This condition, if not corrected, could result in loss of the tailboom and subsequent loss of control of the helicopter.

(a) Within 25 hours time-in-service (TIS) and thereafter at intervals not to exceed 100 hours TIS, inspect the cap angle and adjacent structure for a crack in the area shown in figure 1. Use a 10-power or higher magnifying glass.

(1) If a crack is found in the cap angle, replace it with an airworthy cap angle before further flight.

(2) Repair any crack found in the adjacent structure before further flight.
