#### Airworthiness Directives; MD Helicopters Inc. Model MD-900 Helicopters

**2001-07-09 MD Helicopters Inc:**

Amendment 39-12175. Docket No. 2000-SW-15-AD. Supersedes Emergency AD 99-26-20, Docket No. 99-SW-89-AD.

**Applicability:** Model MD-900 helicopters, with main rotor upper hub (hub) assembly, part number (P/N) 900R2101006-105 or 900R2101006-107, installed, certificated in any category.

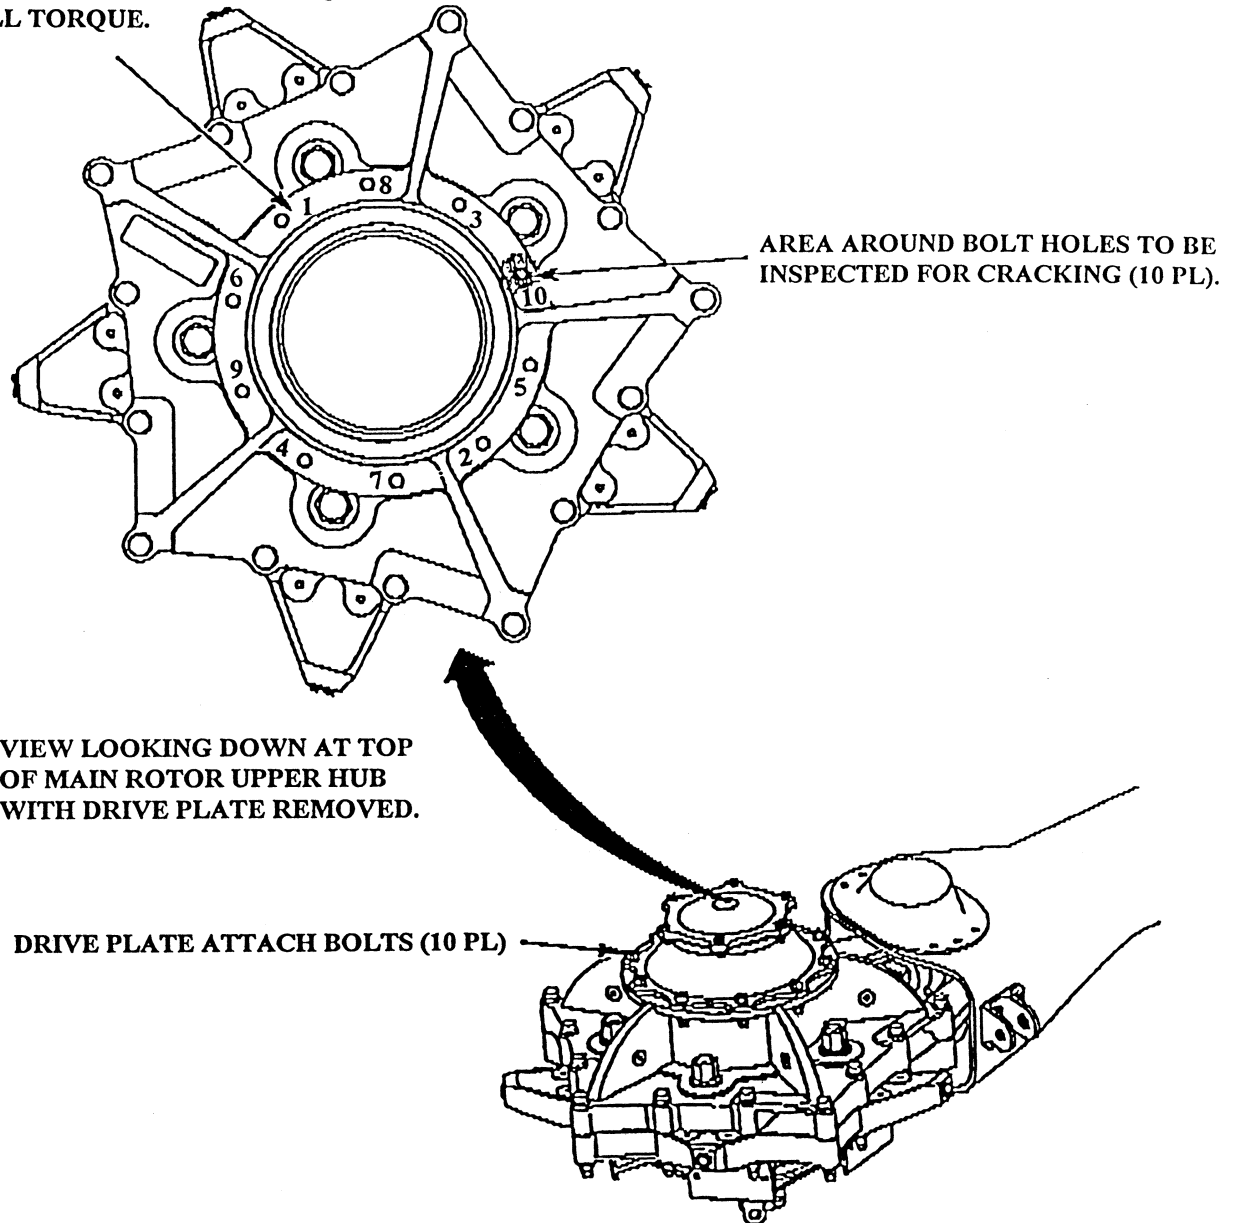
**Figure 1. Main Rotor Upper Hub Assembly Inspection.**

(v) Using paint stripper (Consumable Item List C313 or equivalent) and cleaning solvent (C420 or equivalent), remove the paint from the upper mating surface of the hub assembly to enable an accurate visual inspection of the drive plate attachment bolt hole (bolt hole) area for cracking (Figure 1). Ensure the paint stripper and solvent DO NOT contaminate the upper bearing and upper grease seal areas.

(vi) Using a 10-power or higher magnifying glass and bright light, inspect the mating surface area and the area around and inside the 10 bolt holes of the hub assembly for a crack. If a crack is found, prior to further flight, replace the hub assembly with an airworthy hub assembly.

1. MAIN ROTOR DRIVE PLATE ATTACHMENT HARDWARE TORQUE SEQUENCE.
2. NUMBERING MAY START AT ANY HOLE.
3. TORQUE NUTS TO 1/2 TOTAL TORQUE, THEN FULL TORQUE.

(ii) Mark the main rotor hub holes, bolts, and nuts to correspond with the drive plate hole numbers (see Figure 1).

(viii) Reinstall the main rotor drive plate using 10 new sets of replacement attachment hardware. Torque the nuts to 160 inch pounds above locknut locking/run-on torque in the sequence shown (Figure 1). Record in the rotorcraft logbook, or equivalent record, the locknut locking/run-on torque for each nut.
