[Docket No. 2001-SW-13-AD; Amendment 39-12408; AD 2001-17-17]

Airworthiness Directives; Bell Helicopter Textron, Inc. Model 47B, 47B-3, 47D, 47D-1, 47G, 47G-2, 47G2A, 47G-2A-1, 47G-3, 47G-3B, 47G-3B-1, 47G-3B-2, 47G-3B-2A, 47G-4, 47G-4A, 47G-5, 47G-5A, 47H-1, 47J, 47J-2, 47J-2A, and 47K Helicopters

2001-17-17 Bell Helicopter Textron, Inc.:
Amendment 39-12408. Docket No. 2001-SW-13-AD. Supersedes AD 2000-18-51, Amendment 39-11983, Docket No. 2000-SW-35-AD.

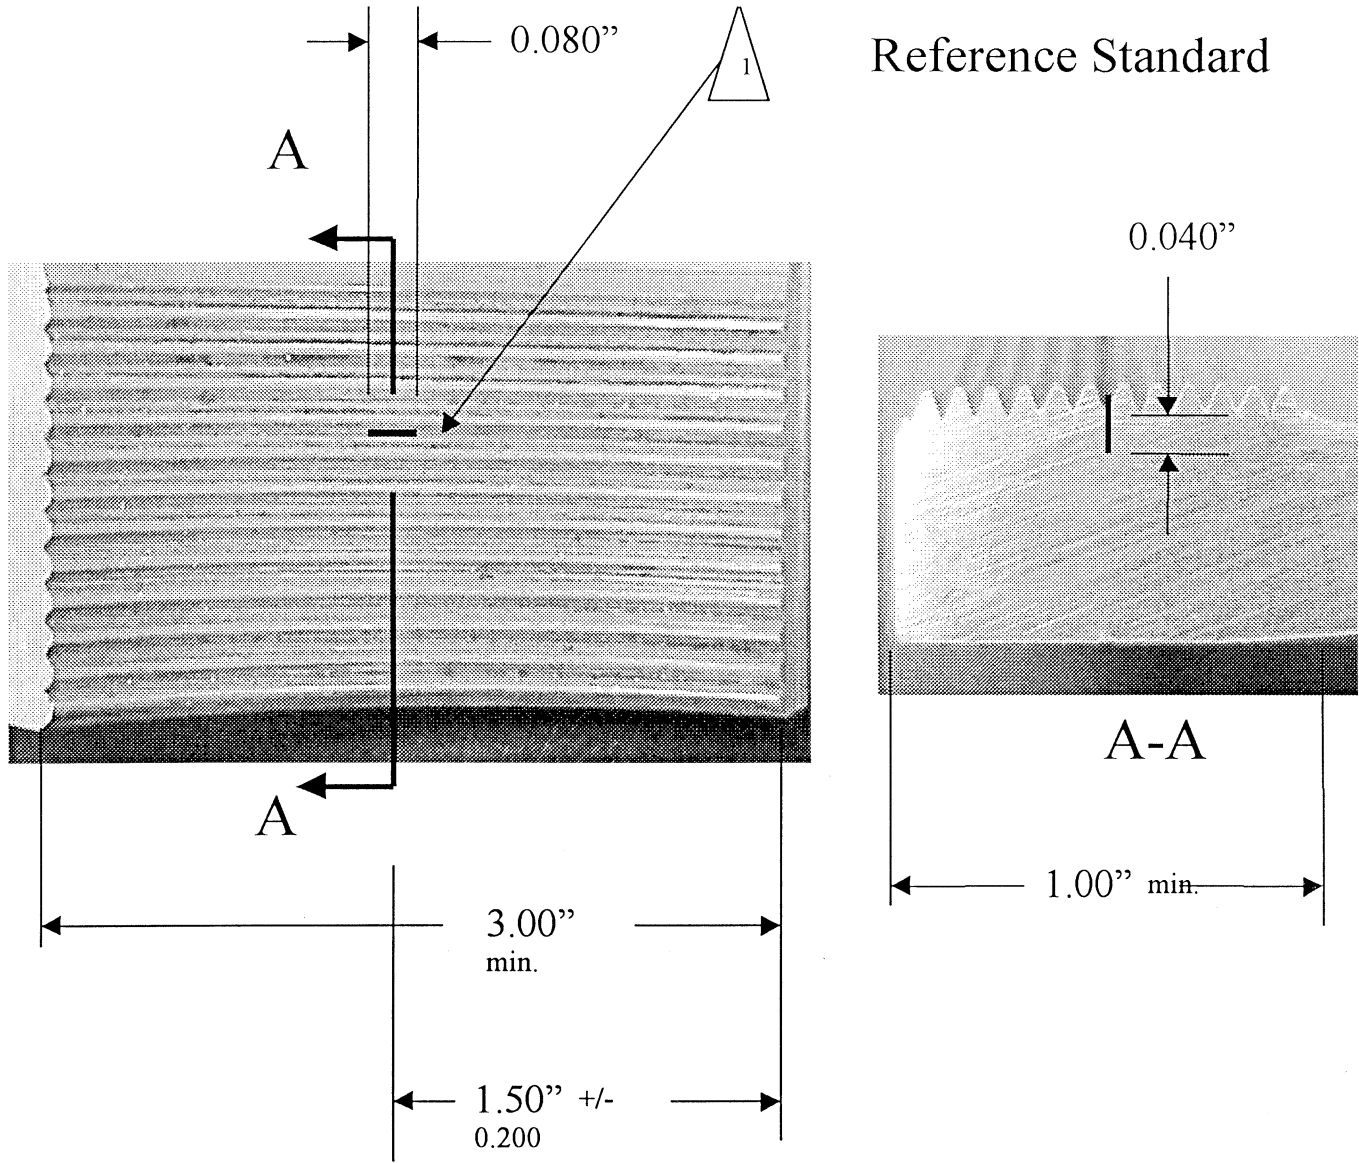
Figure 4, Appendix 1

EDM 1 place only in thread root.
Notch width shall be 0.004 max.
All other dimensions to be +/- 0.004 from indicated.
