[Docket No. 2000–SW–37–AD; Amendment 39–12449; AD 2001–20–03]

#### Airworthiness Directives; Bell Helicopter Textron Canada Model 206L–4 Helicopters

#### 2001-20-03 Bell Helicopter Textron

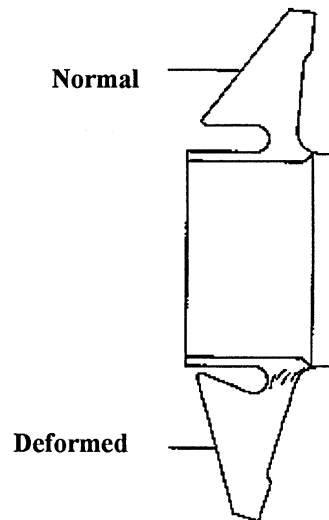
**Figure 1**

(b) Before each engine start, check the indicator for damage in accordance with Figure 1 of this AD. If damage is found, before further flight, replace the damaged indicator with an airworthy indicator, and replace the tail rotor yoke, P/N 406-012-102-107, with an airworthy tail rotor yoke.

**Normal and Deformed (damaged) Indications of the  
High Altitude Tail Rotor Static Stop Yield Indicator (P/N 206-011-752-101)**

(a) Within 100 hours time-in-service, install a high altitude tail rotor static stop yield indicator (indicator), P/N 206-011-752-101, in accordance with the Accomplishment Instructions, Part II, Bell Helicopter Textron Alert Service Bulletin No. 206L-96-104, Revision B, dated July 24, 1998.
