[Docket No. 2001-SW-50-AD]

**Airworthiness Directives; Eurocopter France Model EC120B, EC155B, SA330F, SA330G, SA330J, AS332C, AS332L, AS332L1, AS332L2, AS350B, AS350BA, AS350B1, AS350B2, AS350B3, AS350D, AS355E, AS355F, AS355F1, AS355F2, AS355N, AS365N2, AS365N3, SA-365N, and SA-365N1 Helicopters**

**ACTION:** Notice of proposed rulemaking (NPRM).

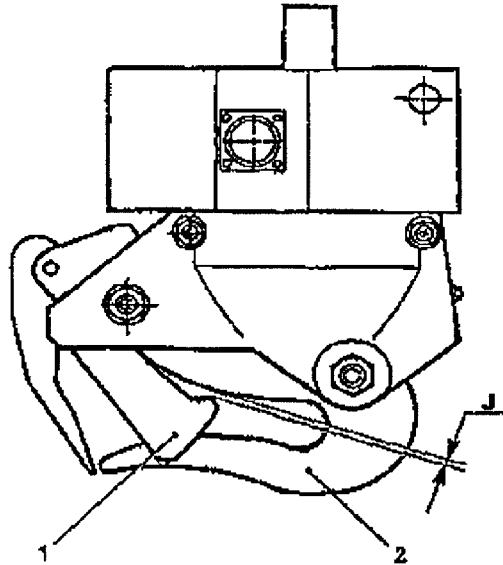
The Direction Generale De L'Aviation Civile (DGAC), the airworthiness authority for France, notified the FAA that an unsafe condition may exist on various ECF model helicopters. The DGAC advises of the discovery of an anomaly on the locking catch of certain cargo hooks that could jam the ring on the cargo hook and jeopardize the release of an underslung load.

This unsafe condition is likely to exist or develop on other helicopters of these same type designs registered in the United States. Therefore, the proposed AD would require, before the next flight utilizing the cargo hook, measuring the clearance between the locking catch and the cargo hook, and removing any cargo hook from service if that clearance is equal to or greater than 14mm (0.55 inches).

Clearance "J" must be less than 14 mm (0.55 inches)

(a) With the cargo hook in the no-load position, measure the clearance "J" in accordance with Figure 1 of this AD. Remove any cargo hook if clearance "J" (see Figure 1) is equal to or greater than 14 millimeters (0.55 inches).
