[Docket No. 2001-SW-39-AD; Amendment 39-12751; AD 2002-10-05]

Airworthiness Directives; MD Helicopters Inc. Model MD-900 Helicopters

ACTION: Final rule.

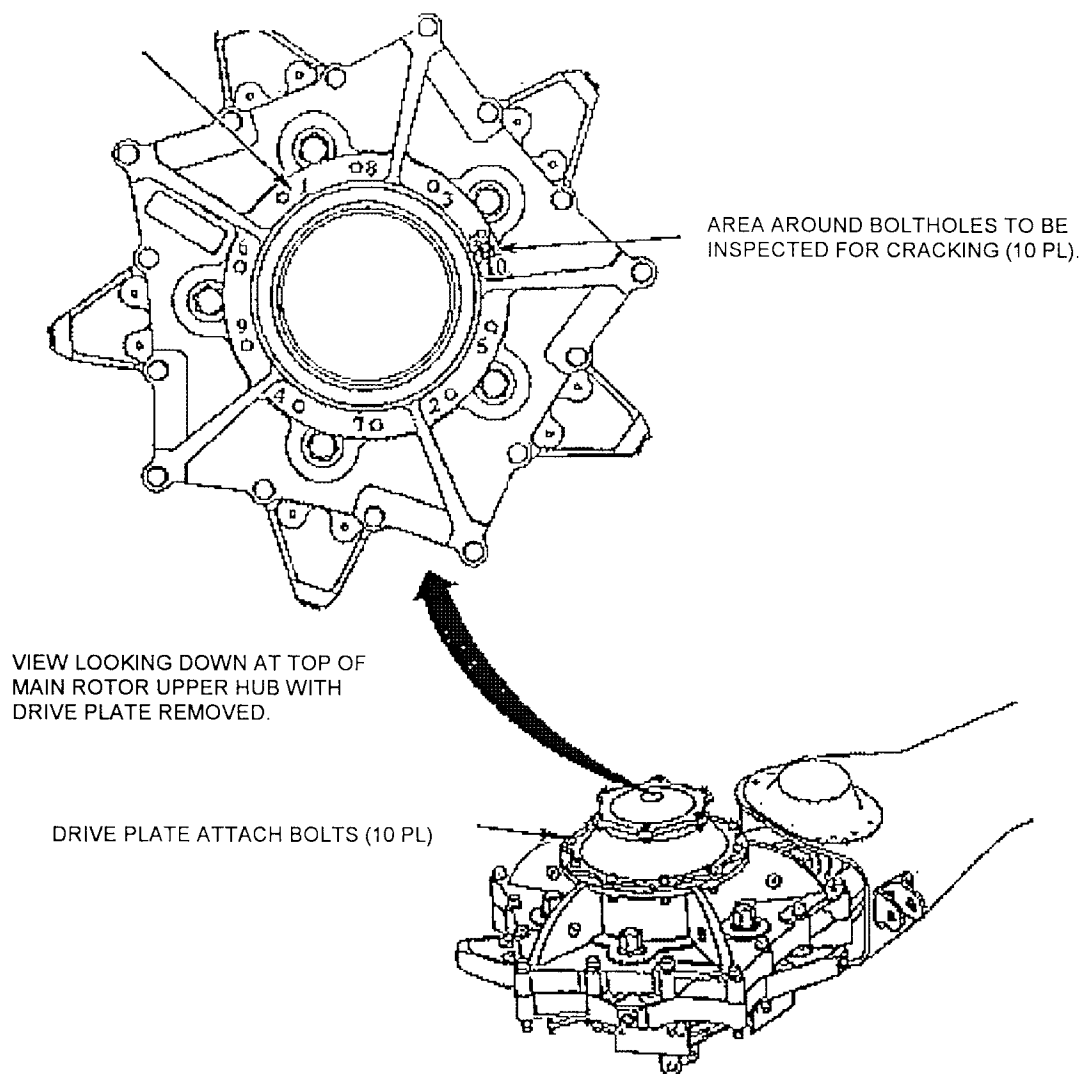
Figure 1. Main Rotor Upper Hub Assembly Inspection

surface of the flange at specified intervals, removing the drive plate and visually inspecting the flange for a crack at specified intervals, and replacing any unairworthy hub assembly. This amendment is prompted by reports that cracks starting at the drive plate attachment holes were found in the hub. The actions specified by this AD are intended to detect a crack in the flange and to prevent failure of the hub assembly, loss of drive to the main rotor, and subsequent loss of control of the helicopter.

1. MAIN ROTOR DRIVE PLATE ATTACHMENT HARDWARE TORQUE SEQUENCE.
2. NUMBERING MAY START AT ANY HOLE.
3. TORQUE NUTS TO 1/2 TOTAL TORQUE, THEN FULL TORQUE.

(ii) Mark the main rotor hub holes to correspond with the drive plate hole numbers (see Figure 1 of this AD).

(v) Using paint stripper (Consumable Item List C313 or equivalent) and cleaning solvent (C420 or equivalent), remove the paint from the upper mating surface of the hub assembly to enable an accurate visual inspection of each drive plate attachment bolt hole (bolt hole) area for cracking (Figure 1). Ensure the paint stripper and solvent DO NOT contaminate the upper bearing and upper grease seal areas.

(vi) Using a 10x or higher magnifying glass and light, inspect the mating surface area and the area around and inside the 10 bolt holes of the hub assembly for a crack. If a crack is found, before further flight, replace the hub assembly with an airworthy hub assembly.

(viii) Reinstall the main rotor drive plate using 10 new sets of replacement attachment hardware. Torque the nuts to 160 inch pounds above locknut locking/run-on torque in the sequence shown (Figure 1). Record in the rotorcraft logbook, or equivalent record, the locknut locking/run-on torque for each nut.
