[Docket No. FAA-2005-22481; Directorate Identifier 2004-NM-176-AD]

Airworthiness Directives; Bombardier Model CL-600-2B19 (Regional Jet Series 100 & 440) Airplanes**AGENCY:** Federal Aviation Administration (FAA), Department of Transportation (DOT).**ACTION:** Notice of proposed rulemaking (NPRM).

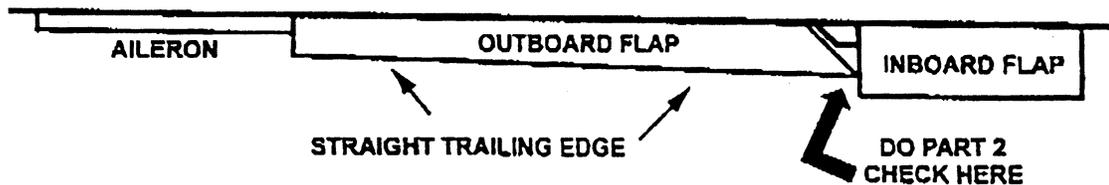
Figure 1. Normal/Abnormal Outboard flap Configuration in Take-off Position”

1. NORMAL

A normal outboard flap has a straight trailing edge, and the inboard corner is slightly above (*i.e.* higher) than the inboard flap.

2. ABNORMAL

The following are indications of an outboard flap with a twist, skew or abnormal deformation:

- Noticeable curve in the trailing edge
- Buckled top or bottom surface
- Higher than normal position of the inboard trailing edge corner

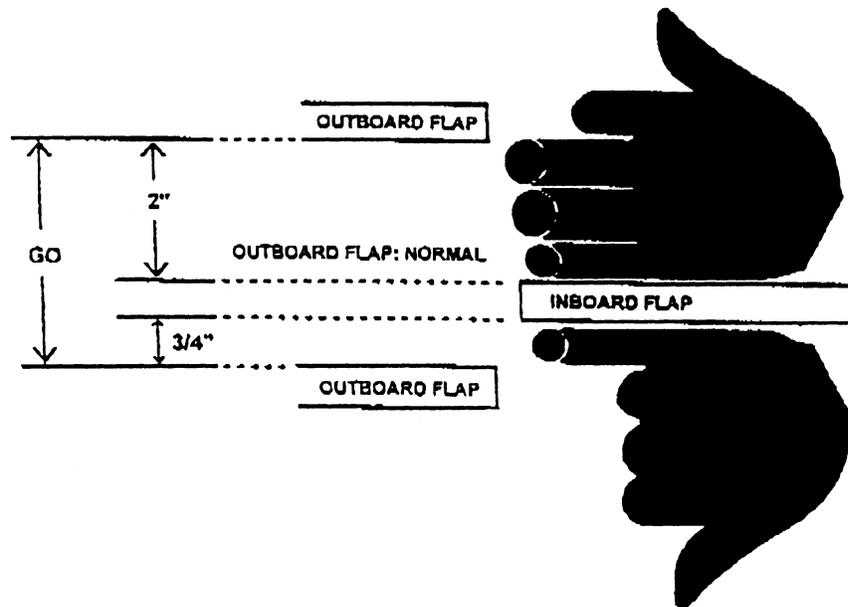
1. FLAPS AT 8 DEGREES

If the outboard flap position is outside the "GO" range as shown below further flight is prohibited.

Whenever the outboard flap position indicator is outside the ‘GO’ range as shown in Figure 2, or whenever directed to do so by the Maintenance Procedure above, perform the following procedures:
