[Docket No. FAA-2005-22511; Directorate Identifier 2005-NM-120-AD]

#### **Airworthiness Directives; Gulfstream Aerospace LP Model Gulfstream 100 Airplanes; and Model Astra SPX, and 1125 Westwind Astra Airplanes**

**ACTION:** Notice of proposed rulemaking (NPRM).

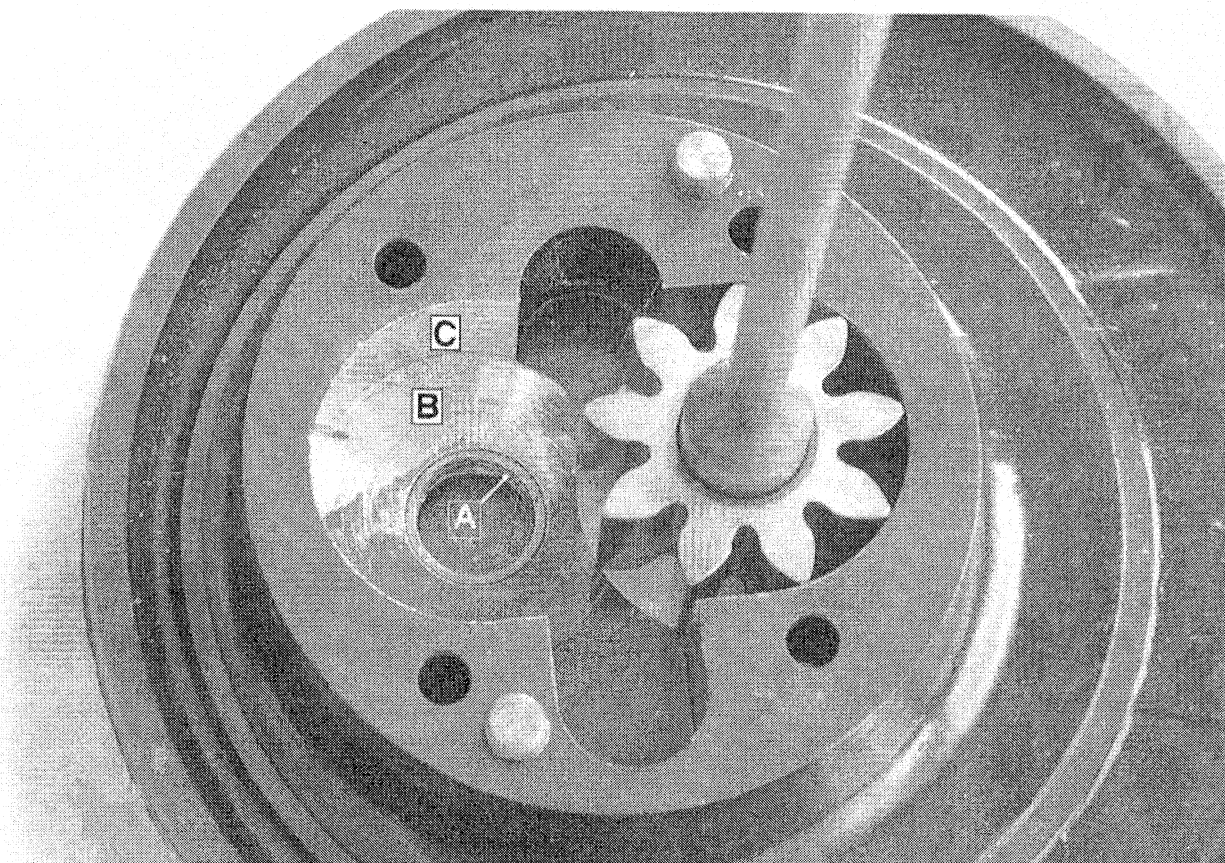
Figure 1

**Note 2:** If wear is present in the B area only as depicted in Figure 1, replacing the MGB and the pump is not required.

(e) Before installing a different MGB or a pump with any TIS, accomplish the requirements of paragraph (a) of this AD.
