[Docket No. FAA-2006-24074; Directorate Identifier 2005-NM-213-AD; Amendment 39-14676; AD 2006-14-05]

### Airworthiness Directives; Bombardier Model CL-600-2C10 (Regional Jet Series 700, 701, and 702) Airplanes, Model CL-600-2D15 (Regional Jet Series 705) Airplanes, and Model CL-600-2D24 (Regional Jet Series 900) Airplanes

**2006–14–05 Bombardier, Inc. (Formerly Canadair):** Amendment 39–14676. Docket No. FAA–2006–24074; Directorate Identifier 2005–NM–213–AD.

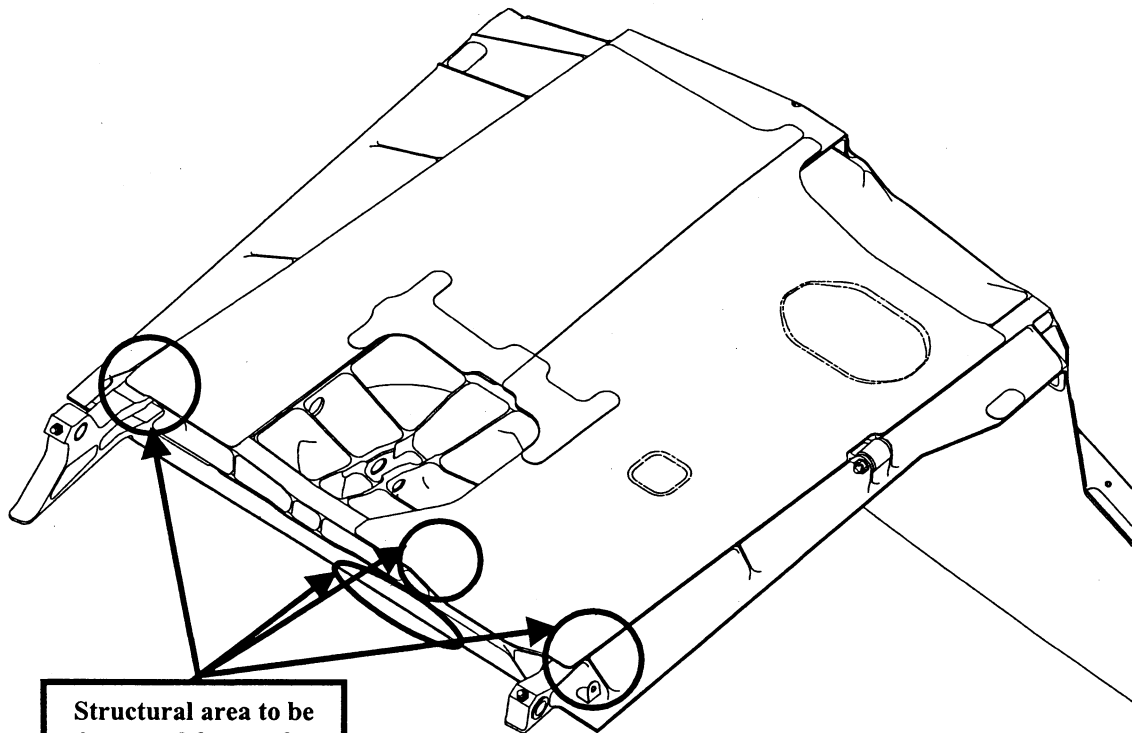
Figure 1  
LH side shown  
RH side opposite

2D24 (Regional Jet series 900) series airplanes, S/Ns 15002 through 15990 inclusive: At the applicable time specified in paragraph (f) of this AD, perform detailed inspections of the lower panel, part number (P/N) CC670–10520, of the left- and right-hand MLG doors for the conditions and in the areas specified in paragraphs (g)(1), (g)(2), (g)(3), and (g)(4) of this AD; and Figures 1, 2, and 3 of this AD.

Structural area to be inspected for cracks (4 PL)

ISO VIEW - INBOARD DOOR  
(CC670-10520)  
FOR ENGINEERING REF ONLY  
SCALE : NONE

(i) If any cracking or deformation, or pulled or missing fastener, as applicable, is found during any inspection done in accordance with paragraph (g) or (h) of this AD: Before further flight, accomplish paragraph (i)(1), (i)(2), or (i)(3) of this AD.

(1) Repair the damage in accordance with a method approved by either the Manager, New York Aircraft Certification Office (ACO), FAA; or Transport Canada Civil Aviation (TCCA) (or its delegated agent); and accomplish repetitive inspections in accordance with a method and at a repetitive interval approved by same.

(2) Replace the lower panel assembly, P/N CC670-10520, of the affected MLG door with a new or serviceable lower panel assembly having the same P/N, according to a method approved by either the Manager, New York ACO, FAA; or TCCA (or its delegated agent). Task Cards 32-12-01-000-801-A01 and 32-12-01-400-801-A01 of the CRJ 700/900

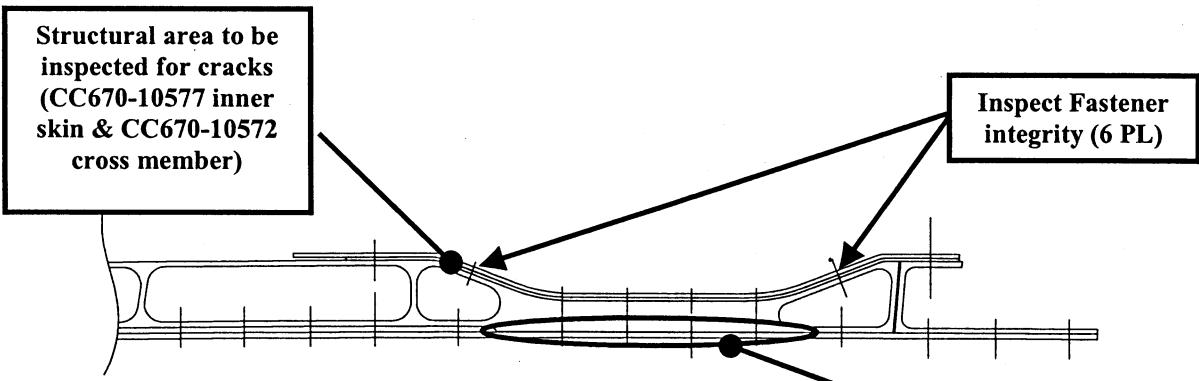
Figure 2  
View LKG INBD  
LH side Shown  
RH side Opp

(1) Inspect the cross member, P/N CC670–10572, of the MLG door lower panel for cracking or deformation, in accordance with Figure 2 of this AD.

(2) Inspect the inner skin, P/N CC670–10577, of the MLG door lower panel at the cross member (P/N CC670–10572) for cracking or deformation, or pulled or missing fasteners, in accordance with Figure 2 of this AD.

(3) Inspect the outer skin, P/N CC670–10574, of the MLG door lower panel at the cross member (P/N CC670–10572) for cracking or deformation, or pulled or missing fasteners, in accordance with Figure 2 of this AD.

Structural area to be inspected for cracks (CC670-10577 inner skin & CC670-10572 cross member)

Inspect Fastener integrity (6 PL)

Inspect lower skin integrity

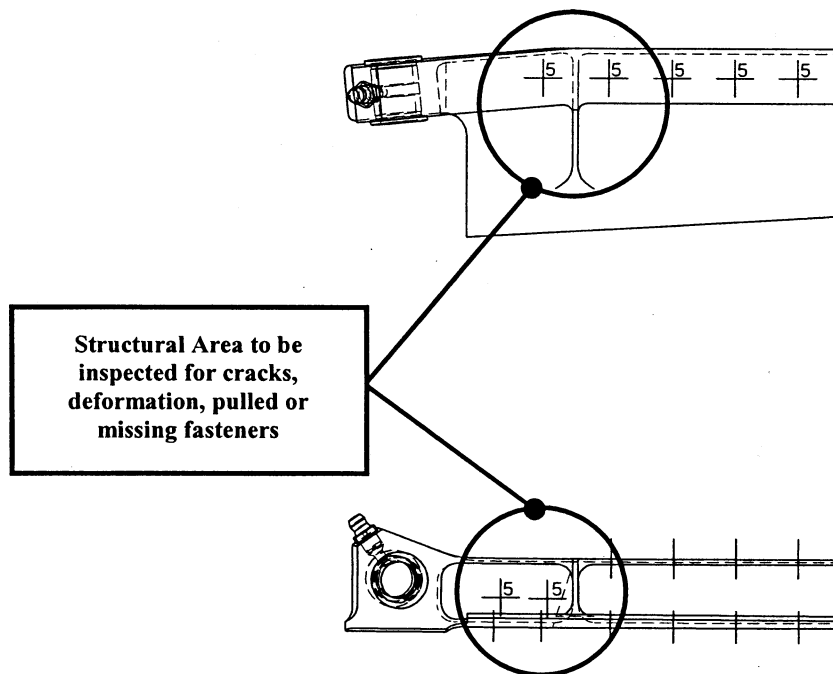
**Figure 3**  
View LKG INBD  
LH side Shown  
RH side Opp

(4) Inspect the forward member, P/N CC670–10570, and aft member, P/N CC670–10571, of the MLG door lower panel for cracking or deformation, or pulled or missing fasteners, in accordance with Figure 3 of this AD. Figures 1 through 3 of this AD follow.
