[Docket No. FAA-2008-0071; Directorate Identifier 2006-SW-27-AD; Amendment 39-16291; AD 2010-10-12]

Airworthiness Directives; Bell Helicopter Textron Canada Model 222, 222B, 222U, 230, and 430 Helicopters

ACTION: Final rule.

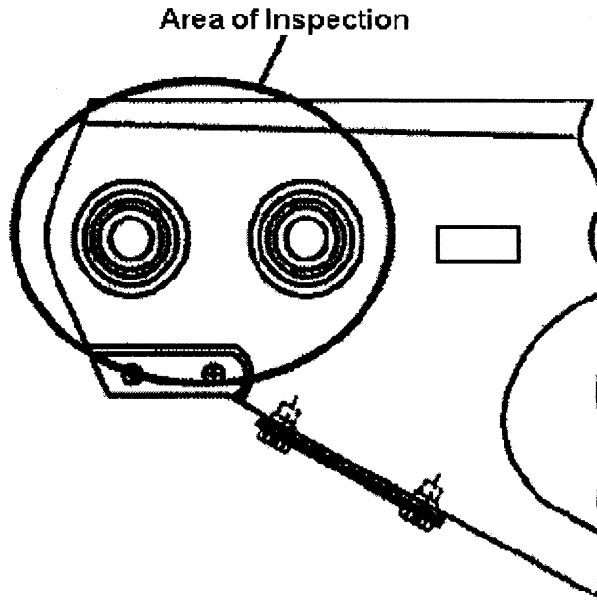
the specified BHTC model helicopters. Transport Canada advises of the discovery of cracked blades during scheduled inspections on three occasions. Two cracks originated from the outboard feathering bearing bore underneath the flanged sleeves. The third crack started from the inboard feathering bearing bore. Investigation found that the cracks originated from either a machining burr or a corrosion site in the bearing bore underneath the flanged sleeves.

(a) Within 3 hours time-in-service (TIS), unless accomplished previously, and thereafter at intervals not to exceed 3 hours TIS, clean and visually check both sides of each blade for a crack in the paint in the areas shown in Figure

Blade Inspection Area

(c) Within the next 50 hours TIS, unless accomplished previously, and thereafter at intervals not to exceed 50 hours TIS, clean the blade by wiping down both surfaces of each blade in the inspection area depicted in Figure 1 of this AD using aliphatic naphtha (C-305) or detergent (C-318) or an equivalent. Using a 10X or higher power magnifying glass, visually inspect both sides of the blade in the areas depicted in Figure 1 of this AD.

(1) If a crack is found, even if only in the paint, before further flight, remove the blade from the helicopter and proceed with the following:

(2) Remove the paint on the blade down to the bare metal in the area of the suspected crack by using plastic media blasting (PMB) or a nylon web abrasive pad. Abrade the blade surface in a span-wise direction only.

(3) Using a 10X or higher power magnifying glass, inspect the blade for a crack.

(i) If a crack is found, replace the blade with an airworthy blade before further flight.

(ii) If no crack is found in the blade surface, refinish the blade by applying one coat of epoxy polyamide primer, MIL-P-23377 or MIL-P-85582, so that the primer overlaps the existing coats just beyond the abraded area. Let the area dry for 30 minutes to 1 hour. Then,

apply one sealer coat of polyurethane, MILC85285 TYI CL2, color number 27925 (semi-gloss white). Reinstall the blade.
