[Docket No. **FAA-2016-4674**; Directorate Identifier **2016-SW-001-AD**; Amendment **39-18835**; AD **2017-06-11**]

Airworthiness Directives; Airbus Helicopters

2017-06-11 Airbus Helicopters:
Amendment 39-18835; Docket No. FAA-2016-4674; Directorate Identifier 2016-SW-001-AD.

This AD defines the unsafe condition as failure of an air conditioner compressor drive pulley (pulley) or tail rotor output wheel (wheel), leading to loss of tail rotor drive and helicopter control.

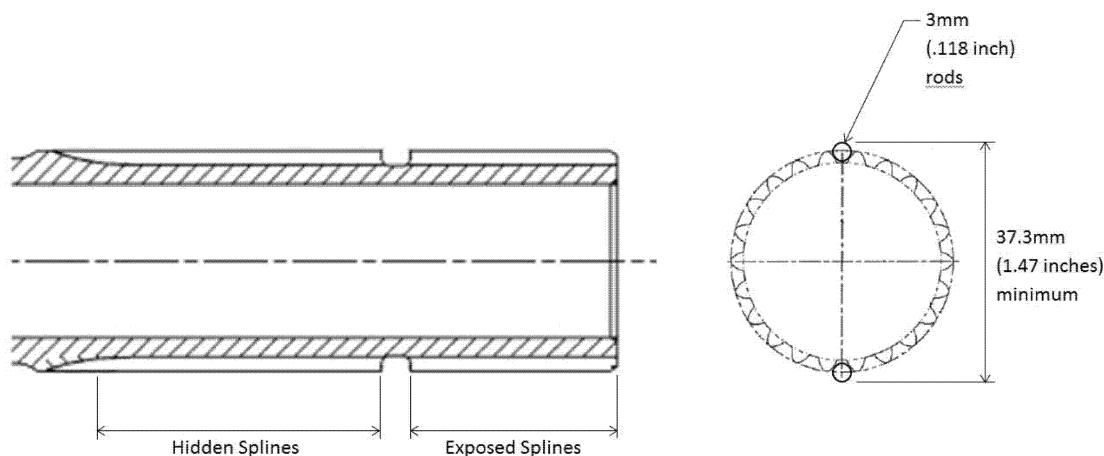
(ii) Inspect the exposed portion of each wheel spline for cracking, scoring, metal pick-up, and wear by using Figure 1 to paragraph (f)(1)(ii) of this AD. To inspect for wear, position two 3 mm (0.118 inch) rods in all diametrically opposed splines and measure to determine whether there is a minimum of 37.3 mm (1.47 inches) across the outside diameter of the rods. If there is any cracking, scoring or metal pick-up, or if a measurement is less than 37.3 mm, replace the wheel.
