[Docket No. FAA–2018–1046; Product Identifier 2018–CE–049–AD]

Airworthiness Directives; Piper Aircraft, Inc. Airplanes

ACTION: Notice of proposed rulemaking (NPRM).

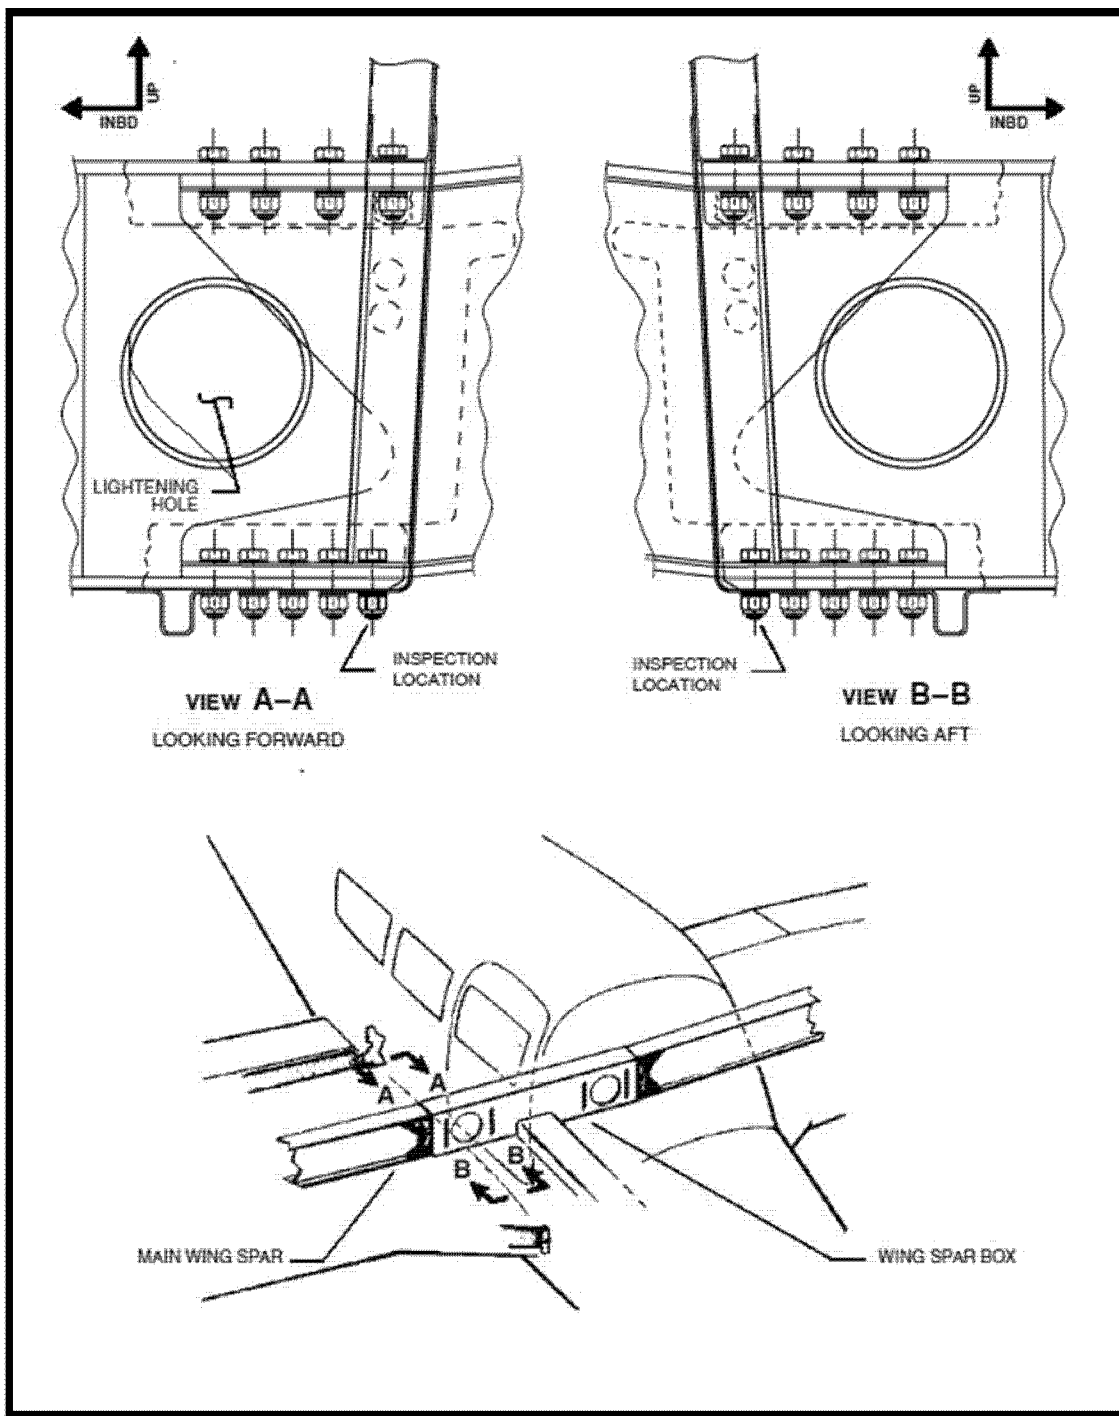
Figure 1. Main Spar Attach Bolt Locations (RH Side Shown)

This AD was prompted by a report of a fatigue crack found in a visually inaccessible area of the lower main wing spar cap. We are issuing this AD to detect and correct fatigue cracks in the lower main wing spar cap bolt holes. The unsafe condition, if not addressed, could result in the wing separating from the fuselage in flight.

(1) Locate the two (2) lower outboard main spar attach bolts, as shown in Figure 1 of Appendix 1, installed on the lower cap of the main spar, on the forward and aft sides of the spar web.

Within the compliance time specified in paragraph (h)(1) or (2) of this AD, eddy current inspect the inner surface of each bolt hole on the lower main wing spar cap for cracks by using the procedure in appendix 1 of this AD.

further flight, replace the main wing spar with a new (zero hours TIS) main wing spar or with a main wing spar that has been inspected as specified in appendix 1 of this AD and no cracks were found.
