DEPARTMENT OF TRANSPORTATION

Federal Aviation Administration

[Docket No. FAA–2021–0189; Project Identifier AD–2020–00645–R; Amendment 39–21875; AD 2021–26–16]

Airworthiness Directives; Various Restricted Category Helicopters

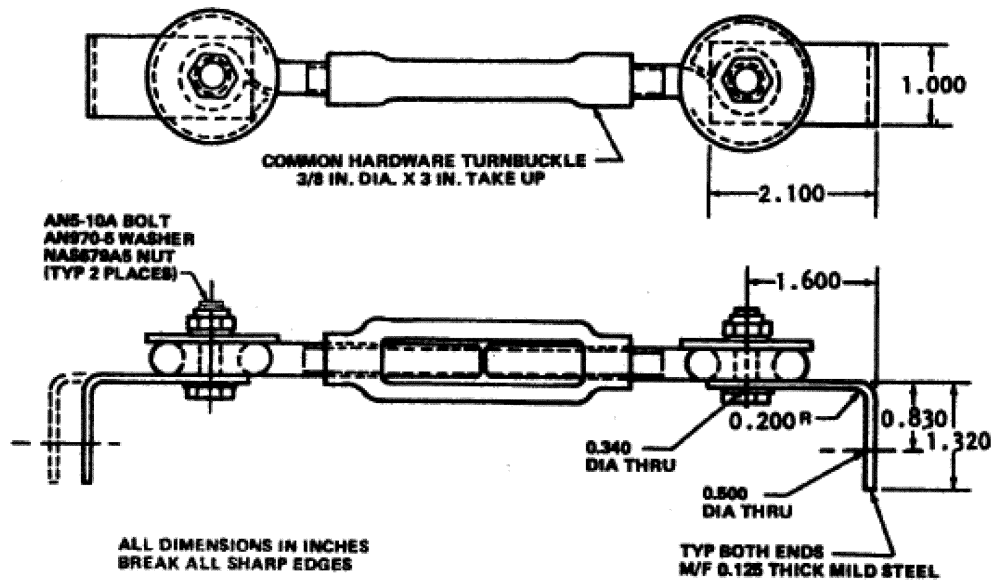
Figure 1 to the Introductory Text of Paragraph (g)(3) – Main Driveshaft Installation and Removal Tool

(3) Within 25 hours TIS after the effective date of this AD, remove main driveshaft P/N SKCP2180–1, SKCP2281–1, SKCP2281–1R, or SKCP2281–103 by following “6–24.3. Removal—Main Driveshaft P/N SKCP2281–103” on page 6–24, including “4–24. Removal—Air Inlet Filters” on page 4–17 and “Figure 4–9. Engine Air Inlet Filter Installation” on page 4–16, of Headquarters, Department of the Army, Aviation Unit and Intermediate Maintenance Instructions Army Model UH–1H/V/EH–1H/X Helicopters, Technical Manual TM 55–1520–210–23–1, Change No. 42, dated April 14, 2003 (TM 55–1520–210–23–1 C 42), except where instructed to “refer to figure 6–12.2” in TM 55–1520–210–23–1 C 42, refer to Figure 1 to the introductory text of paragraph (g)(3) of this AD, and where instructed to “see figure 6–12.3” in TM 55–1520–210–23–1 C 42, see Figure 2 to the introductory text of paragraph (g)(3) of this AD, and:

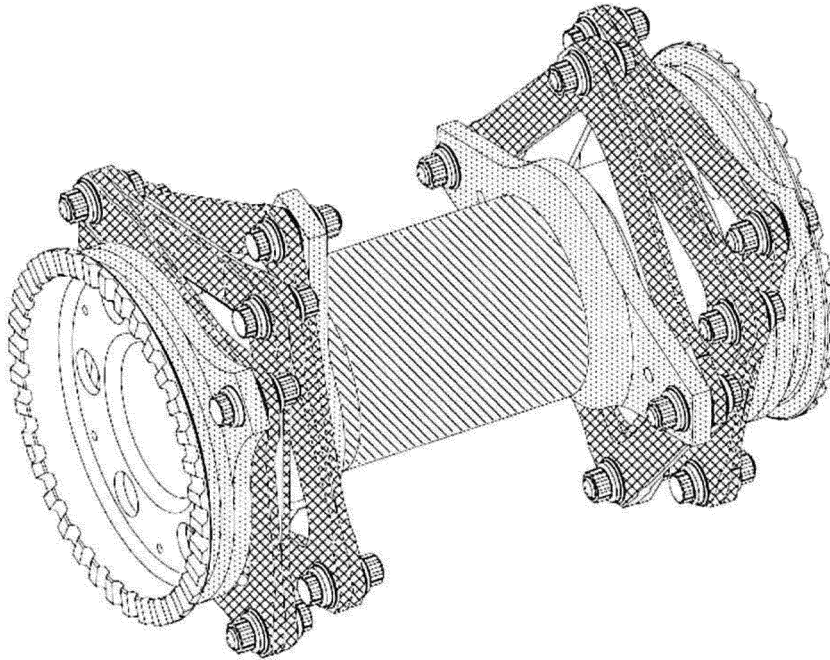
Figure 3 to Paragraph (g)(3)(iv) – Damage Limits

(iv) Inspect the main driveshaft for mechanical damage, corrosion, an edge dent, and nick as shown in Figure 3 to paragraph (g)(3)(iv) of this AD. For the purposes of this inspection, mechanical damage may be indicated by a crack, scratch, or wear; and corrosion may be indicated by corrosion or pitting. If there is a scratch, wear, corrosion, pitting, an edge dent, or a nick within allowable limits, before further flight, repair the main driveshaft in accordance with FAA-approved procedures. If there is a crack, or a scratch, wear, corrosion, pitting, an edge dent, or a nick that exceeds allowable limits,

1. No cracks are permitted
2. Repairs must be no less than 1.000 inch apart.
3. Repairs not to be within 0.500 inches of bolt hole.
4. Faying surfaces must be free of any raised metal areas.
5. All repairs to be smooth at maximum depth and smoothly blended with surrounding surface.
6. Exposed bare metal may be touched up with Sermetel Product 1122 or 196. Zinc Chromate, primer color T, even though it does not blend cosmetically with Sermetel coating, can be used if Sermetel touch-up products are unavailable.

before further flight, replace the main driveshaft. The main drive shaft may be overhauled in accordance with FAA-

approved procedures to accomplish the replacement required by this paragraph.
