[Docket No. FAA-2022-0891; Project Identifier AD-2022-00585-A,E,R]

Airworthiness Directives; Various Airplanes, Helicopters, and Engines

ACTION: Notice of proposed rulemaking (NPRM).

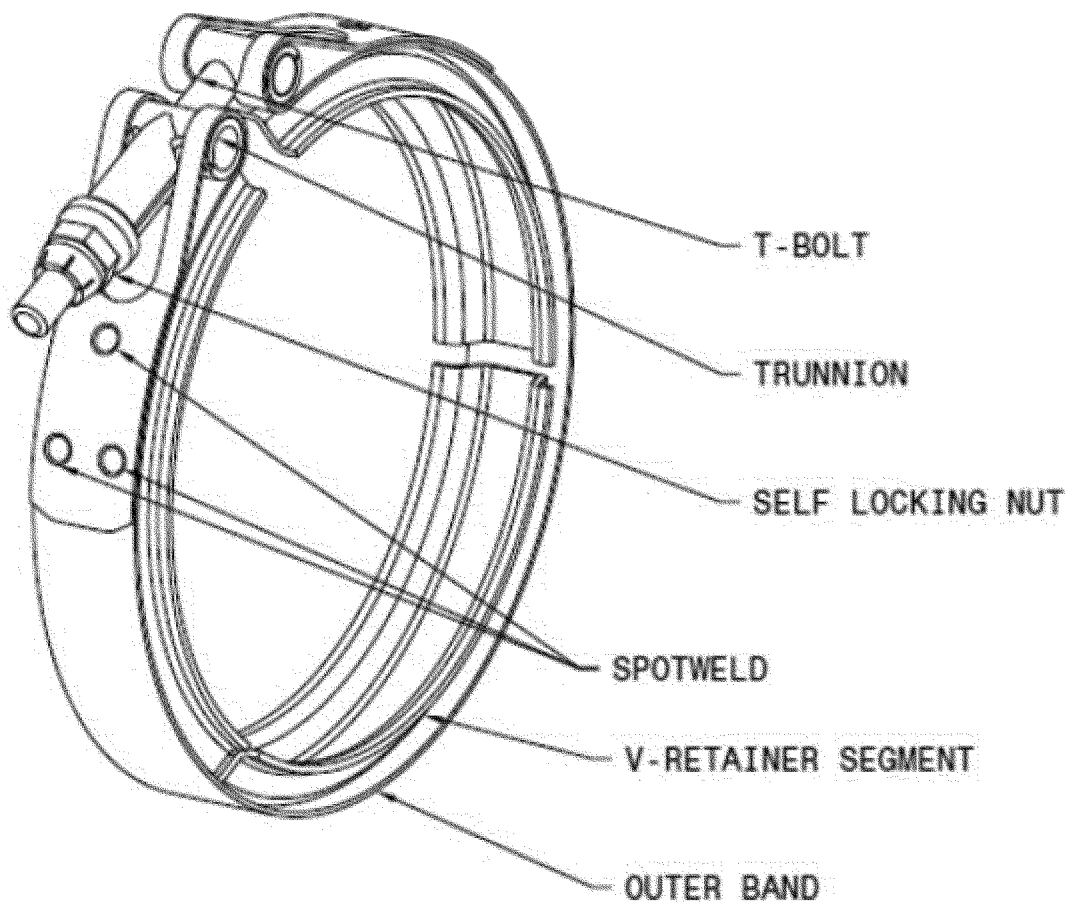
Figure A

The final report concluded that the common denominator in the incidents and accidents reviewed is the spot-welded, multi-segment exhaust tailpipe v-band coupling (see Figure A). These couplings come in either two or three segment varieties. The segments are the number of v-retainer segments, which are attached to the outer band via spot welds. Although multi-segment exhaust tailpipe couplings can also be riveted, the riveted couplings do not create an unsafe condition.

Spot-welded, multi-segment exhaust tailpipe v-band coupling

The majority of the events studied by the working group indicated fatigue failure of spot-welded, multi-segment exhaust tailpipe v-band couplings as a result of stress corrosion cracking that originated at or near a spot weld. This is the same unsafe condition identified in the other v-band coupling AD actions previously referenced. The data studied by the working group contained evidence of pre-existing cracking of the couplings, known embrittlement at the spot weld locations simply due to that manufacturing method, and outer band cupping on the multi-segment couplings (which is the result of age, over-use, and potential over-torquing). The working group also found that many of the couplings had safety wire across the bolt end. The safety wire could be helpful if there was a bolt or nut failure (extremely rare events) or the nut was missing. However, the safety wire was of no value when the failure was transverse band cracking and total

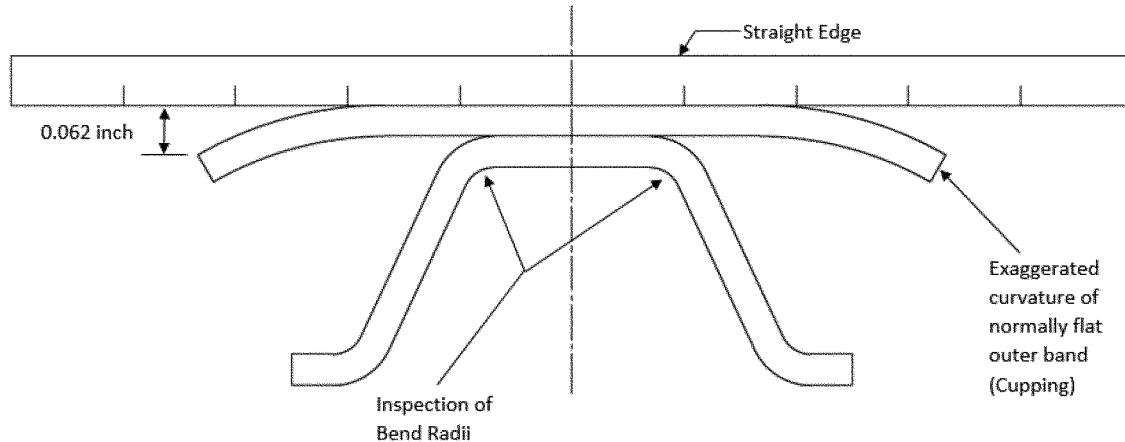
Figure 1 to paragraph (k)(1)(iii) – Inspection Depiction

(iii) Visually inspect the flatness of the outer band using a straight edge. Lay the straight edge across the width of the outer band as depicted in figure 1 to paragraph (k)(1)(iii) of this AD. If the gap between the outer band and the straight edge exceeds 0.062 inch, before further flight, remove the v-band coupling from service and install a new v-band coupling.

(v) Visually inspect the bend radii of the v-retainer coupling segments, throughout the length of the segment, as depicted in figure 1 to paragraph (k)(1)(iii) of this AD, for cracks. If there are any cracks, before further flight, remove the v-band coupling from service and install a new v-band coupling.
