[Docket No. FAA-2023-0430; Project Identifier MCAI-2022-01092-R; Amendment 39-22378; AD 2023-05-09]

Airworthiness Directives; Airbus Helicopters Deutschland GmbH (AHD) Helicopters

2023–05–09 Airbus Helicopters

39–22378; Docket No. FAA–2023–0430; Project Identifier MCAI–2022–01092–R.

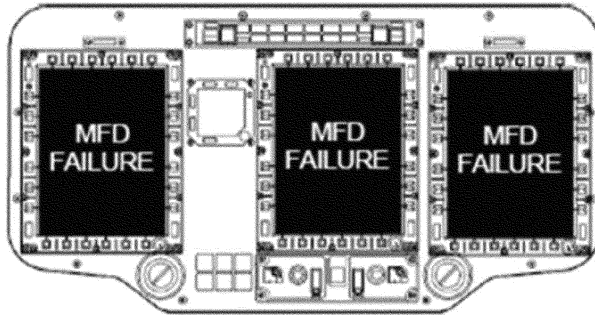
Figure 1 to Paragraph (g)(2): RFM
Emergency Procedure—Model MBB-BK117
Helicopters

- MFD FAILURE displayed on all MFDs
- If autopilot upper modes were coupled, they may decouple after 10 seconds (indicated by an „autopilot decouple“ voice message).

1. Double engine emergency shutdown - Perform

1. Aircraft trajectory - Maintain using IESI and stand-by compass.
- Use AFCS "recovery" or "go-around" modes, if desired
- Operate aircraft within the approved performance
2. MFD2 pb - OFF

3. MFD2 pb - ON

4. MFD2 - Maintain in FND format
5. LAND AS SOON AS POSSIBLE

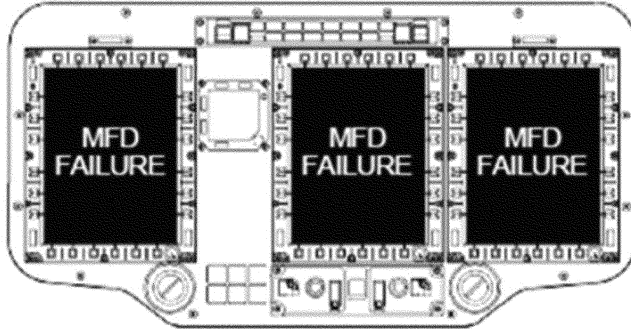
**Figure 2 to Paragraph (g)(2): RFM
Emergency Procedure—Model EC135
Helicopters**

- MFD FAILURE displayed on all MFDs
- If autopilot upper modes were coupled, they may decouple after 10 seconds (indicated by an „autopilot decouple“ voice message).

1. Double engine emergency shutdown - Perform

1. Aircraft trajectory
 - Maintain using IESI and stand-by compass.
 - Use AFCS "recovery" or "go-around" modes, if desired
 - Operate aircraft within the approved performance
2. MFD2 pb - OFF

3. MFD2 pb - ON

4. MFD2 - Maintain in FND format
5. LAND AS SOON AS POSSIBLE
