[Docket No. FAA-2023-1055; Project Identifier AD-2023-00583-T; Amendment 39-22445; AD 2023-10-09]

### Airworthiness Directives; The Boeing Company Airplanes

**SUMMARY:** The FAA is adopting a new airworthiness directive (AD) for all The Boeing Company Model 787-8, 787-9, and 787-10 airplanes. This AD was prompted by reports of damaged decompression panels from operators. This AD requires repetitive inspections for damaged fastener holes on the vertical and bottom edges of the inward and outward blowing decompression panels installed on the forward and aft cargo compartment vertical sidewall linings and applicable on-condition actions. The FAA is issuing this AD to address the unsafe condition on these products.

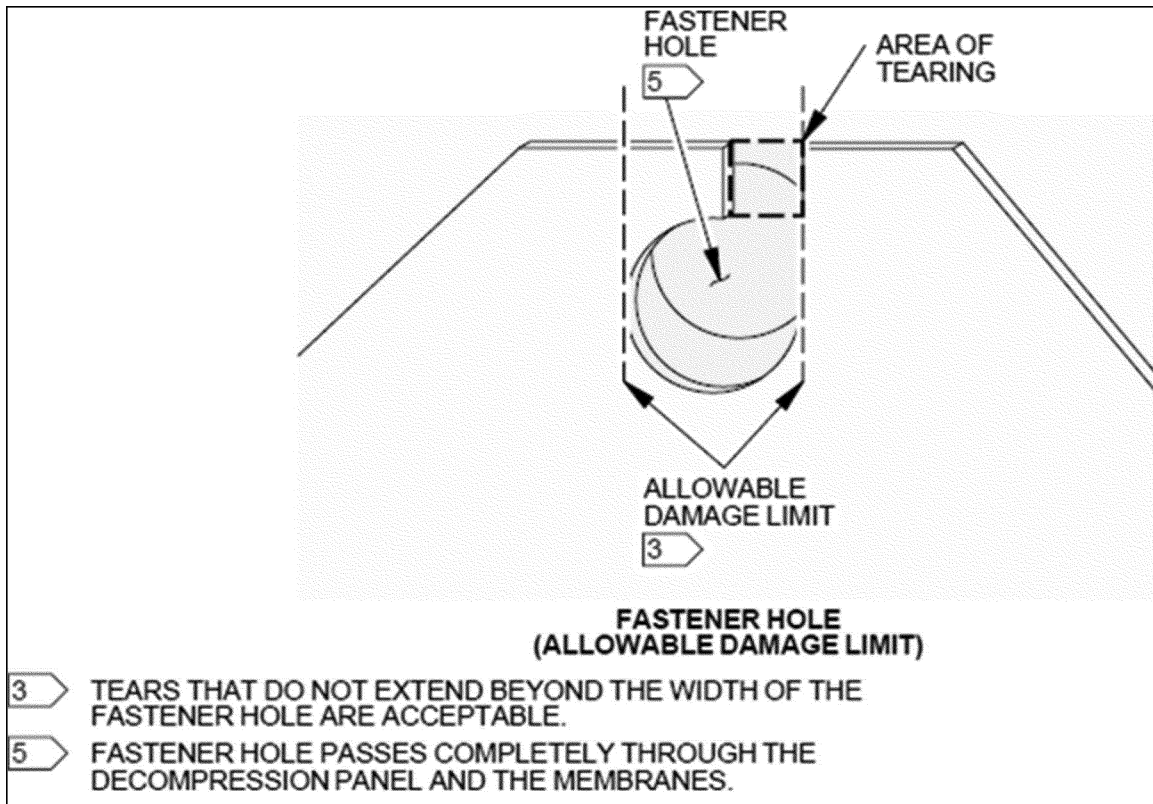
Figure 1 to paragraph (g)(3)(i)—Allowable damage not extending beyond fastener hole width

(i) If the damage is on the fastener hole, the damage must not extend beyond the width of the fastener hole. Refer to figure 1 to paragraph (g)(3)(i) of this AD. Where figure 1 to paragraph (g)(3)(i) of this AD refers to tears or tearing, this includes all types of damage as defined in paragraph (g)(2) of this AD.

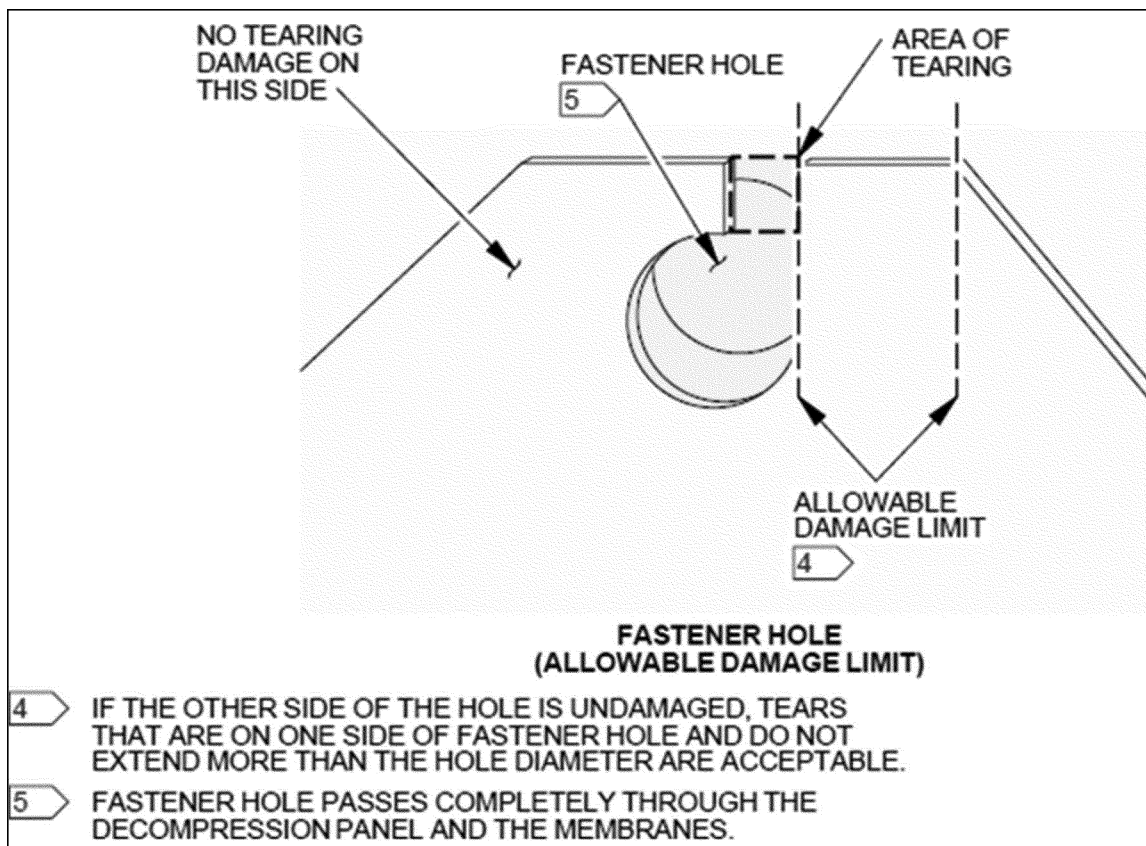
**Figure 2 to paragraph (g)(3)(ii)—Allowable damage not extending more than fastener hole diameter**

(ii) If the damage is on one side of the fastener hole and the other side of the fastener hole has no damage, the damage must not extend more than the diameter of

the fastener hole. Refer to figure 2 to paragraph (g)(3)(ii) of this AD. Where figure 2 to paragraph (g)(3)(ii) of this AD refers to tears, tearing, or tearing damage, this
