[Docket No. FAA-2022-0891; Project Identifier AD-2022-00585-A,E,R; Amendment 39-22432; AD 2023-09-09]

#### Airworthiness Directives; Various Airplanes, Helicopters, and Engines

**ACTION:** Final rule.

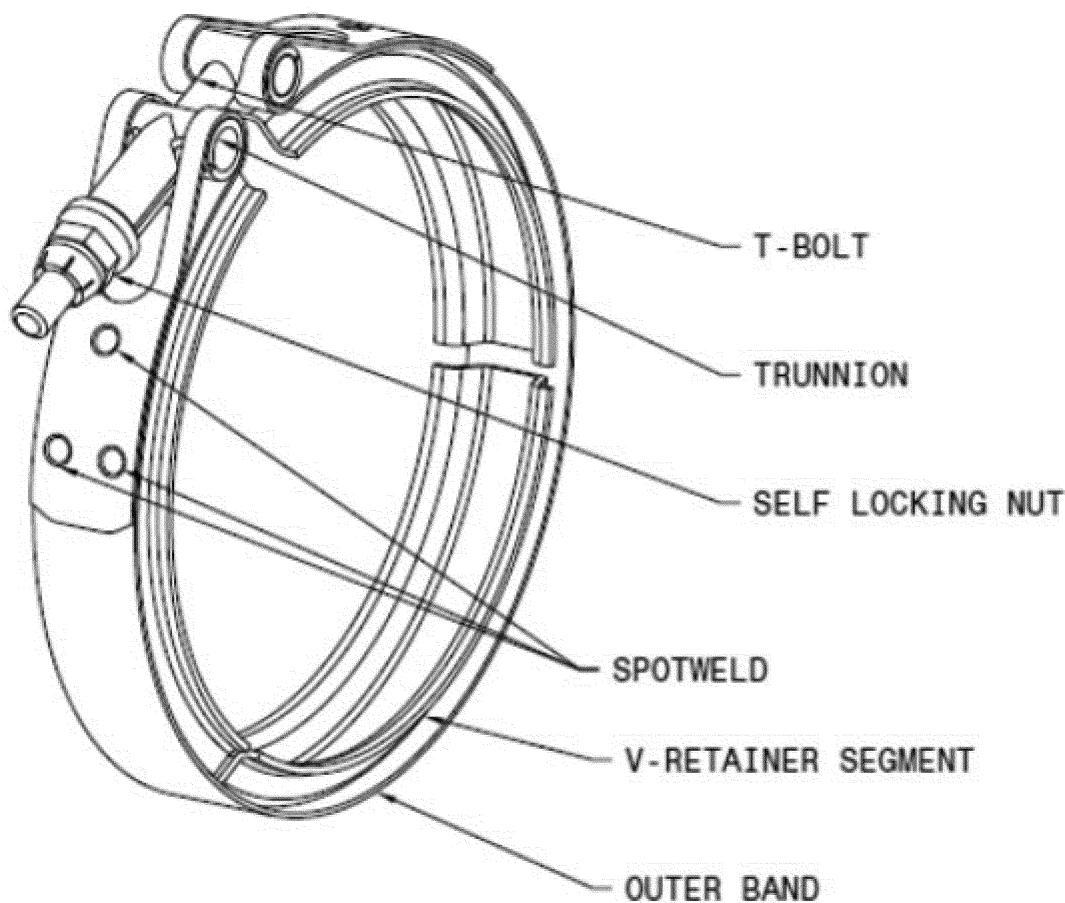
**Figure A**

The final report concluded that the common denominator in the incidents and accidents reviewed is the spot-welded, multi-segment exhaust tailpipe v-band coupling (see Figure A). These couplings come in either two or three segment varieties. The segments are the number of v-retainer segments, which are attached to the outer band via spot welds. Although multi-segment exhaust tailpipe couplings can also be riveted, the riveted couplings do not create an unsafe condition.

### **Spot-welded, multi-segment exhaust tailpipe v-band coupling**

The majority of the events studied by the working group indicated fatigue failure of spot-welded, multi-segment exhaust tailpipe v-band couplings as a

result of stress corrosion cracking that originated at or near a spot weld. This is the same unsafe condition identified in the other v-band coupling AD actions

previously referenced. The data studied by the working group contained evidence of pre-existing cracking of the couplings, known embrittlement at the

spot weld locations simply due to that manufacturing method, and outer band cupping on the multi-segment couplings (which is the result of age, over-use, and potential over-torqueing). The working group also found that many of the couplings had safety wire across the bolt end. The safety wire could be helpful if there was a bolt or nut failure (extremely rare events) or the nut was missing. However, the safety wire was of no value when the failure was transverse band cracking and total separation at the spot weld. The data studied by the working group indicated many accidents were due to v-band couplings that were of the multi-segment, spot-welded design, when used in a specific location (the tailpipe to the turbocharger exhaust housing flange on turbocharged reciprocating engine-powered aircraft).

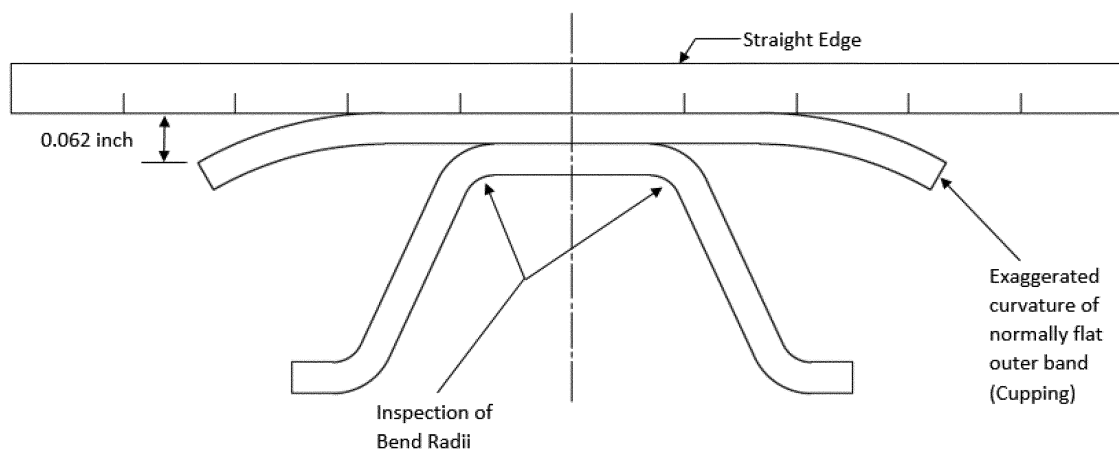
Figure 1 to paragraph (l)(1)(iii) – Inspection Depiction

(iii) Visually inspect the flatness of the outer band using a straight edge. Lay the straight edge across the width of the outer band as depicted in figure 1 to paragraph (l)(1)(iii) of this AD. If the gap between the outer band and the straight edge exceeds 0.062 inch, before further flight, remove the v-band coupling from service and install a new v-band coupling.

(v) Visually inspect the bend radii of the v-retainer coupling segments, throughout the length of the segment, as depicted in figure 1 to paragraph (l)(1)(iii) of this AD, for cracks. If there are any cracks, before further flight, remove the v-band coupling from service and install a new v-band coupling.
