[Docket No. FAA-2023-2232; Project Identifier AD-2023-00943-R; Amendment 39-22681; AD 2024-04-02]

Airworthiness Directives; Robinson Helicopter Company Helicopters

ACTION: Final rule.

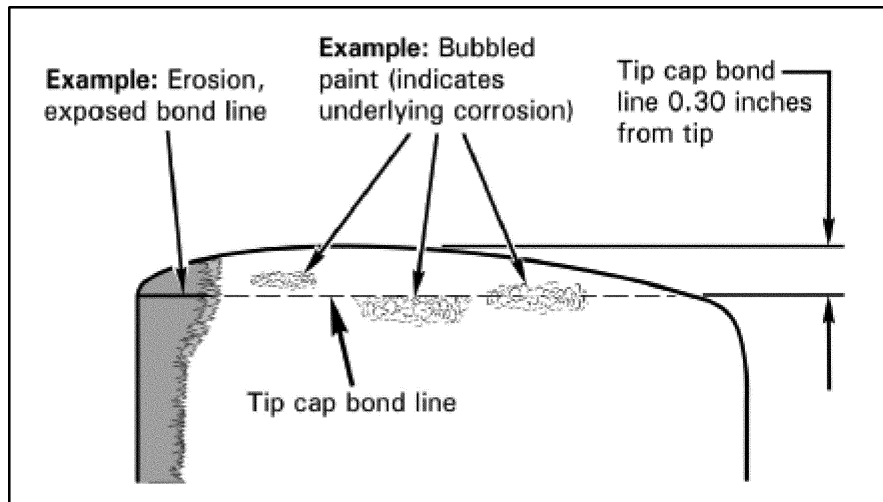
Figure 1 to Paragraph (g)(1)—TRB Tip Cap Check/Inspection

(1) Within 10 hours time-in-service (TIS) after the effective date of this AD and thereafter before the first flight of each day, visually check each TRB tip cap area (at and adjacent to the tip cap bond line on each surface and edge of the TRB) for an exposed tip cap bond line or bubbled paint, as depicted in Figure 1 to paragraph (g)(1) of this AD. These items may indicate evidence of corrosion. The owner/operator (pilot) holding at least a private pilot certificate may accomplish this TRB tip cap check and must enter compliance with this paragraph of the AD into the helicopter maintenance records in accordance with 14 CFR 43.9(a) and 91.417(a)(2)(v). The record must be maintained as required by 14 CFR 91.417, 121.380, or 135.439.

(2) Within 100 hours TIS or during the next 100 hour or annual inspection after the effective date of this AD, whichever occurs first, and thereafter at intervals not to exceed 100 hours TIS or during the next 100 hour or annual inspection, whichever occurs first, visually inspect each TRB tip cap area (at and adjacent to the tip cap bond line on each surface and edge of the TRB) for evidence of corrosion, which may be indicated by an exposed tip cap bond line or bubbled paint, as depicted in Figure 1 to paragraph (g)(1) of this AD.

(3) As a result of the actions required by either paragraph (g)(1) or (2) of this AD, if there is evidence of corrosion, an exposed tip cap bond line, or bubbled paint, before further flight, remove all of the corrosion.
