[Docket No. FAA-2024-2011; Project Identifier AD-2023-01121-R]

Airworthiness Directives; MD Helicopters, LLC, Helicopters

ACTION: Notice of proposed rulemaking (NPRM).

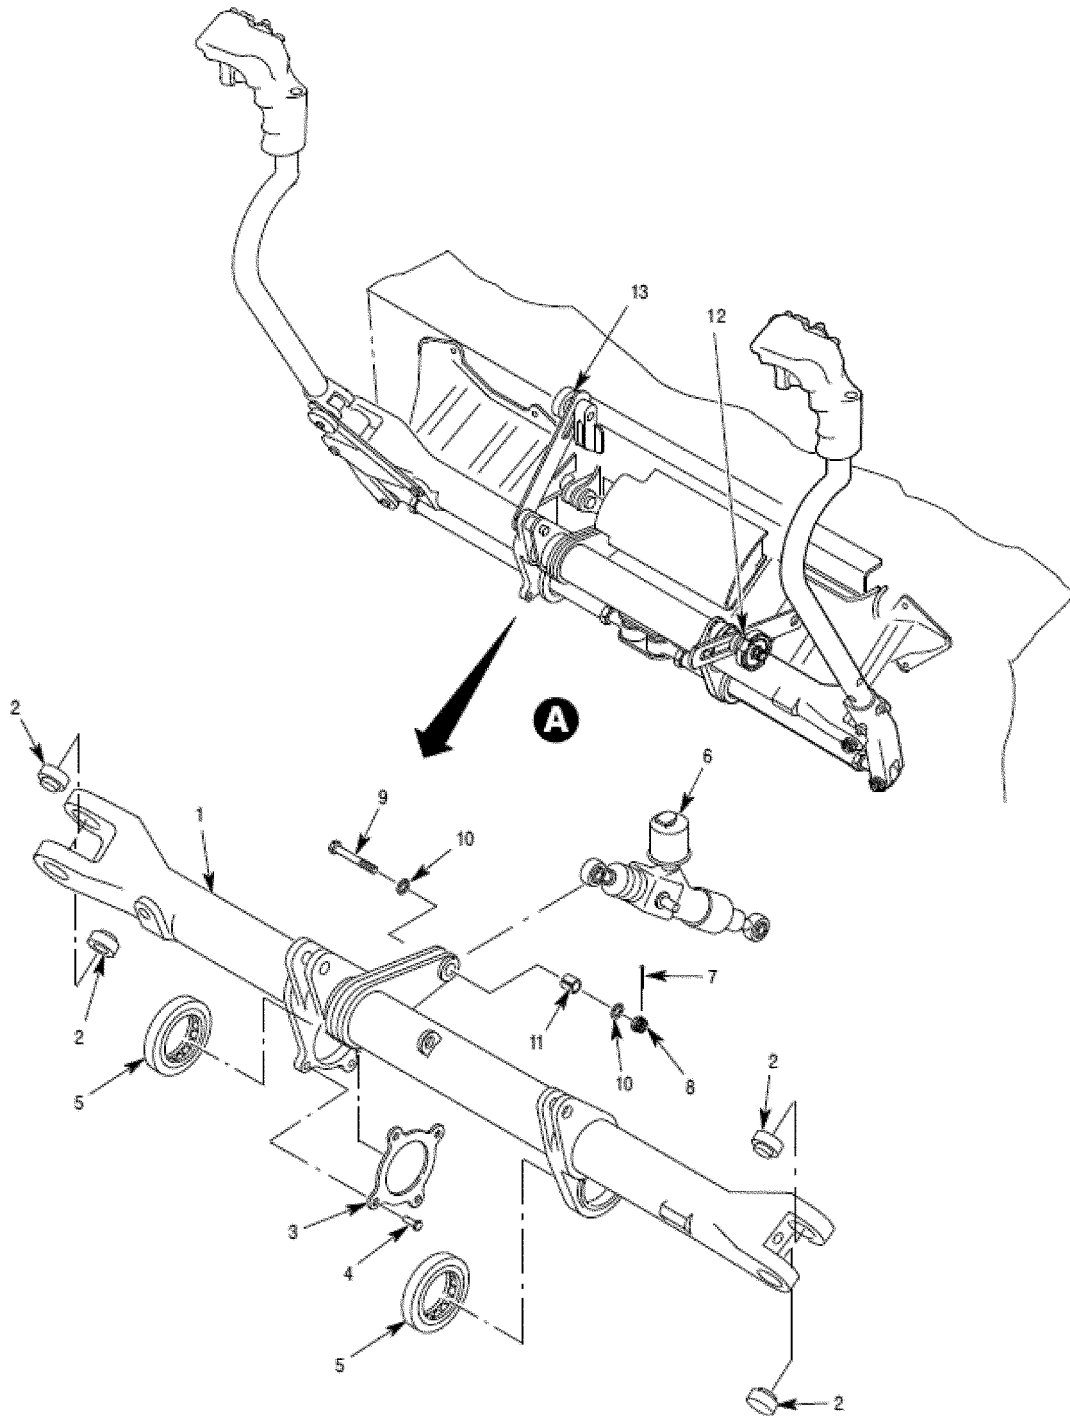
(ii) Visually inspect each roller bearing (number 5) as depicted in Figure 1 to paragraph (g)(1) of this AD for corrosion and degradation. If a roller bearing has any corrosion or degradation, before further flight, remove the roller bearing from service and install an airworthy roller bearing.

(g)(2)(iii) of this AD, before further flight, inspect each roller bearing (number 5) as depicted in Figure 1 to paragraph (g)(1) of this AD for damage. For the purposes of this inspection, damage may be indicated by corrosion, lack of lubrication (dry exterior surface), or material degradation.

(i) Using a flashlight and mirror, visually inspect the torque tube for corrosion and cracks. If there is any corrosion or a crack, before further flight, remove the torque tube from service and install an airworthy torque tube.

(i) Disconnect the one-way lock (number 6) of the torque tube by removing the cotter pin (number 7), nut (number 8), bolt (number 9), washers (number 10), and slotted bushing

(ii) Loosen the longitudinal cyclic friction knob (number 12 or 13) of the torque tube assembly as depicted in Figure 1 to paragraph (g)(1) of this AD.

(B) If any roller bearing (number 5) as depicted in Figure 1 to paragraph (g)(1) of this AD has any damage, before further flight, remove the roller bearing from service and install an airworthy roller bearing.

(A) Install the slotted bushing (number 11), washers (number 10), bolt (number 9), nut (number 8), and new (zero total hours TIS) cotter pin (number 7) as depicted in Figure 1 to paragraph (g)(1) of this AD.

(B) Ensure the edge of the slotted bushing (number 11) protrudes 0.010 to 0.080 inch (0.25 to 2.03 mm) above the surface of the cyclic torque tube after the nut is tightened.
