[Docket No. FAA-2024-0769; Project Identifier AD-2023-00556-T; Amendment 39-22815; AD 2024-16-09]

Airworthiness Directives; The Boeing Company Airplanes

SUMMARY: The FAA is adopting a new airworthiness directive (AD) for certain The Boeing Company Model 777-200, -200LR, -300, -300ER, and 777F series airplanes. This AD was prompted by a report indicating multiple findings of cracks in the fuselage skin common to the underwing longeron (UWL). This AD requires external or internal (depending on configuration) inspections for any cracking of the left and right side fuselage skin common to the UWL, and applicable on-condition actions. The FAA is issuing this AD to address the unsafe condition on these products.

2024–16–09 The Boeing Company:

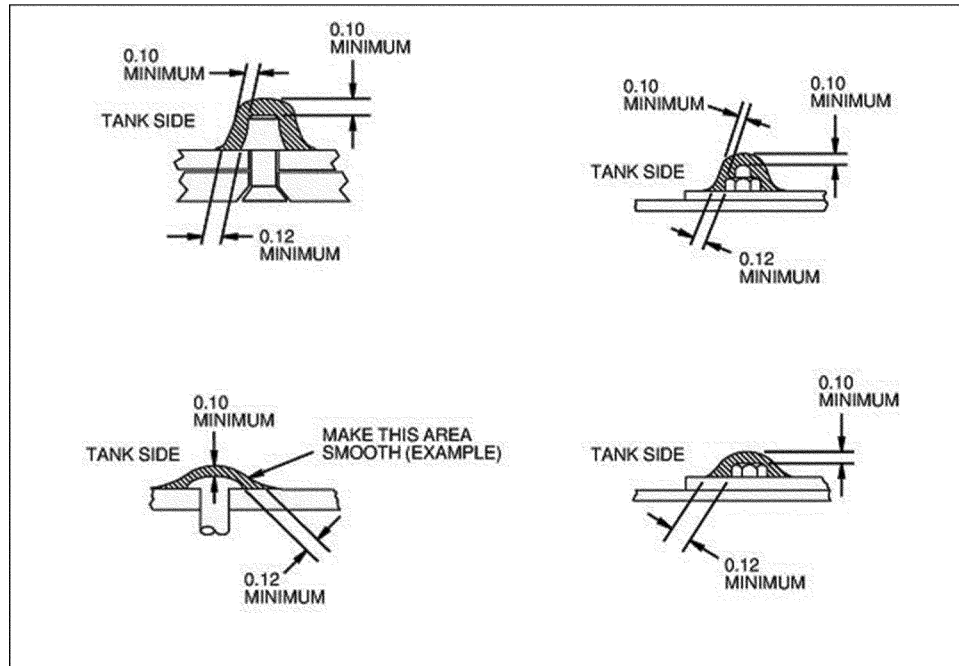
Figure 1 to Paragraph (h)(3)—Cap Sealing Dimensions (all Dimensions are in Inches)

Boeing concluded that only the cap seals on the interior side of the fuel tank require the dimensions specified in Figure 1 of paragraph (h)(3) of the proposed AD to perform their intended function, which is consistent with the labels shown in Figure 1 of paragraph (h)(3) of the proposed AD. Boeing recommended replacing the text “applying a cap seal (sealant) to a fastener, fastener head, and fastener threads and collars, for this AD, during application of any cap seal to a fastener, fastener head, or fastener threads and collars” with the text “applying a cap seal (sealant) to a fastener location that penetrates the fuel tank boundary, for

The FAA agrees. Boeing 777 AMM 28–11–00 meets the sealant requirements of Figure 1 to paragraph (h)(3) of this AD. As such, it would be an acceptable procedure to follow when sealing inside the fuel tank in accordance with paragraph (h)(3) of this AD. The FAA has added a note to paragraph (h)(3) of this AD accordingly.

Note 4 to paragraph (h)(3): Guidance on an acceptable cap sealing procedure for accomplishing the actions required by paragraph (h)(3) of this AD can be found in Boeing Model 777 Aircraft Maintenance Manual (AMM) section 28–11–00.
