**September 2000****BORDER PATROL****Procurement of MD  
600N Helicopters  
Should Be Reassessed**

B-284951

September 29, 2000

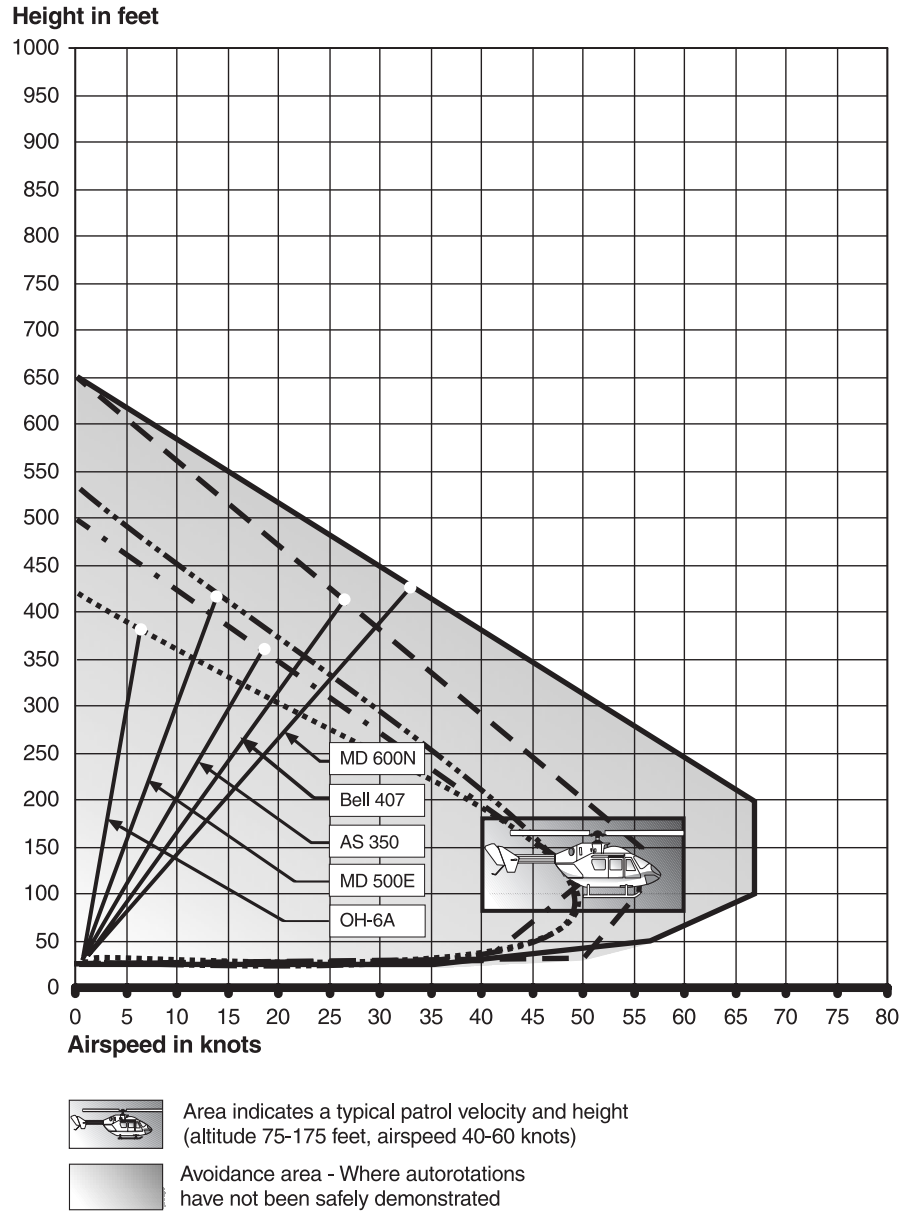
**Figure 3: Height/Velocity Curves for MD 500E, MD 600N, Bell 407, American Eurocopter AS 350, and Hughes OH-6A**

Most of the pilots we interviewed believed that the autorotation characteristics of the MD 600N are inappropriate for much of the flying performed during Border Patrol air operations missions. Autorotation is a pilot-recovery maneuver performed in the event of an engine failure that keeps the main rotor blades moving so that the aircraft descent can be controlled. Aircraft height and airspeed factors to be avoided during autorotation are depicted as a height/velocity curve.<sup>8</sup> Pilots are instructed

MDH officials stated that the pilots based their concerns on a misunderstanding of the height/velocity curve rather than on the helicopter's operational characteristics. According to MDH, the MD 600N's height/velocity curve appears to cover more area because of more stringent testing conditions used for establishing the curve.<sup>9</sup> However, we examined the height/velocity curves for several helicopters that were tested at or estimated for sea level. The MD 600N height/velocity curve had a larger area to avoid (see fig. 3). A senior FAA certification official said that this is a valid means for showing how different aircraft height/velocity curves relate to the height and airspeed of a typical Border Patrol mission.

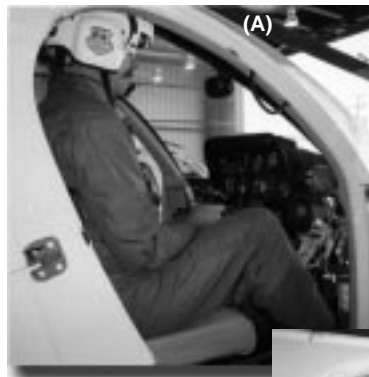
In addition to the heavy controls, some pilots said that the MD 600N is so uncomfortable that it affects their ability to do their work. The pilots said that after 2 hours, they must stop for a break; and several said that they suffered from pain in their knees, back, and buttocks caused by uncomfortable seats. Some pilots reported using cushions provided by Air Operations headquarters or their own cushions to relieve some of the discomfort. Several pilots also said that visibility is limited because of the door frames, particularly while using the cushions. They reported that they must get in awkward positions to look at objects below or behind them.

(A) Pilots explained that visibility is limited by the door frames, and that awkward positions are sometimes necessary to see objects below or behind them.

Air Operations officials agreed that the seats in the MD 600N are uncomfortable. Pilots had said they wanted padded seats, so the officials said they asked for high-quality seats during the procurement.<sup>17</sup> Air Operations officials recently took action to replace the seats provided under the original procurement. Seats tested by Border Patrol pilots during the flight evaluations for the stability augmentation system have been ordered and are being manufactured, as of September 21, 2000, according to INS.

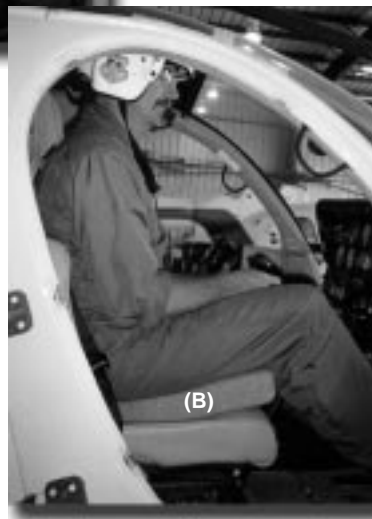
(B) Some pilots reported using seat cushions provided by Air Operations headquarters or their own cushions to relieve some of the discomfort caused by the seats in the MD 600N.

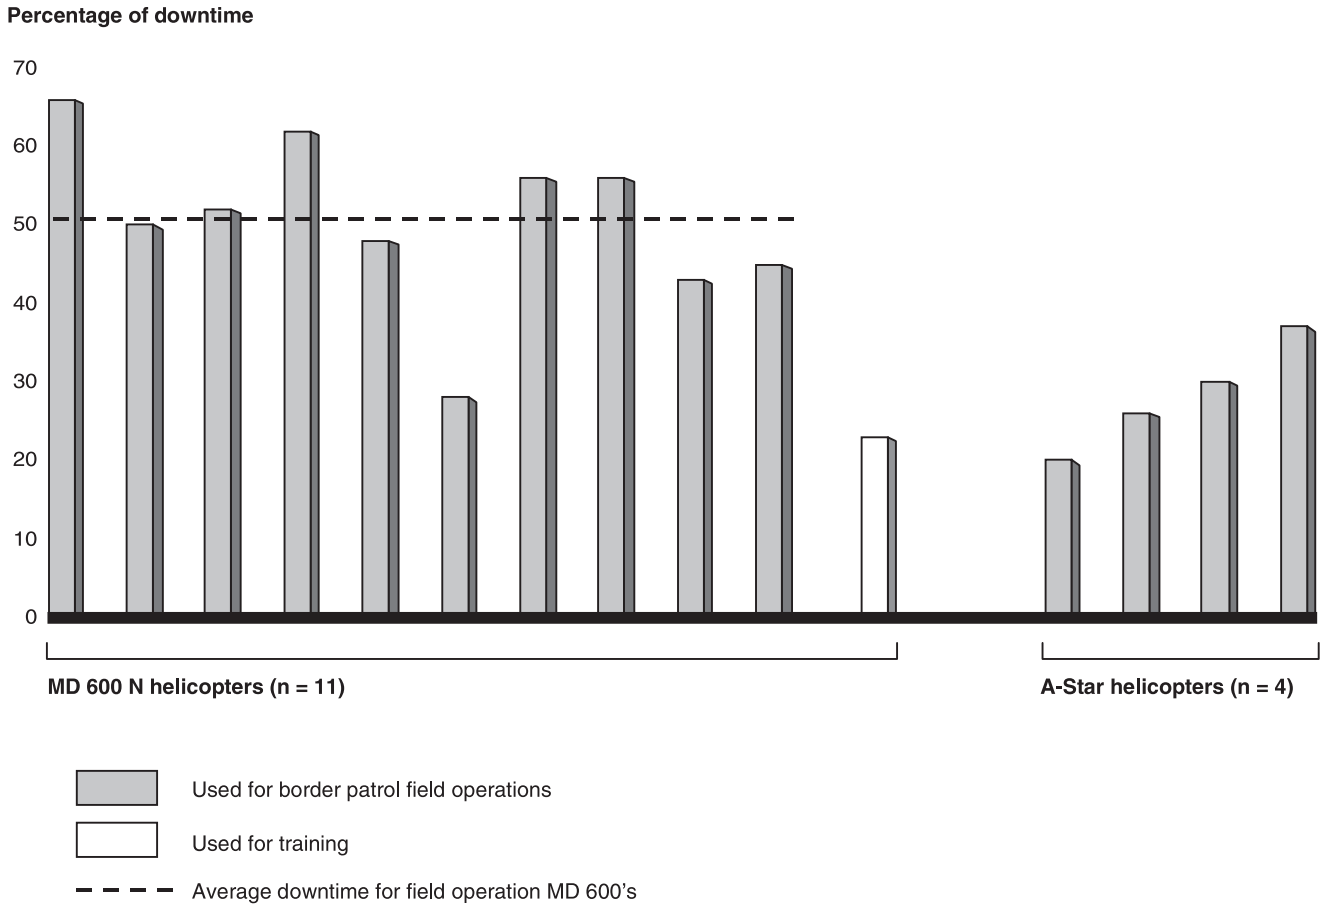
**Figure 5: Downtime for Border Patrol 600N Helicopters**

A major concern of most sector chiefs and their staffs was the significant amount of time in which the MD 600N helicopters were unavailable for use or “down.” Air Operations records for December 1998 to March 2000 show that the 10 MD 600Ns assigned to Border Patrol field operations were unavailable, on average, over 50 percent of the time.<sup>18</sup> This downtime included any time that the helicopters were not operational due to avionics repair, maintenance, or while waiting for parts. In comparison, the four Border Patrol Eurocopter “A-Star” helicopters were down 28 percent of the time during the same period. Reasons for the downtime included delays in obtaining an engine repair contract, slow manufacturer approval for modifications, and parts availability.

the engines. The damage was discovered in November 1999, but the helicopters were not returned to service until March and April 2000, respectively, because Air Operations was without an engine repair contract from October 1999 to June 2000. Emergency engine repairs were requested in late November but not authorized until mid-February 2000.

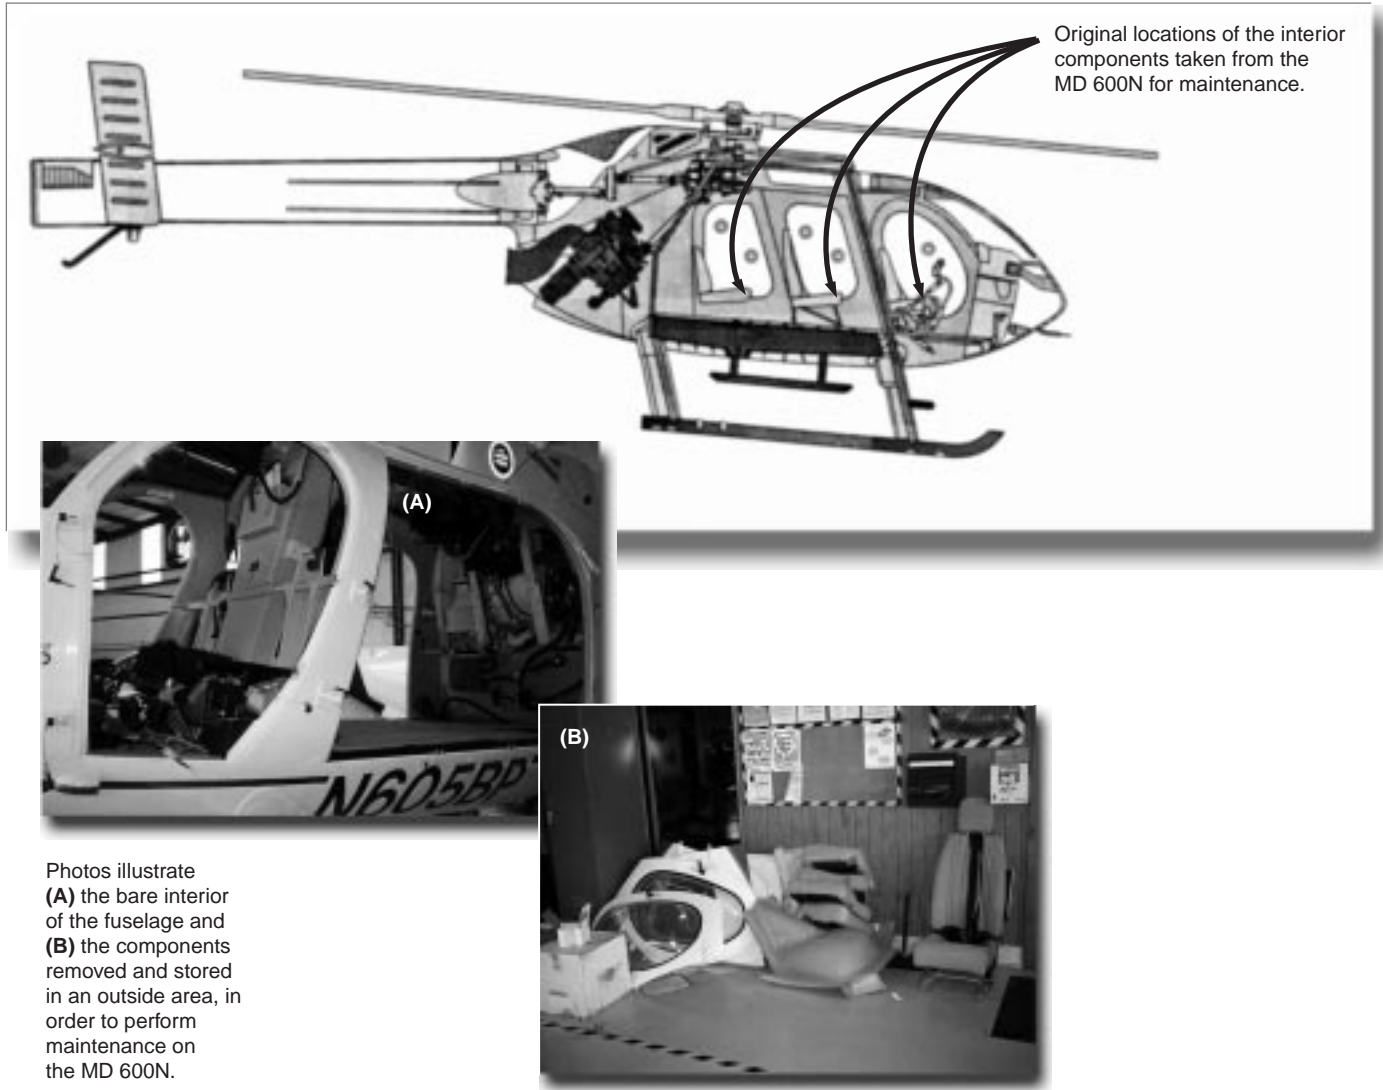
Figure 6: Aircraft Repairs Often Require Interior to Be Removed

Finally, mechanics in two sectors said that the design of the helicopter makes working on it time consuming because many repairs require that the aircraft be taken apart. One mechanic stated, for example, that often carpet must be pulled up, seats removed, and the interior vinyl removed in order for mechanics to access the aircraft's parts for a 100-hour inspection. Helicopters by other manufacturers, such as Bell, have their transmissions and drive trains located externally and would not need to have the interiors removed for a routine inspection, he said. The interiors have also experienced unusually high levels of wear and tear because of the need to remove them, one mechanic said.
