Research
Paper
FPL-RP-674

Durability of Hardboard Lap Siding

Performance in Laboratory Testing and in Long-Term Exterior Exposure

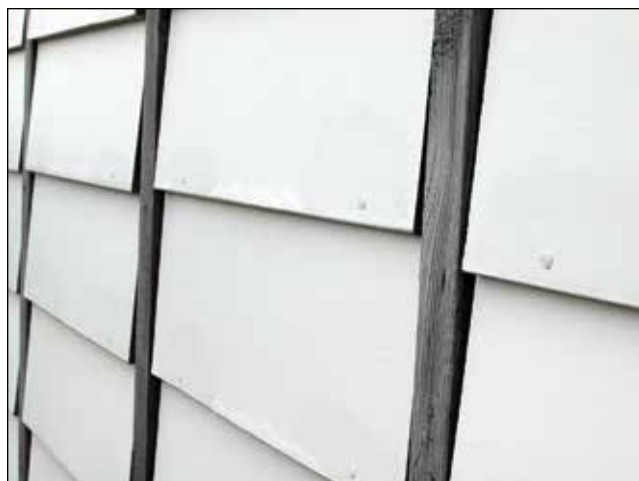
Figure 2. Two adjacent specimens in a column, each showing edge welting. This photo was taken after roughly 7 years of exposure. Welting is predominantly at mid-length of specimen (between the nails). Note lack of perceptible swelling (or welting) at the nails. The points at which on-fence thickness was measured were slightly outboard of (toward specimens ends from) the nails.

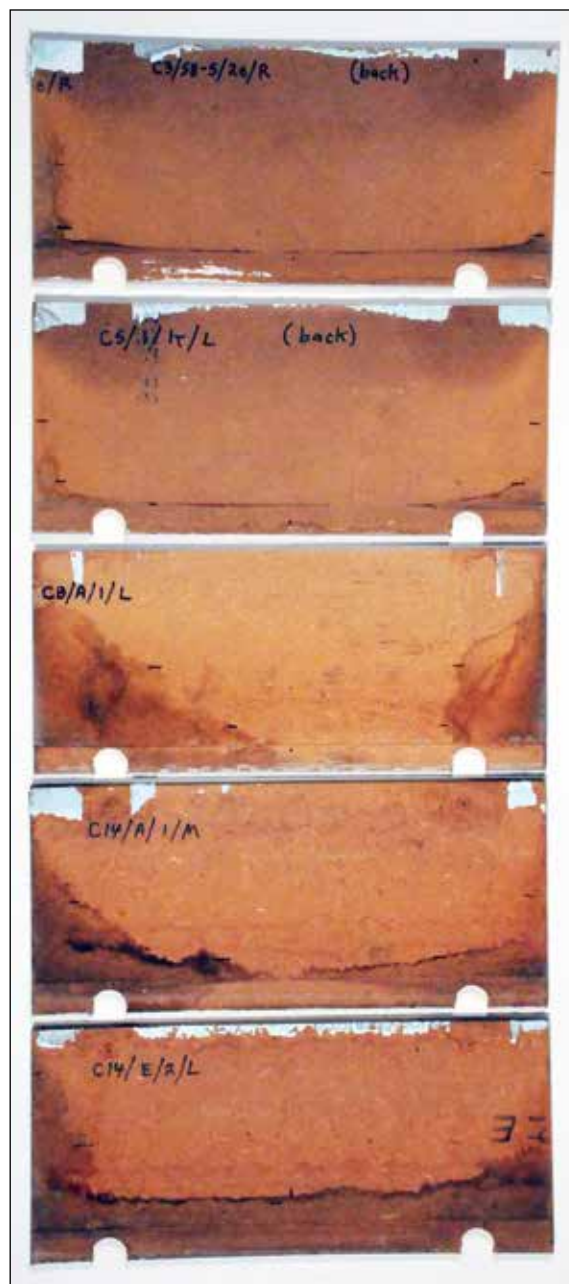
Figure 3. Rear surfaces of five specimens with staining at the drip edge at mid-specimen length. All five specimens also have staining above the lap area extending inward from the board ends, which is more extensive. The distance by which staining extends upward from the drip edge at mid-specimens length is modest in specimens C3/58-5/2e/R, C5/1/1/L, and C14/A/1/M. Intensity of staining at the drip edge is modest (faint) in specimens C3/58-5/2e/R and C5/1/1/L, but is perceptible. In all these specimens, staining at the drip edge is continuous between at least one end of the specimen and specimen mid-length.

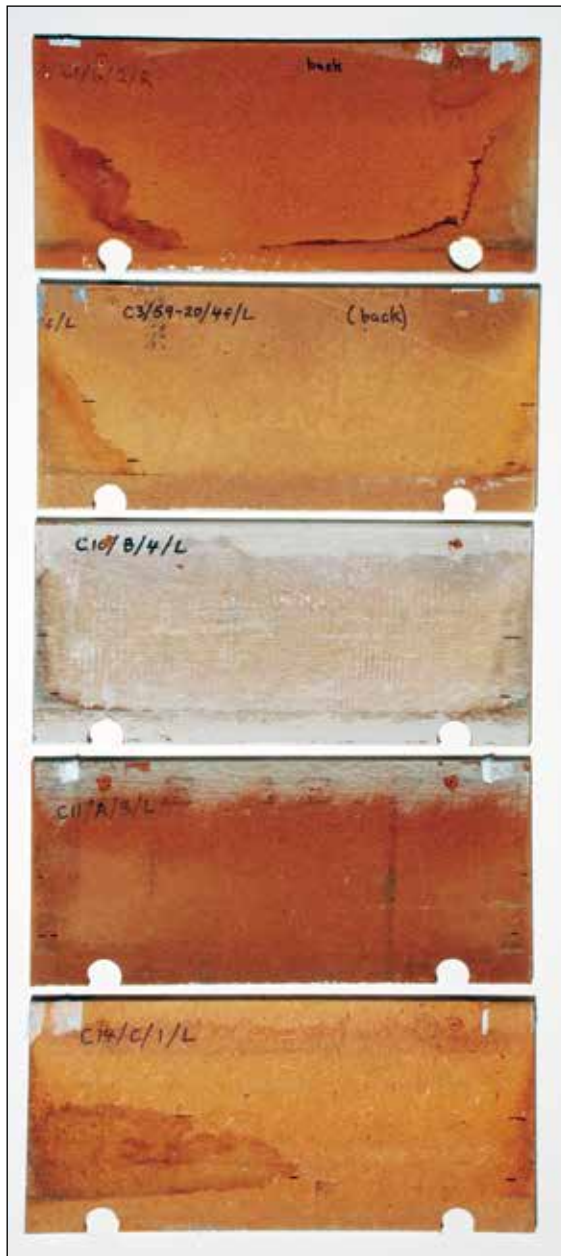
Figure 4. Rear surfaces of five specimens with staining wholly or mostly restricted to areas above the lap. In specimen C11/A/3/L, the extent of staining is modest, and the intensity so modest as to be barely perceptible. With the exception of specimen C14/C/1/L, these specimens had more extensive staining than average for their respective board classes.

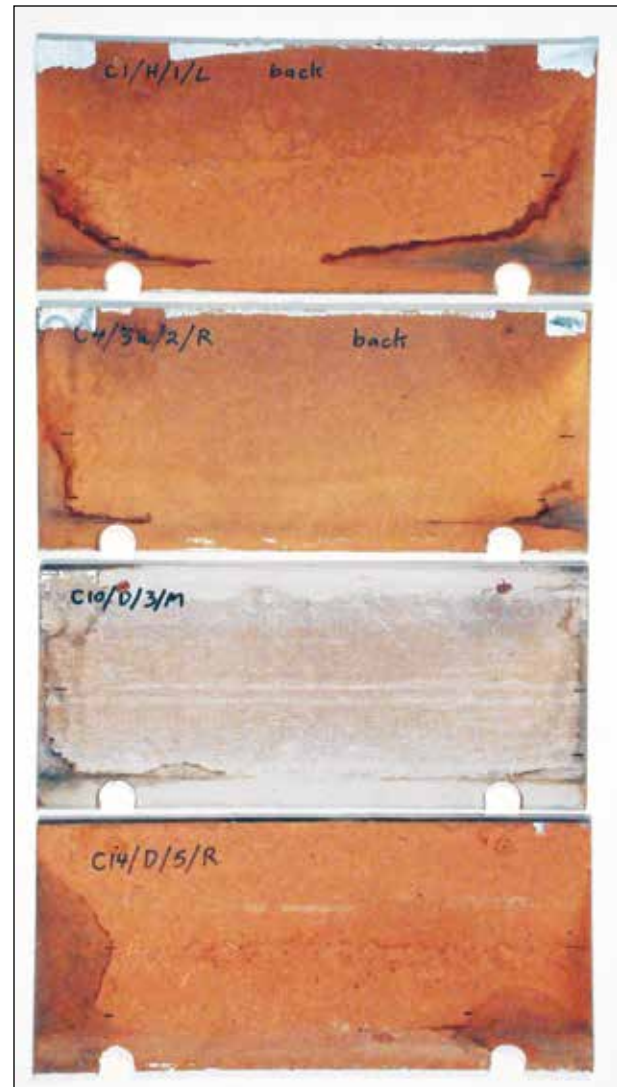
Staining in the lap area that was restricted to board ends was also sometimes observed (Fig. 5). The second evaluation phase involved documentation of sideways extent of back-surface stains from board ends, in the lap area; measurements of stain extent were made at the drip edge.

Figure 5. Rear surfaces of four specimens with staining above the lap area, extending to varying degrees into the lap area, and as far down as the drip edge on at least one specimen end, but not extending to specimen mid-length at the drip edge.

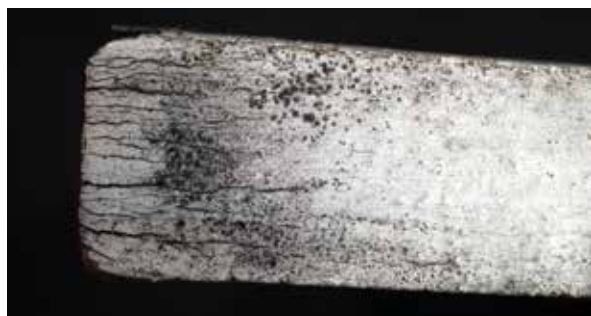
Localized drip-edge paint failures commonly occurred early during the exposure period at the ends of specimens where the drip edge intersected with the specimen end cuts. As indicated previously, the specimen end cuts were not painted and localized edge swelling occurred at end cuts. Where

the end cut intersected the drip edge, the localized swelling resulted in rupture of the paint film (at the ends of the drip edge). The rate at which drip-edge paint cracks extended from the specimen ends progressed slowly. At the final inspection, at roughly 75% of specimen ends, extension of drip edge cracks from swollen ends did not exceed 15 mm. In specimens that developed prominent drip-edge paint cracking, the cracks typically developed in patches along the drip edge, often at some distance from the board ends. Until cracking progressed to advanced stages, the patches did not connect with cracks at the specimen ends. A summary of the extent to which drip-edge paint cracks extended from the swollen ends of boards at the final inspection is shown in Table 7. The linear extents were typically modest and thus most convenient to measure on a millimeter scale. In boards of classes 8 and 12, drip-edge cracking was typically continuous along the entire length of the drip edge at the final inspection. In all other classes of board, patches of drip-edge cracks, which were typically most prevalent near specimen mid-length, rarely or never connected with board ends at the final inspection.

Figure 7a. Magnified image of the end of the drip edge of a specimen of Class 1 board. Drip-edge paint cracking is prevalent near the end of the specimen, but does not extend more than 16 mm from the specimen end. Patches of mildew are present only near the inboard terminations of drip-edge cracks. This specimen was from a bottom course location, (where water exposure was greatest), and in the left-most column of specimens (at the southwest corner of the building). This specimen showed more drip-edge mildew than any other specimen. In this photograph the outer specimen face is at the top of the specimen.

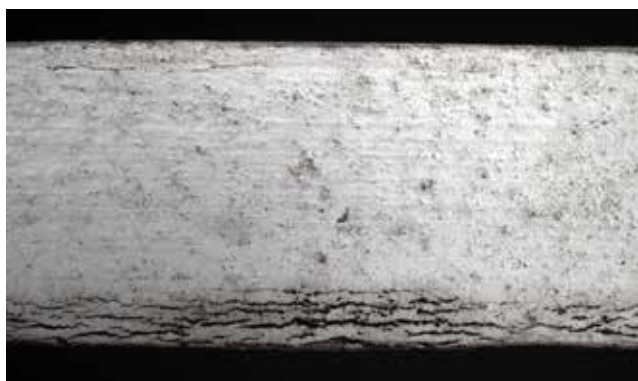
Figure 7b. Magnified image of the drip edge of a specimen of class 4 board approximately at specimen mid-length. A patch of drip-edge cracks is present near the outer edge of the drip edge, and a small amount of mildew is present in the patch of drip-edge cracks. The specimen was from a bottom course location. In this photograph, the outer specimen face is at the bottom of the specimen.

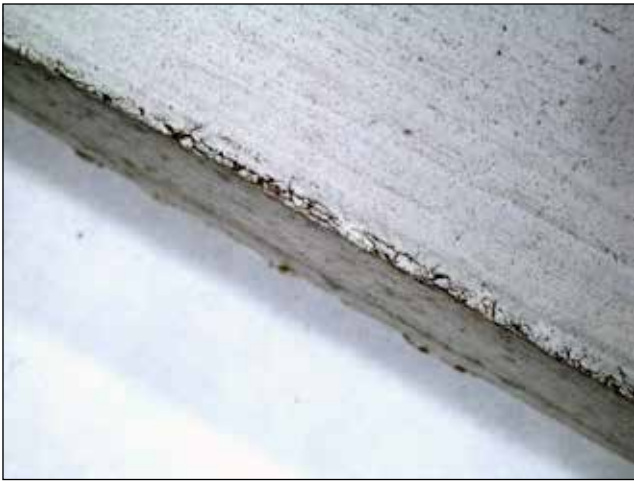
Figure 12. Magnified image showing initiation of cracking at the interface of the drip edge and the outer specimen face in a specimen of class 2 board. With the exception of these observed cracks, some cracking near the unpainted end cuts, and some surface dirt, the specimen was in pristine condition after 155 months of exposure. This specimen did not have a shaped drip edge, inasmuch as it was a specimen of noncommercial board.

indicated substantial variation in film thickness on drip edges (much more so than on specimen faces), with much of the variation being localized, and associated with unevenness of the substrate surface. Projecting fibers or fiber fragments were commonly present on drip-edge surfaces, which protruded partially (and occasionally completely) through the paint film.
