REPORT ON

THE BOISE, IDAHO FLOOD

August 20, 1959

Boise National Forest

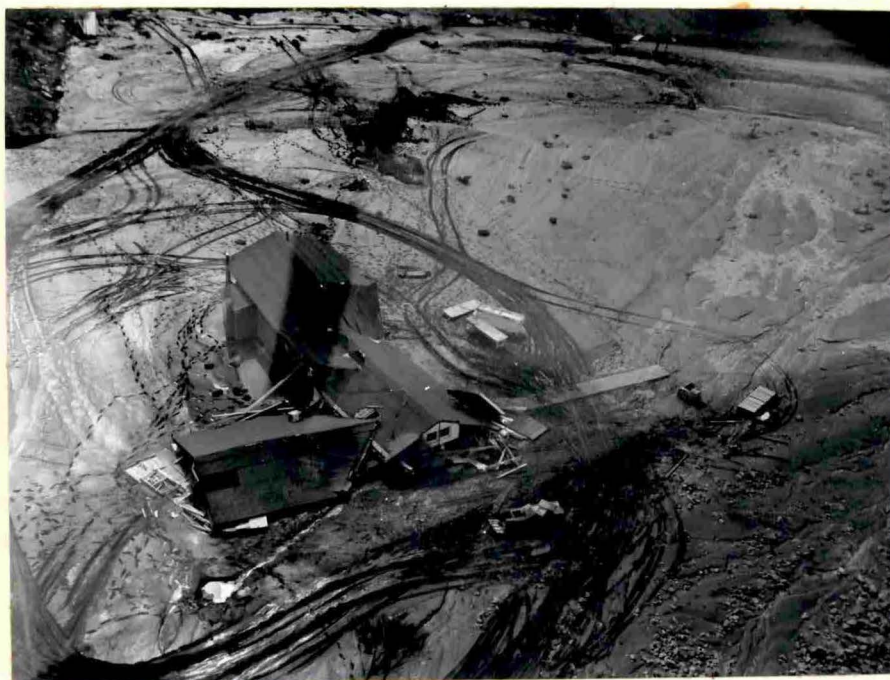
Damage to property near the mouths of the major drainages was heavy.  
The Boise City Police clubhouse was totally destroyed.

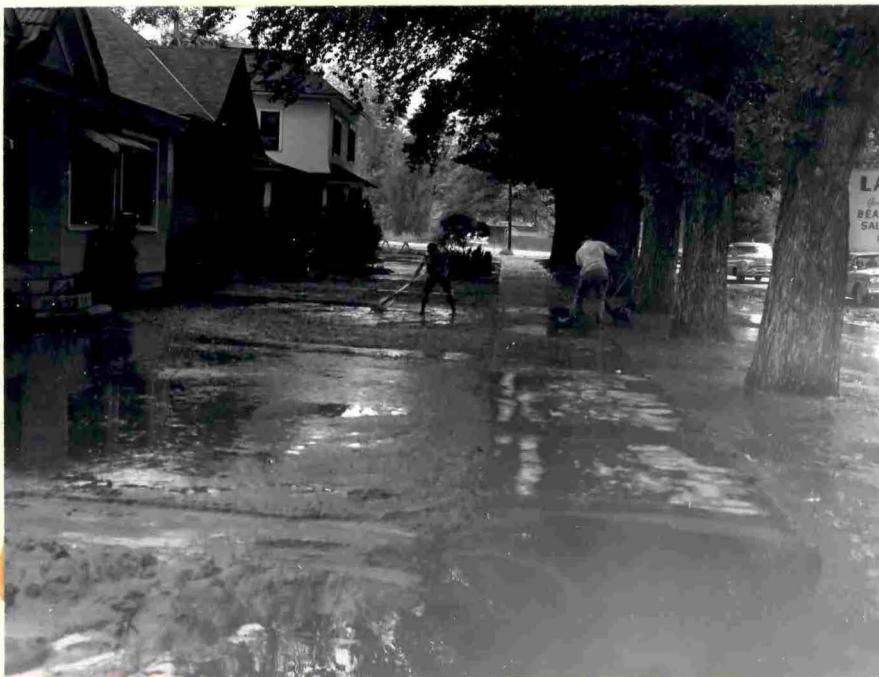
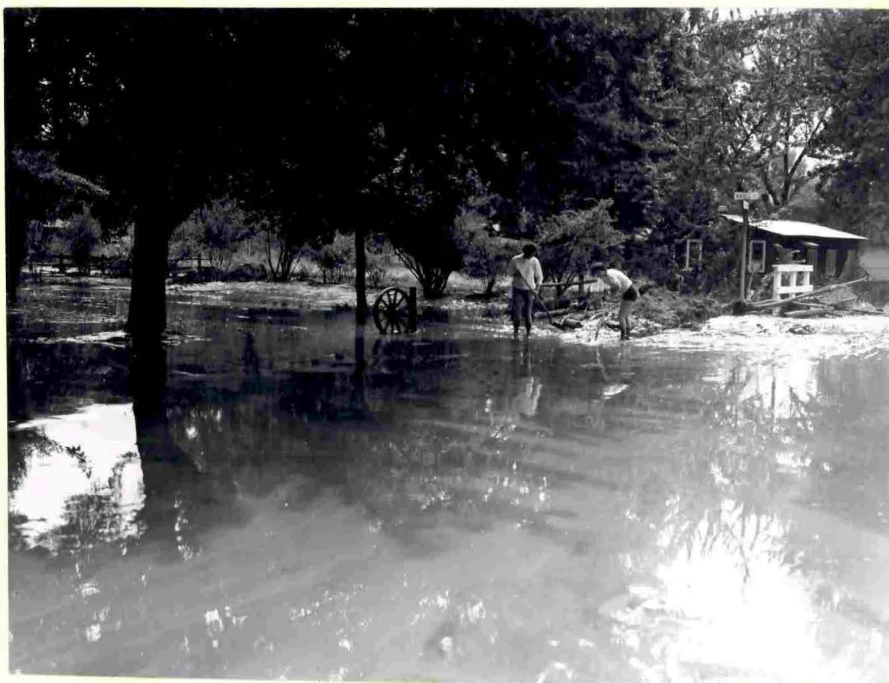
Lawns were covered with several inches of silt and sand. Many basements were flooded, with heavy damage to furniture and other items.

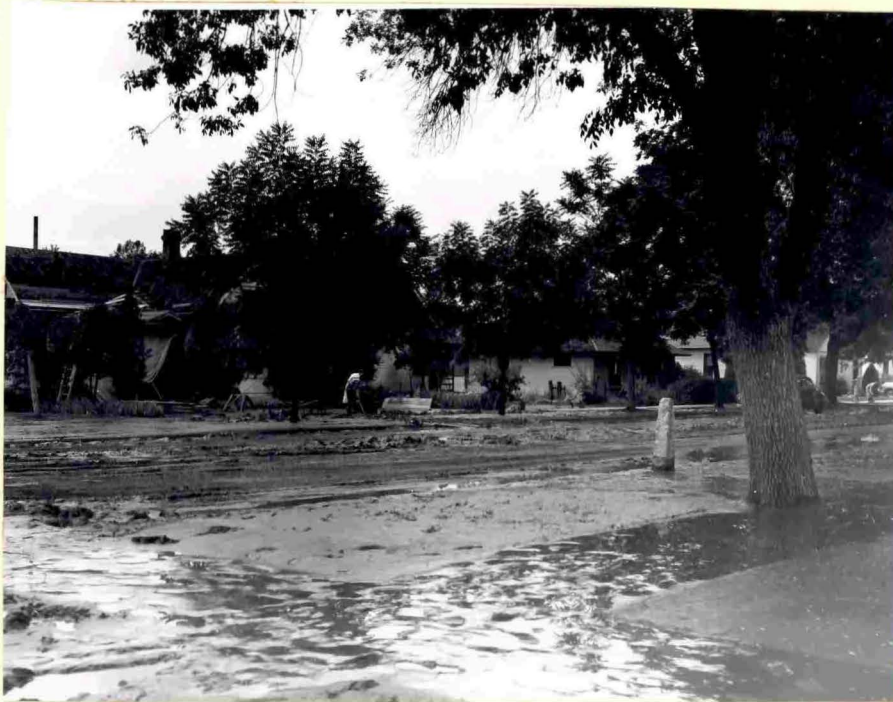
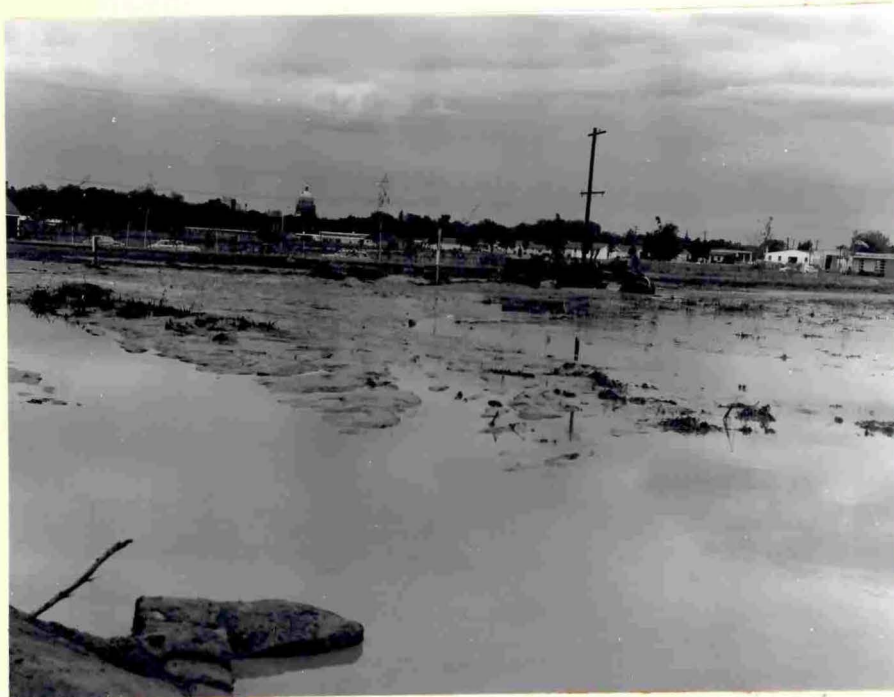
Much time and effort will be needed to clean up the portion of east Boise hit by the flood waters.

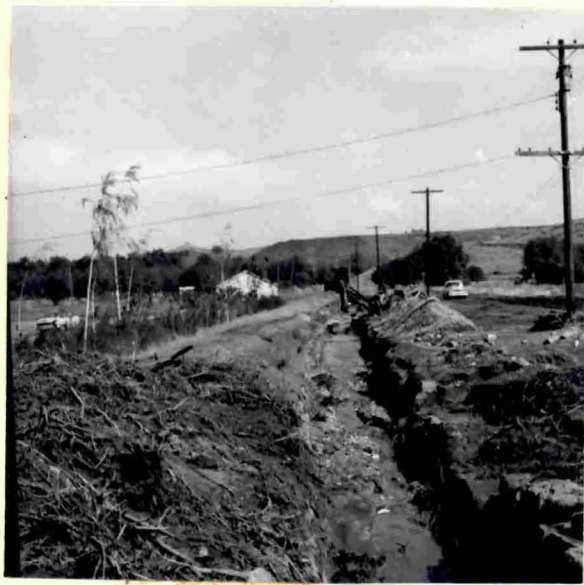
Heavy damage was done by the waters from Cottonwood Creek to the irrigation canals in the east Boise area.

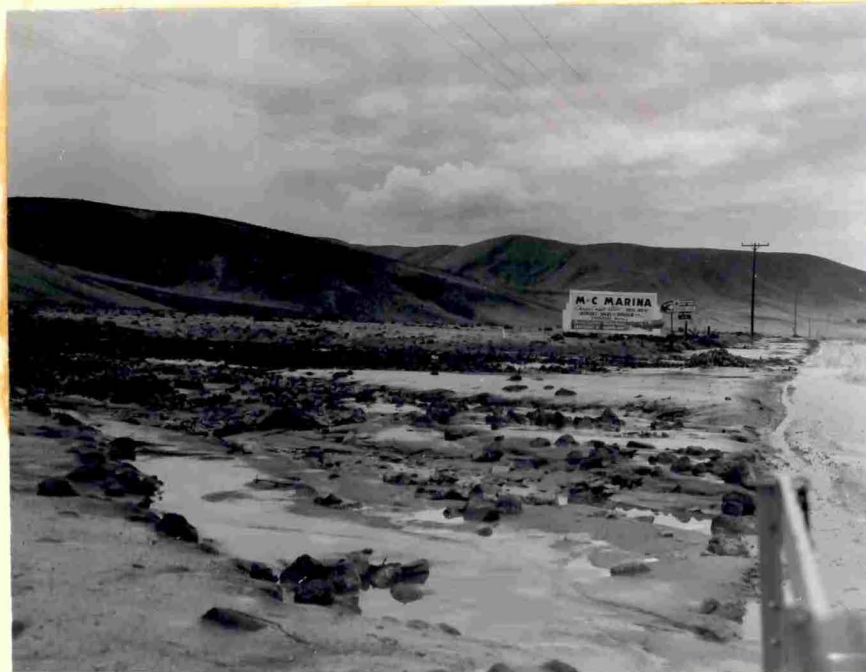
Mud and rock cover a large area to depths of 2 to 6 feet between the mouth of Maynard Gulch and Highway 21. At this point the highway was blocked for several hours.

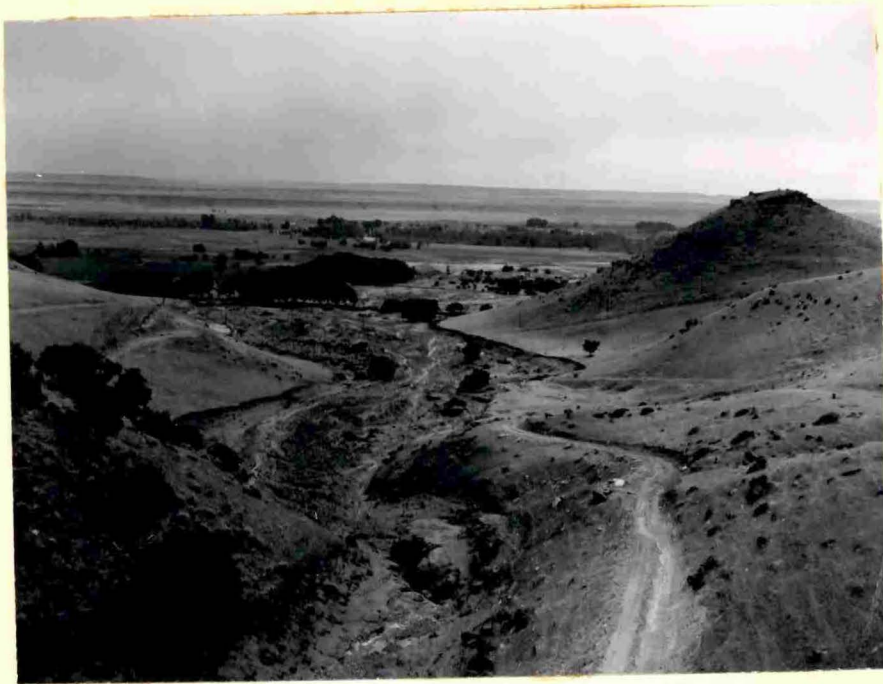
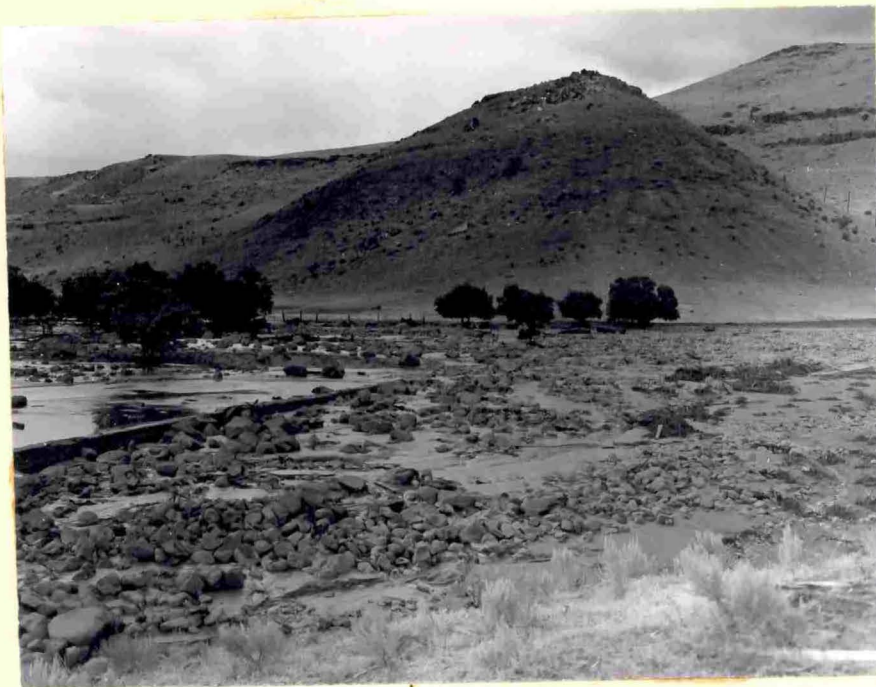
An amount of water, soil, and debris equaling or exceeding that which roared out of Maynard Gulch came down Warm Springs Creek. Both of these watersheds were burned off in the fire of August 3, 1959.

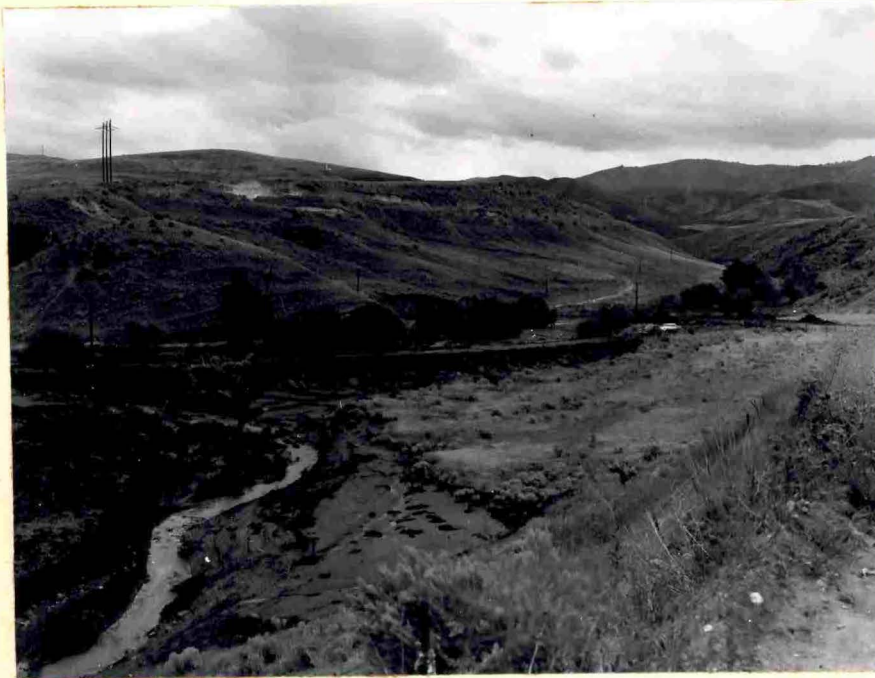
Flood waters from Cottonwood Creek cut a wide channel as they passed the Aldape Ranch. Run-off from the areas burned in both the Lucky Peak fire of 1959 and the Rocky Canyon fire of 1957 came together at the mouth of Picket Pin Creek.

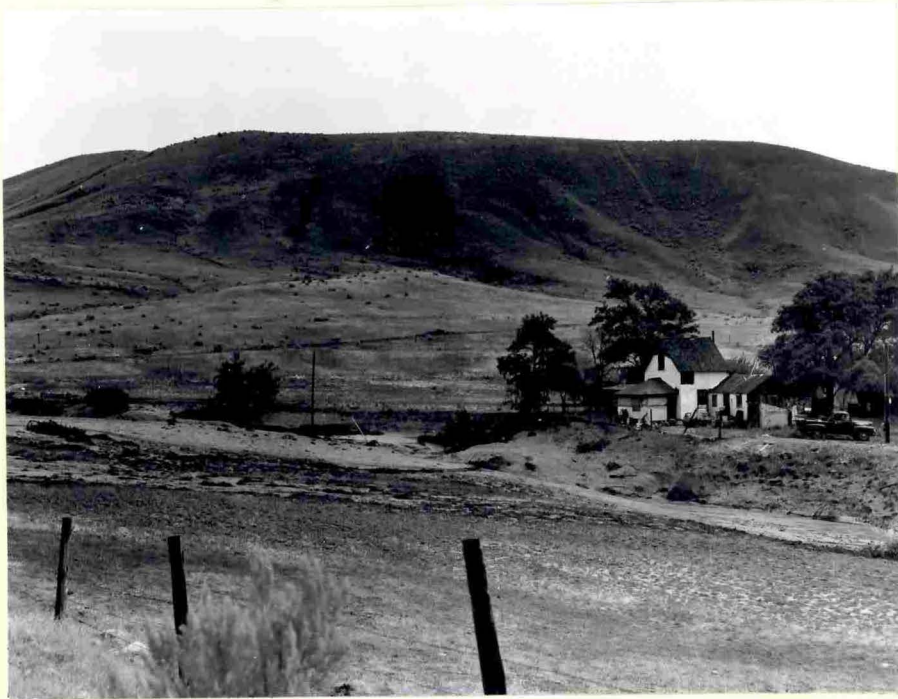
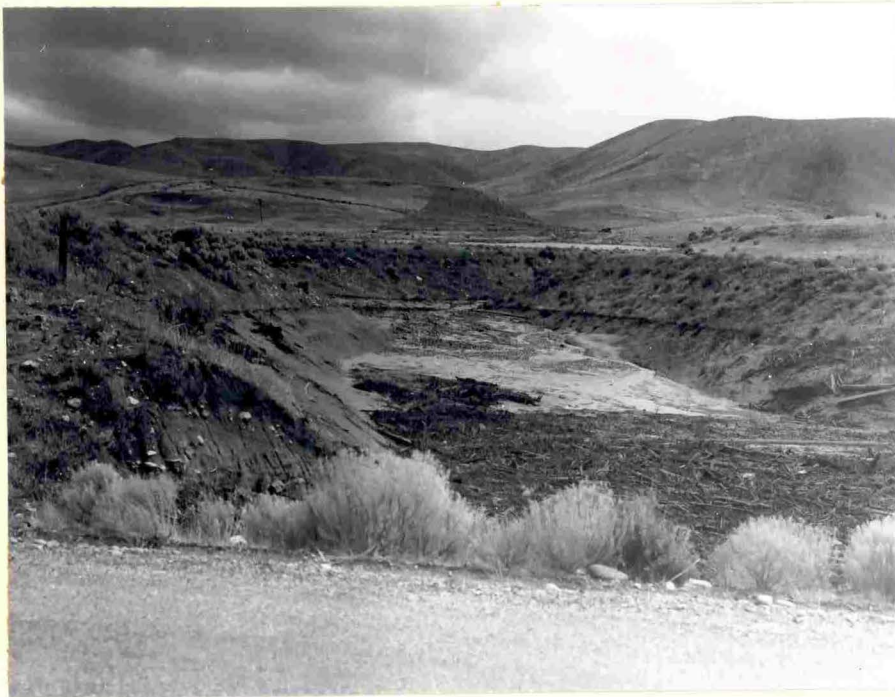
The watershed drained by this small gulch near the Highland Valley road was partially burned off in the August 3, 1959, fire. A large amount of water and debris came down the dry stream channel and filled a catch basin at the edge of Highway 21.

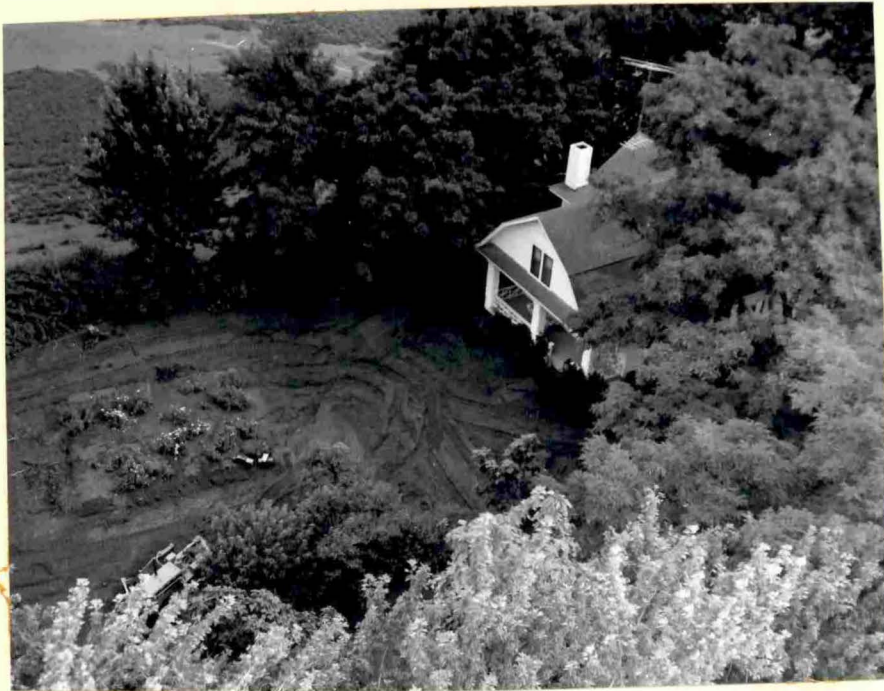
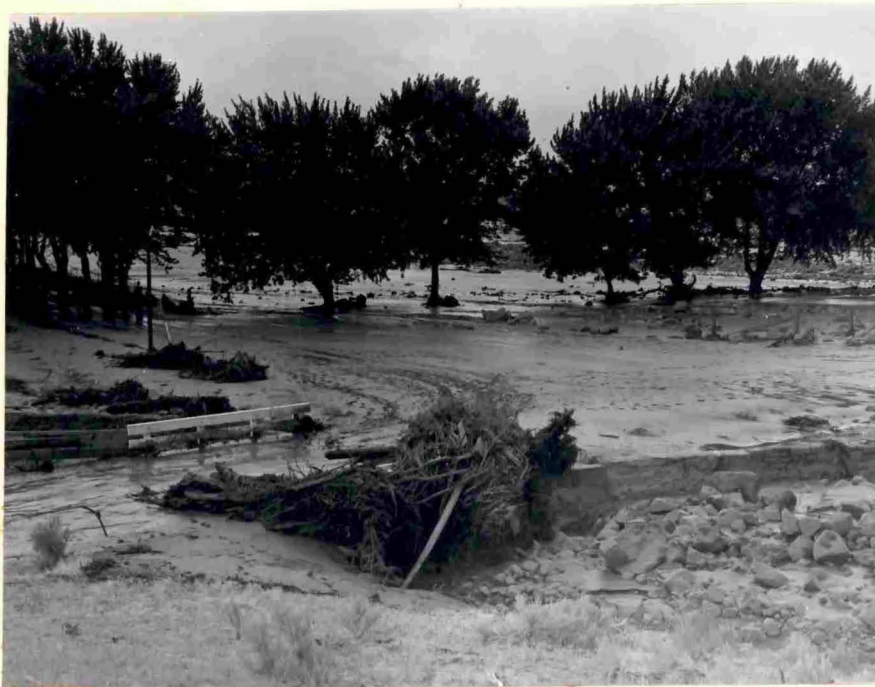
The Eckert ranch home, surrounded by mud and rocks, near the mouth of Warm Springs Creek.

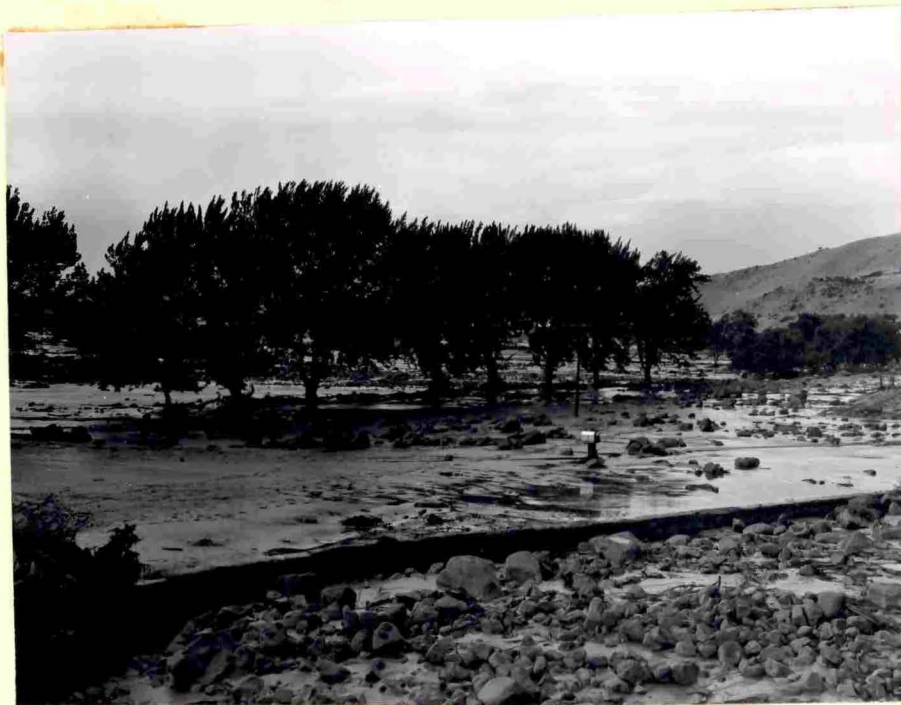
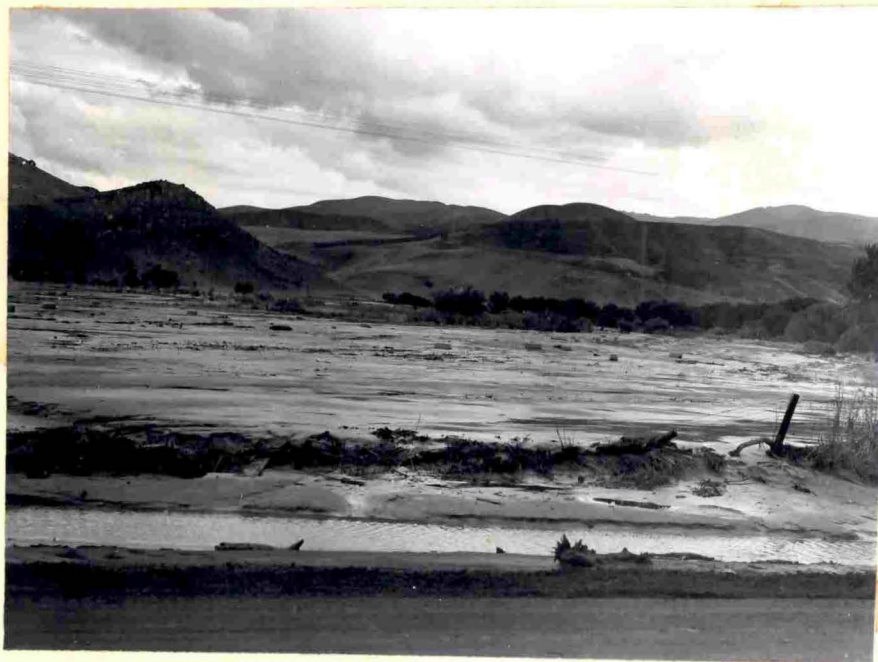
Pastures and hay fields of the Eckert ranch, near Barber, was severely damaged. Large amounts of rock will make rehabilitation of the land difficult.

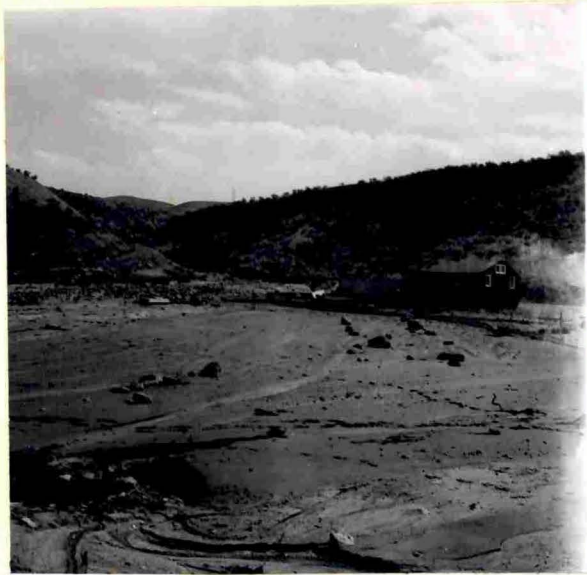
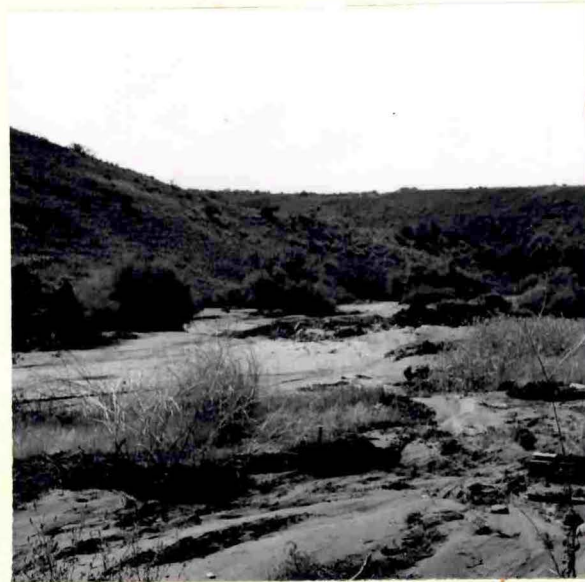
Flood waters from Curlew Gulch destroyed the City Police clubhouse and narrowly missed two other homes. The upper Curlew watershed was burned off by a fire of 1958. Another portion was burned during the Rocky Canyon fire of 1957.

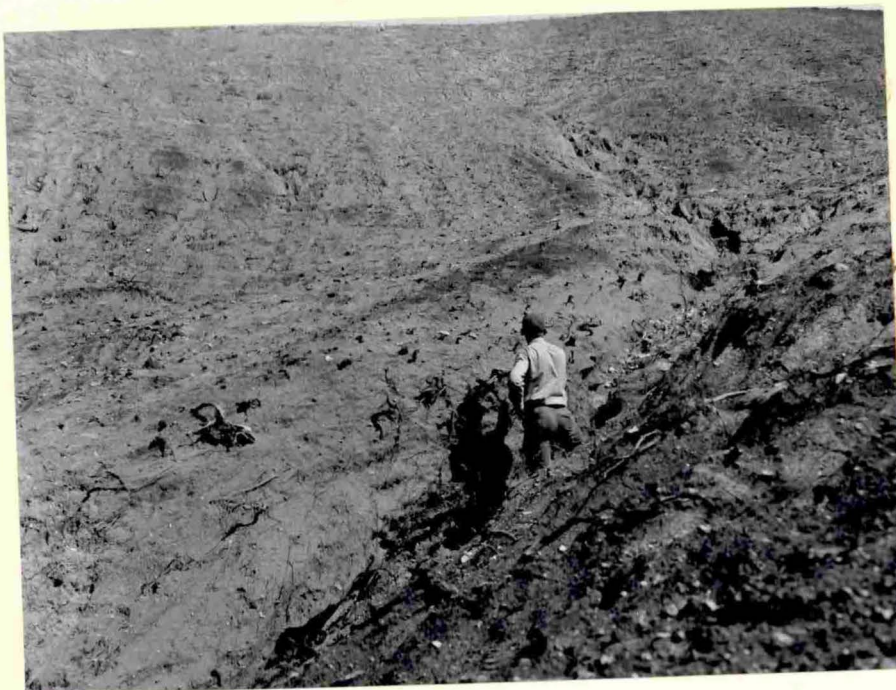
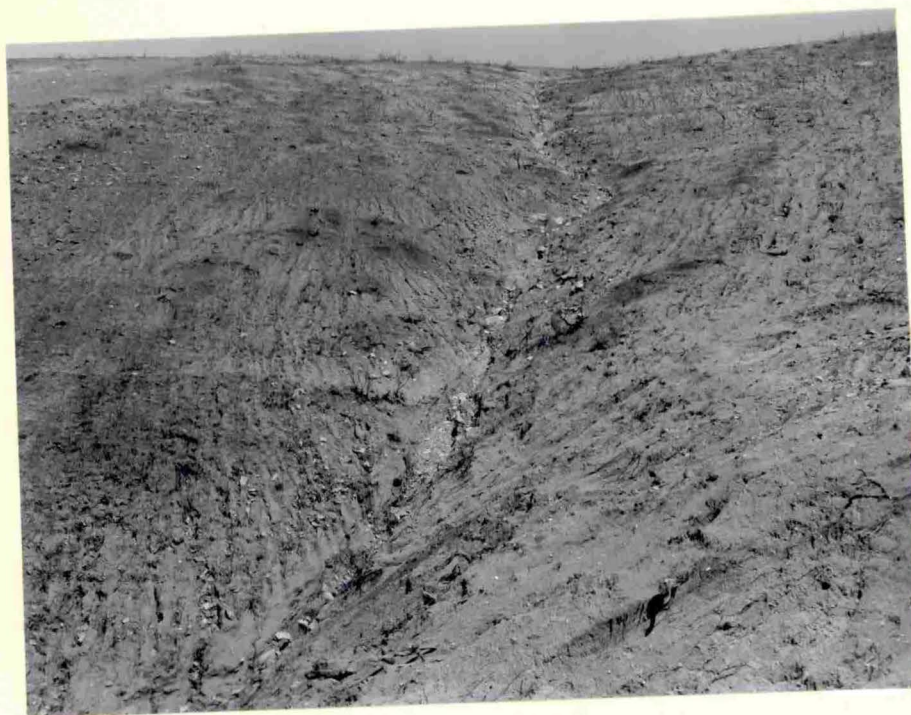
Storm run-off rapidly cut gullies in the exposed soil. This SSW slope of 35 percent had an average of 83 rills per 100 feet along the contour. Rills ranged in depth from 1/2 inch to 8 inches, and from 1 to 18 inches in width.

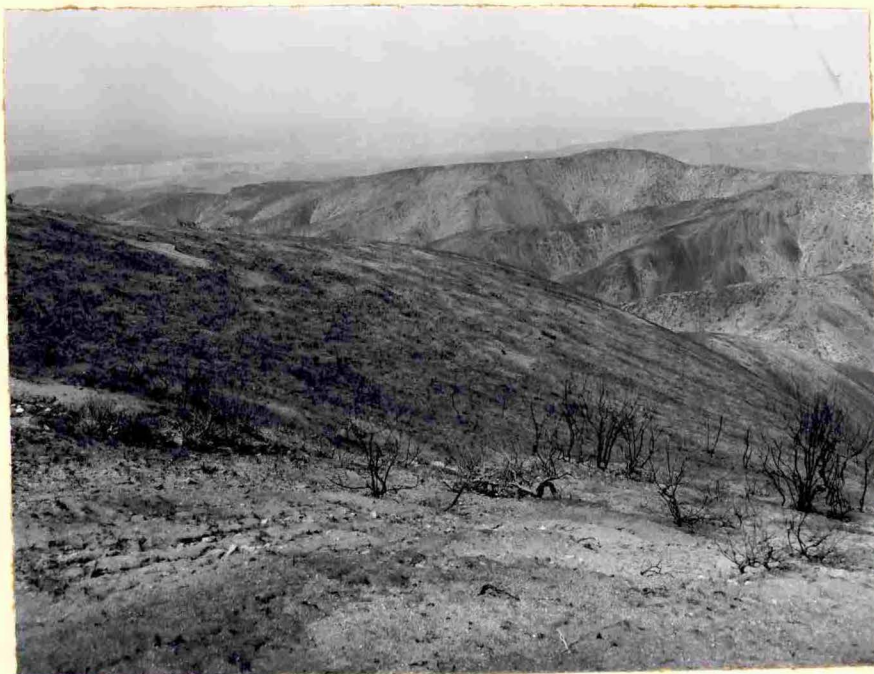
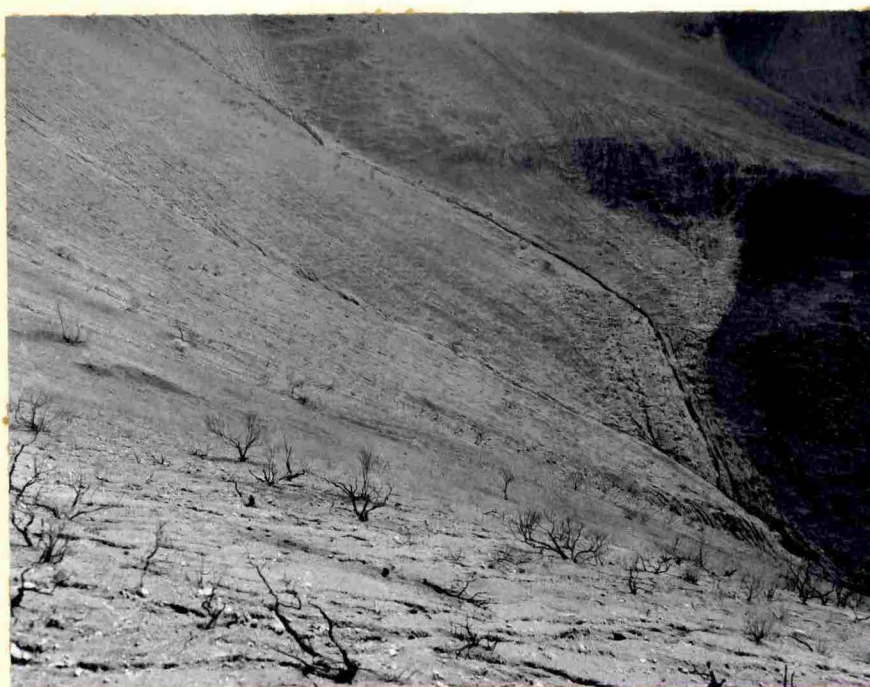
Future rains will continue to wash soil down these completely bare slopes. It will probably be many years before perennial vegetation becomes well established under a revegetation program.

The only assurance of permanent safety on these watersheds is to revegetate them to perennial grasses.

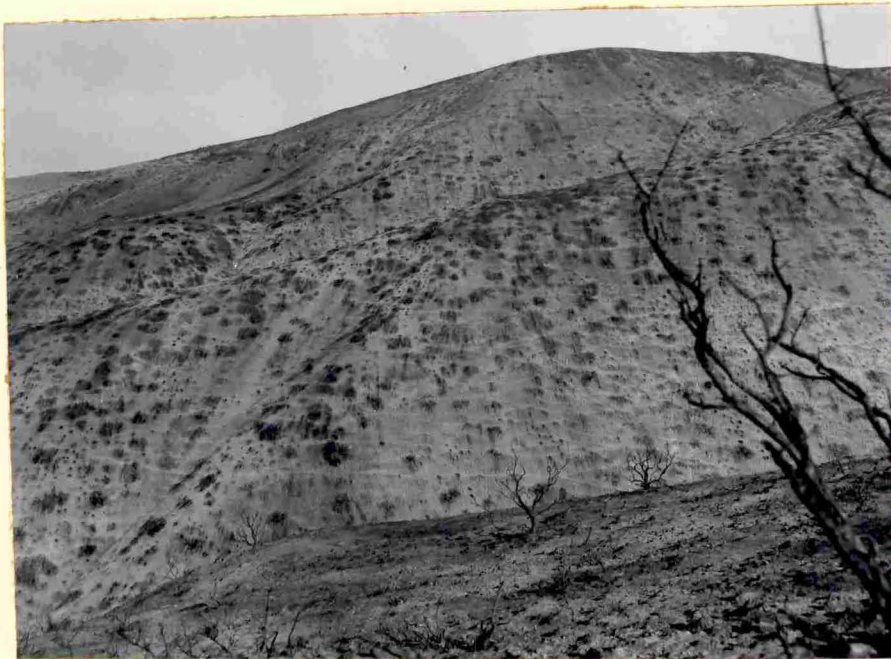
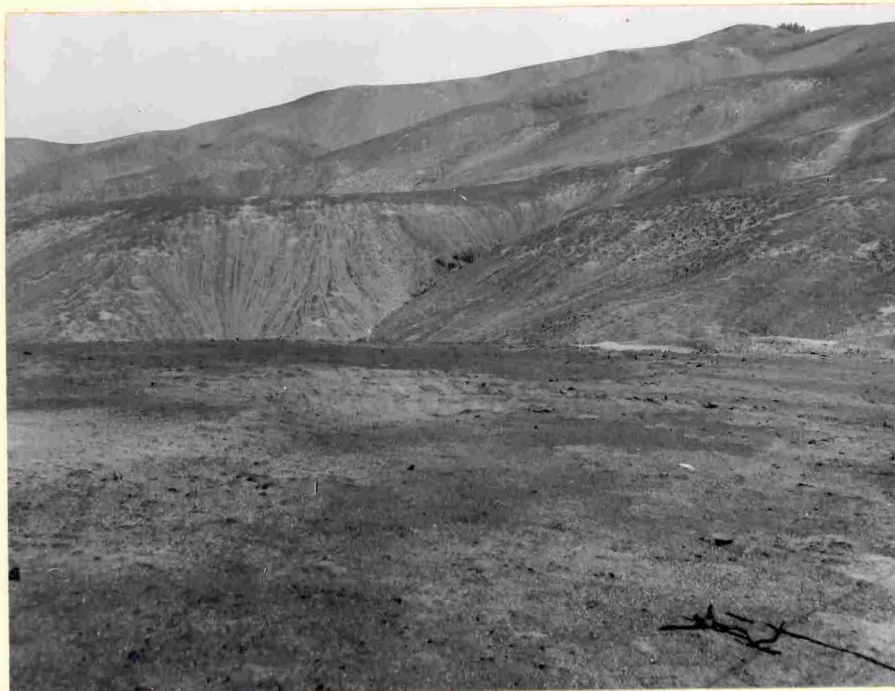
A range fire of August 3, 1959, destroyed almost all vegetation, leaving the coarse, granitic soil completely bare. Erosion channels on the steep slopes are easily visible in these photographs. Darker-colored patches are ash-covered areas where the soil stayed in place.

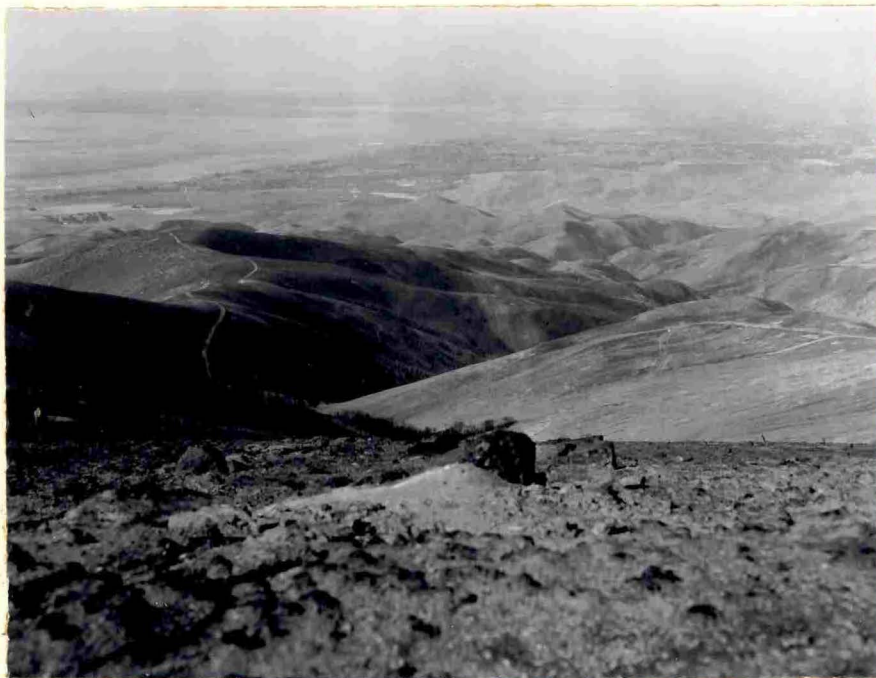
View of Maynard Gulch watershed from the Boise Ridge, near Lucky Peak. This was the source of much of the tremendous run-off that surged out of Maynard Gulch and across State Highway 21 near Barber.

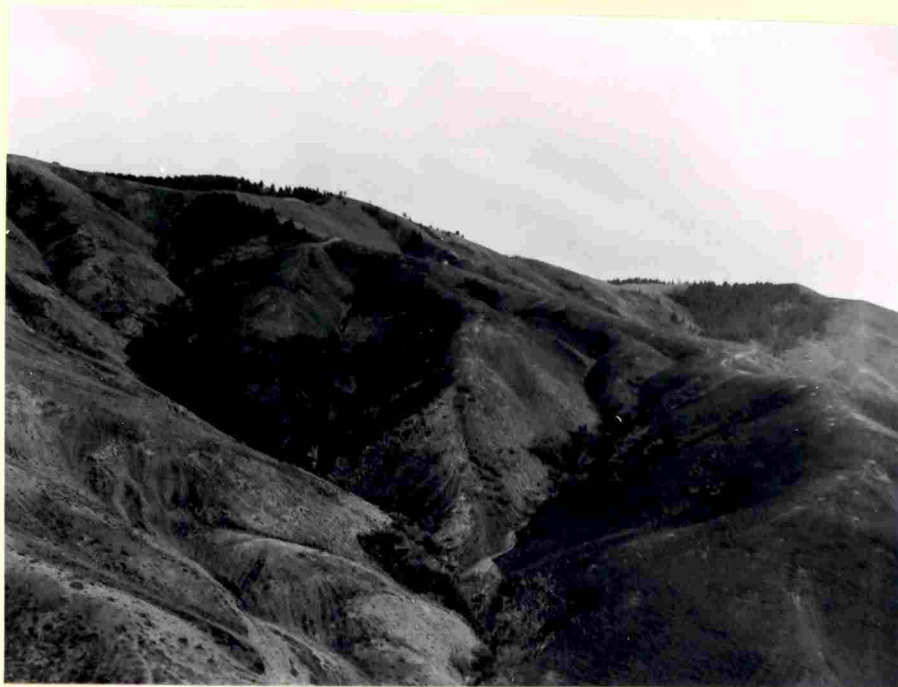
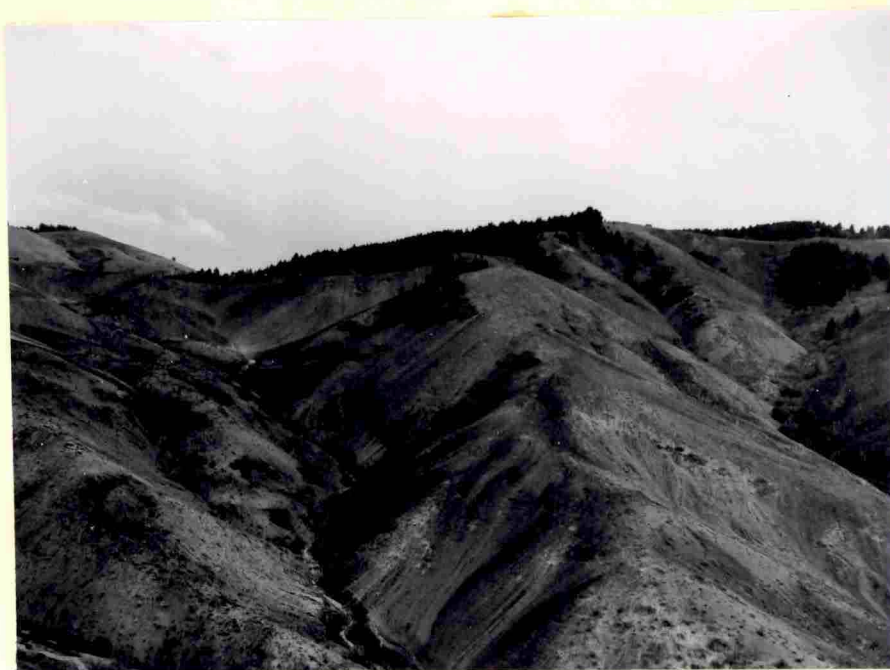
Upper slopes of Picket Pin Creek. Water running off these slopes---bared by the fire of August 3, 1959---constituted a major portion of the flood waters that caused extensive property damage in the east portion of Boise.

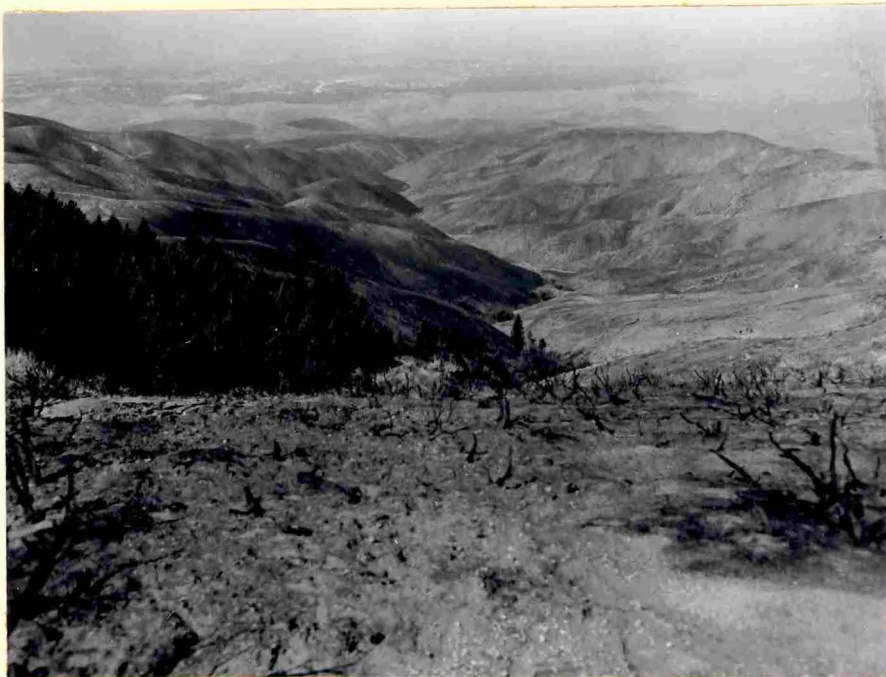
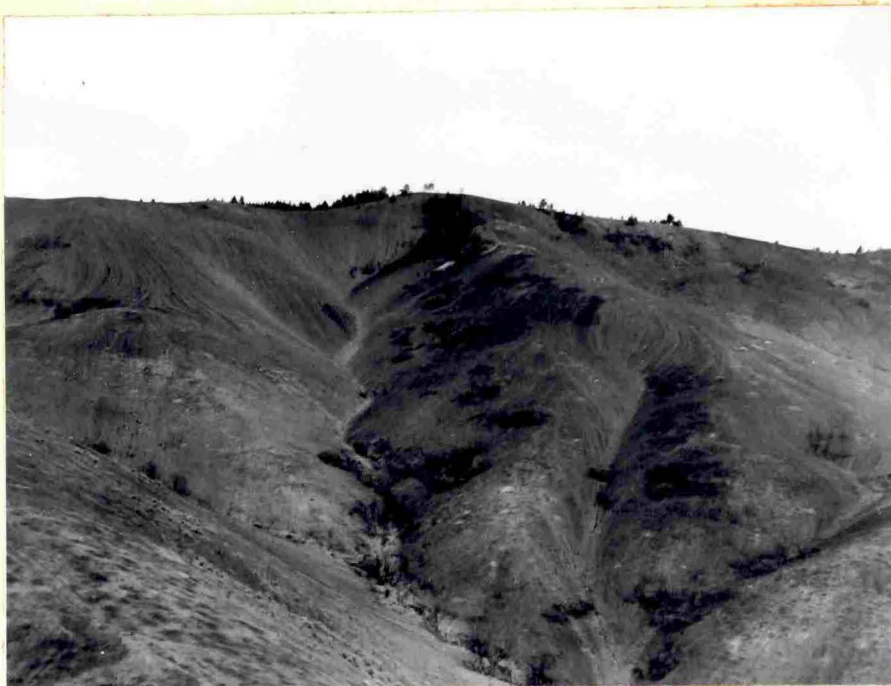
View of a portion of the upper reaches of Warm Springs Creek. Torrents of water, rock, and soil caused great damage to Eckert's ranch at the mouth of Warm Springs Creek.

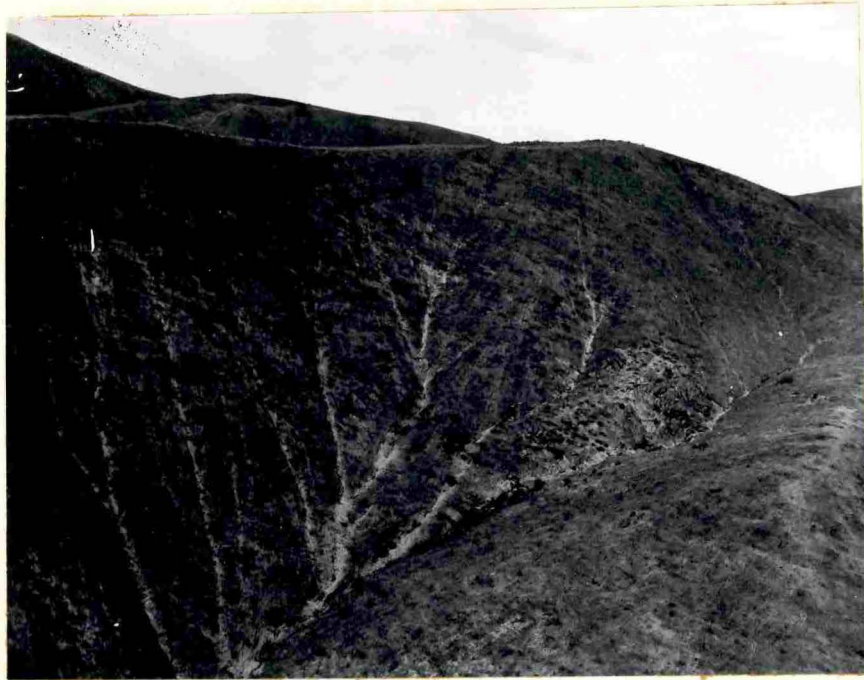
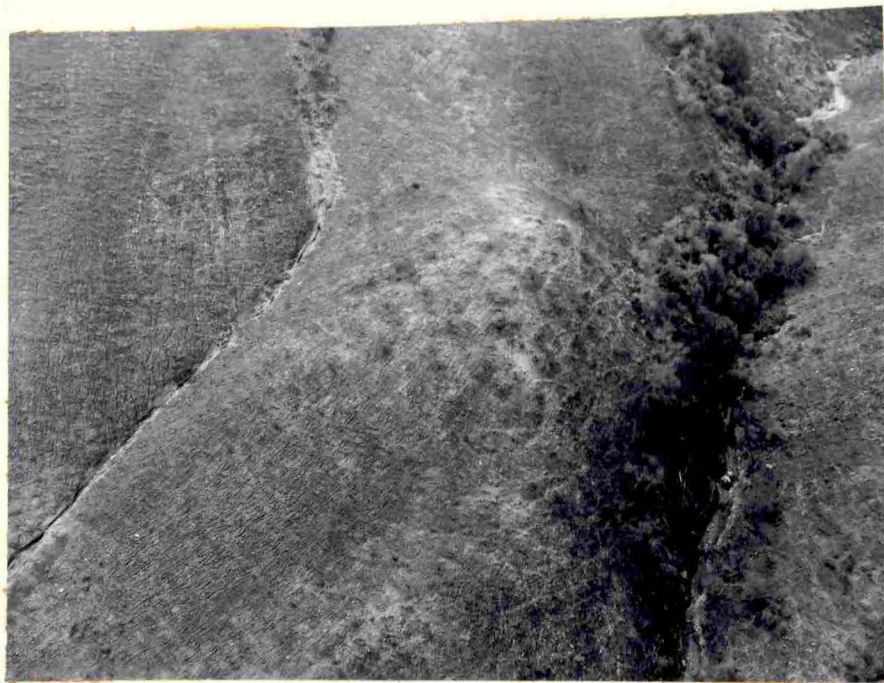
Storm run-off cut many rills and gullies on the slopes of Curlew Creek. This area burned during the summer of 1958, and had a light cover composed primarily of annual grass and forbs.

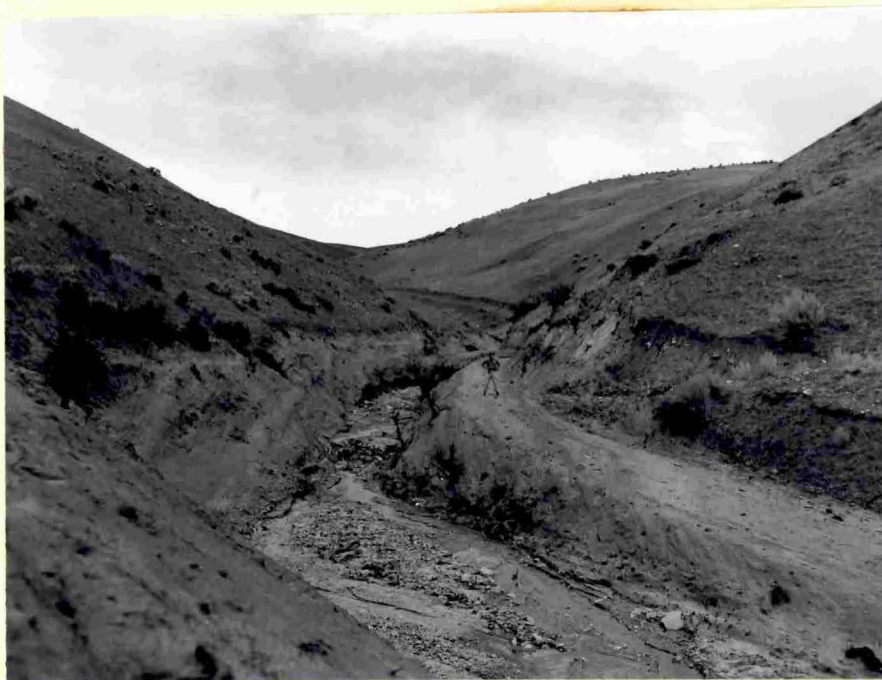
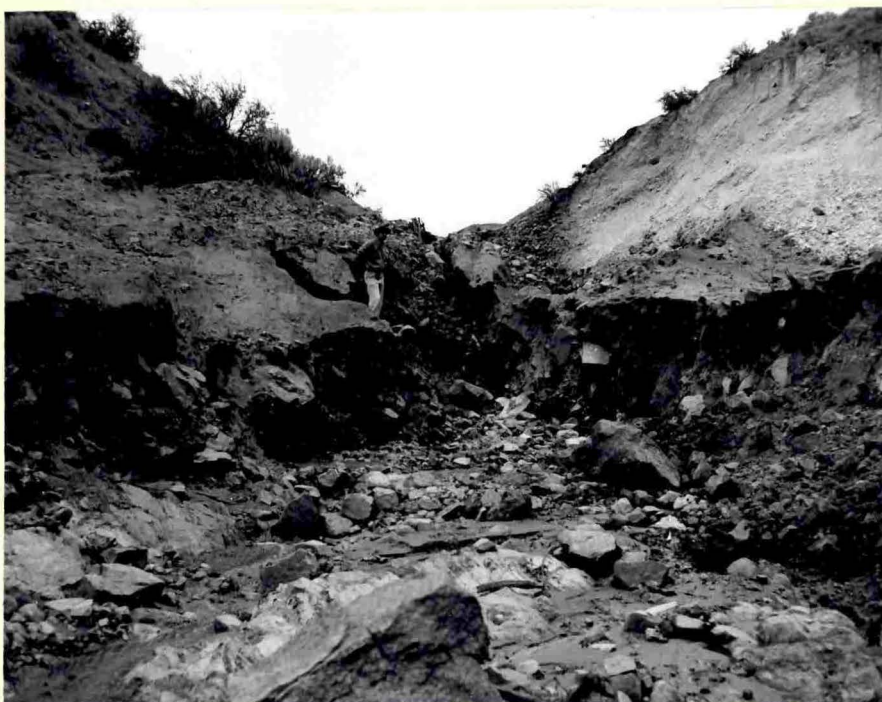
For  $1\frac{1}{2}$  miles upstream from the mouth, Maynard Gulch cuts through an unburned area. These photographs show the force of the flood water as it came down from the upper reaches of the watershed that had been burned.

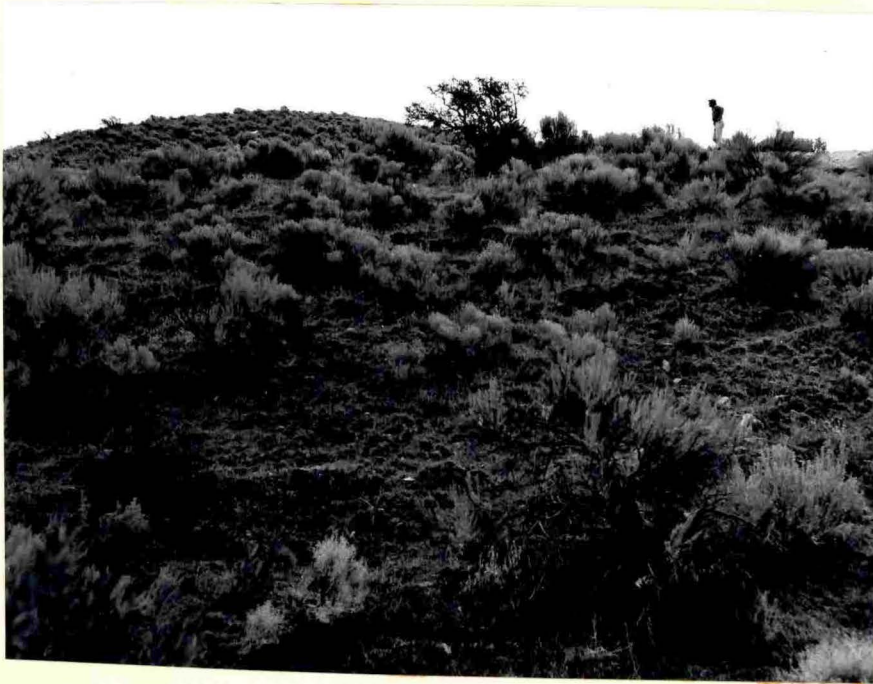
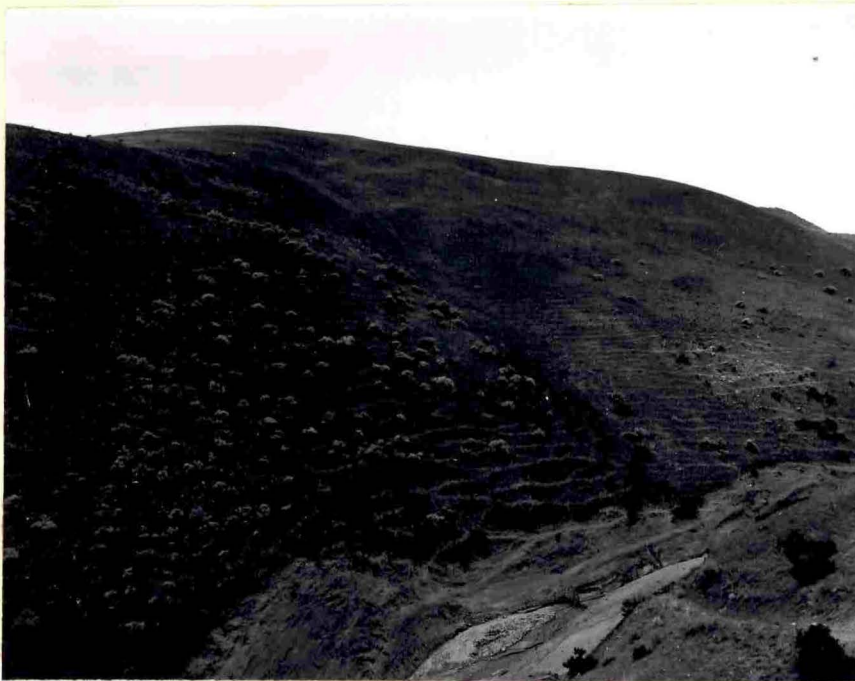
Unburned portion of the lower Maynard Gulch watershed. Vegetation on north-facing slopes (above) contains more perennials such as bluegrass, fescue, sagebrush, and rabbitbrush. South-facing slopes (below) are dominated by annuals such as cheatgrass, fiddleneck, and groundsmoke, with a few rabbitbrush and sagebrush shrubs. Although some run-off occurred from these unburned slopes, soil erosion was negligible.

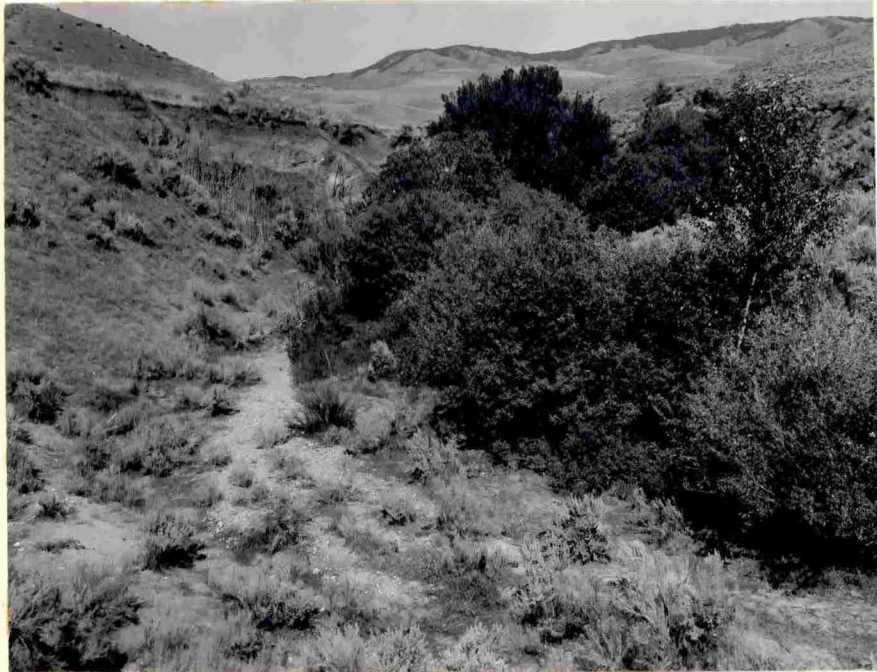
Crane Gulch, 1/4 mile above a recently developed housing area (Highlands). No channel cutting resulted from the storm; however, if the large Crane watershed is ever burned there will be grave danger to the housing development at the mouth.

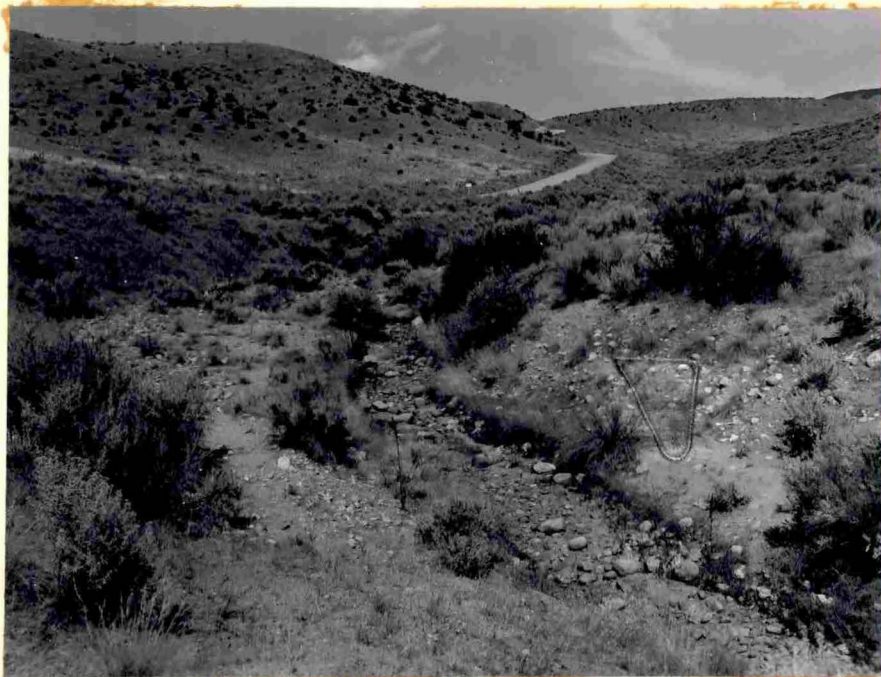
Hull's Gulch, at a point 200 yards upstream from the Boise Water Corporation's reservoir No. 1, shows only a small amount of new channel cutting. This watershed absorbed most of the rainfall and no damage occurred to property located at the mouth of the gulch.
