REPORT ON

THE BOISE, IDAHO FLOOD

August 20, 1959

Boise National Forest

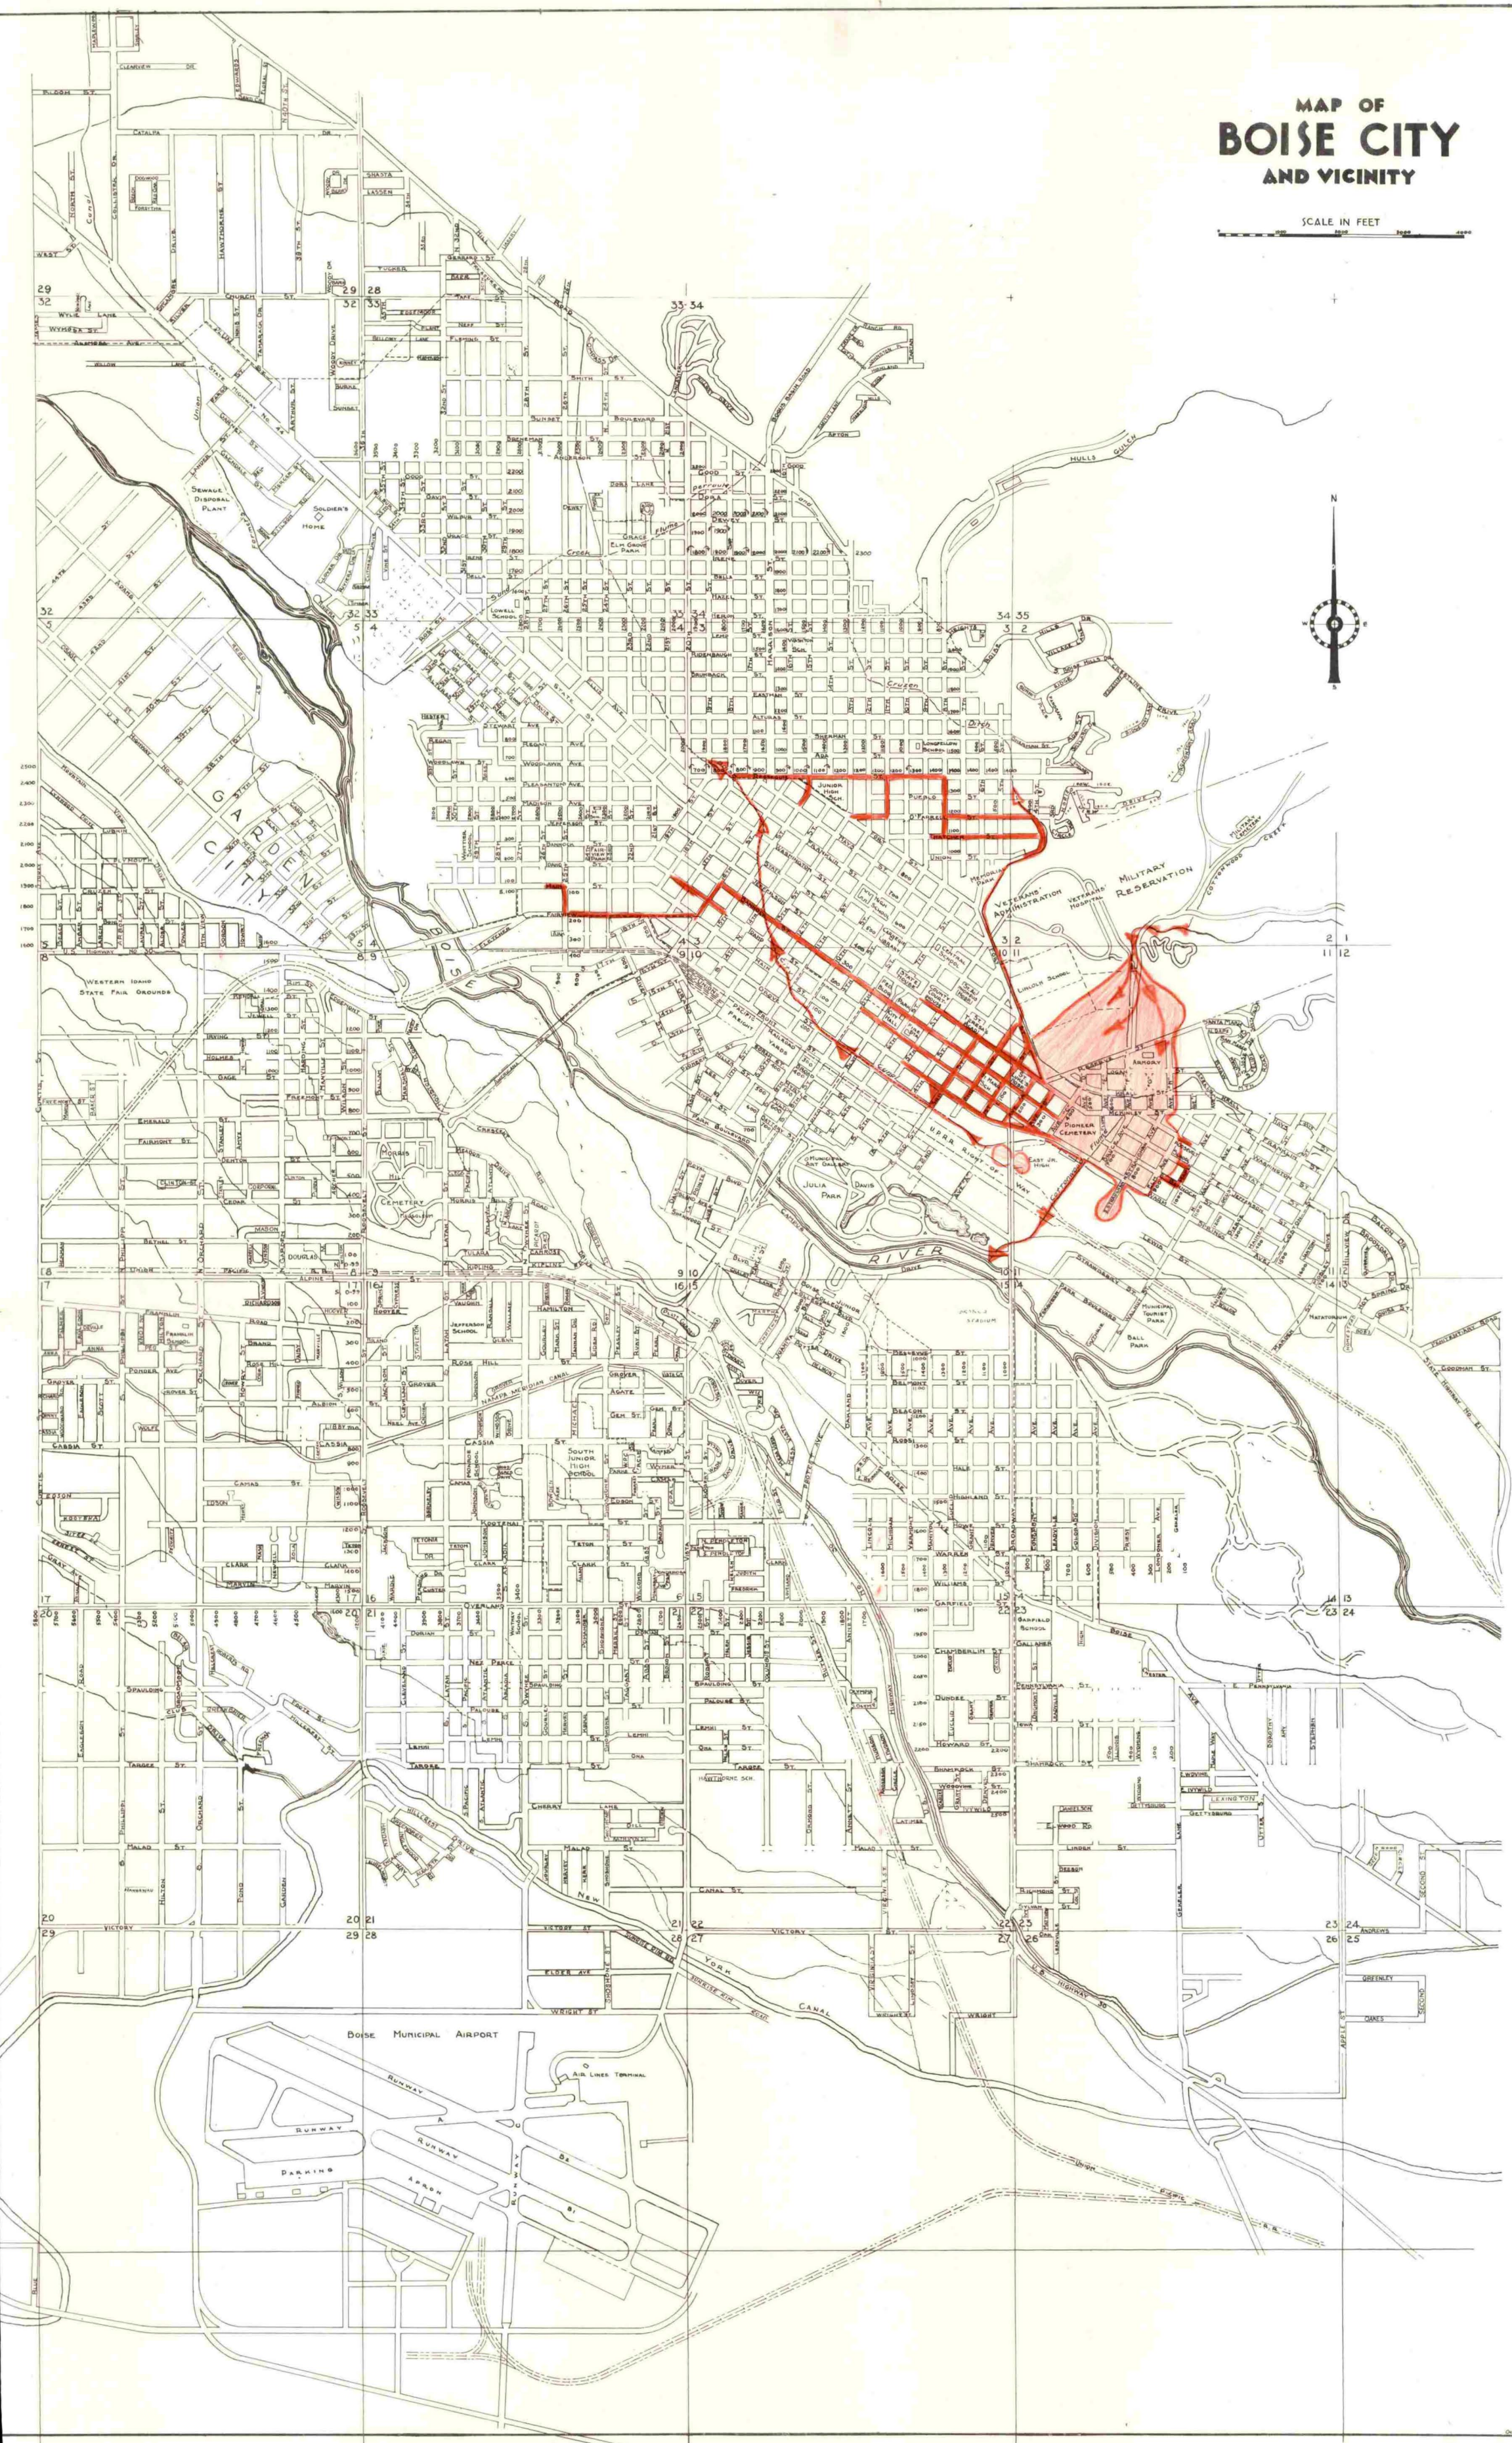
Figure 2

The principal damage sustained by the City of Boise and its residents was flooded basements, mud-covered lawns, and clogged sewers. The deluge that struck the city came from Cottonwood Creek and its tributaries. One week after the flood it was estimated that 200 tons of mud had been removed by the city and untold quantities are left to be washed gradually into the storm sewers. The total clean-up will take months. Newspaper clippings, included with some copies of this report, give a vivid written and pictorial account of the damage. The map in figure 2 shows the extent of flooding within the city.
