# NATIONAL BUREAU OF STANDARDS REPORT

## FAILURES IN WIRE BASKETS OF URETERAL STONE DISLODGERS

**NBS REPORT**

10 009

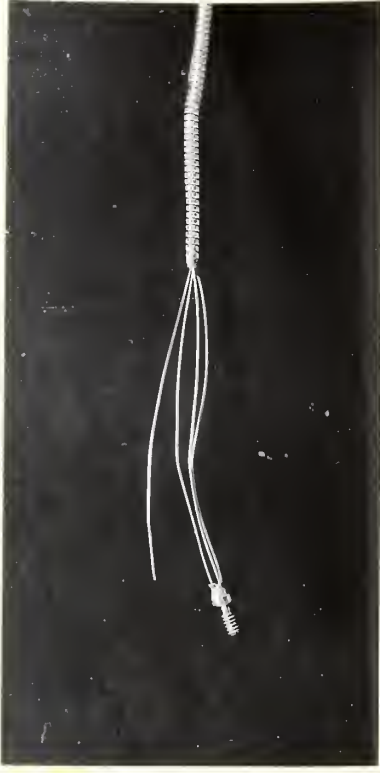
It is reported<sup>1</sup> that the majority of repair items are returned because of basket failure. Typical stone dislodgers which have failed appear in Figures 1b and 1c. One can see that failure in these cases is a matter of the wire basket having come apart near the connectors. Other failures related to the plastic filiform tip have also been reported<sup>2</sup>, but these will not be discussed in this report. The purpose of this report is to identify possible metallurgical causes of the type of failure appearing in Figures 1b and 1c, and to recommend procedures for minimizing the frequency of such failures.

The used stone dislodger appearing in Figure 8 shows a filiform tip connector with somewhat different geometry than those connectors appearing in Figures 6 and 7. Furthermore, the central hole in the filiform tip of Figure 8a does not penetrate the full length of the tip, as is the case in Figures 6a and 7a. These small differences in design are also illustrated by comparing Figures 1c and 1b. The sectioned filiform tip in Figure 8a is the same as that appearing in Figure 1c, whereas the tip shown in Figure 7a is the same as that in Figure 1b.

(b) IX  
Used stone dislodger which has failed. Unit produced by Greenwald Surgical Co. for C. R. Bard, Inc.

1. Since the analysis presented in this report shows that cumulative damage to basket wires during re-use eventually leads to fracture, the most obvious recommendation to make is to minimize the re-use of individual stone dislodgers. Ideally, a stone dislodger should have its basket wires replaced after a reasonable number of cycles of use. A definition of what represents "a reasonable number of cycles of use" will have to be provided by individuals having a day-to-day familiarity with the use of stone dislodgers.

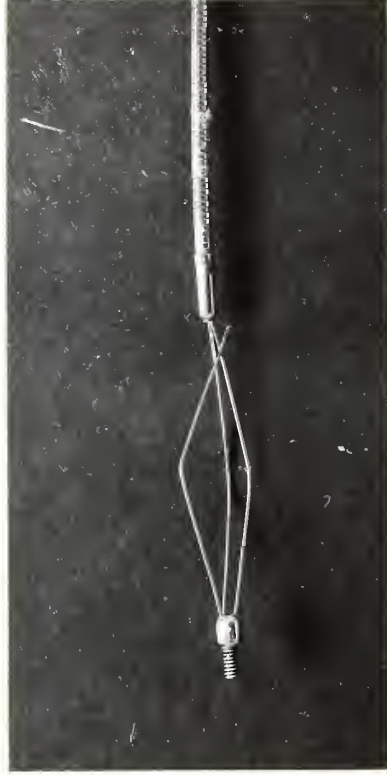
Longitudinal views of a used basket wire with its nickel plate flaking off appear in Figure 10. These views are close-ups of the sharply bent wire appearing in Figure 1c. Figure 10a reveals a circumferential crack in the nickel layer. (The threads appearing on either side of the crack in Figure 10a are simply dust particles and have no relationship to the crack.) Views of surfaces at the top of the bend in Figure 10a appear in Figures 10b and 10c. Figure 10b is taken at a slightly different section level than that of Figure 10c. Separation of the nickel layer from the basket wire due to poor bonding is obvious in Figure 10b. The soundness of the stainless steel basket wire beneath the flaking nickel plate is attested to in both Figures 10b and 10c.

(c) IX  
Used stone dislodger which has failed. Unit produced by American Cystoscope Makers, Inc.

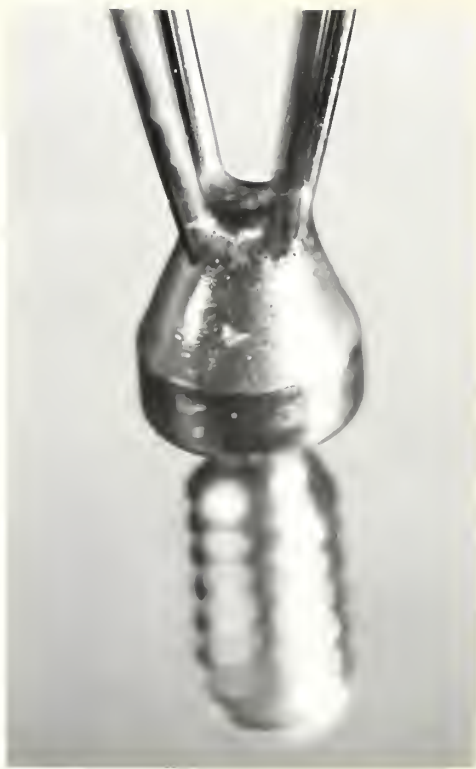
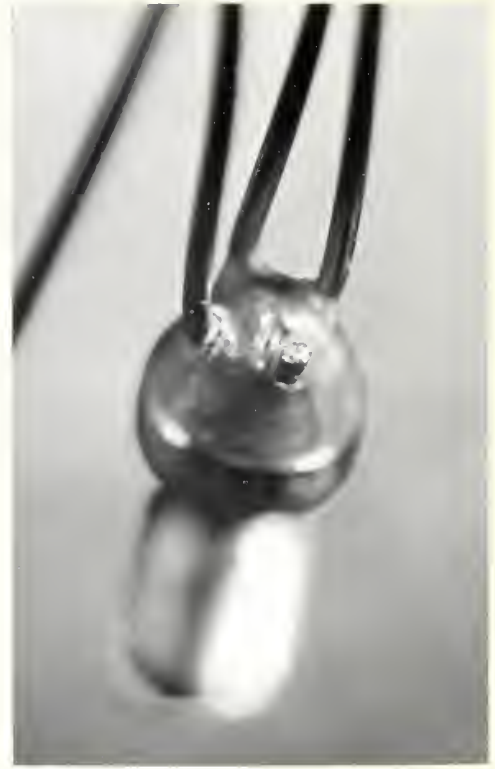
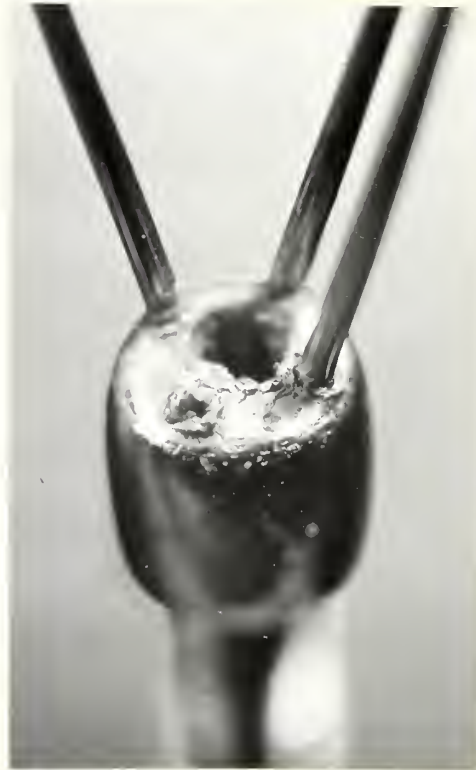
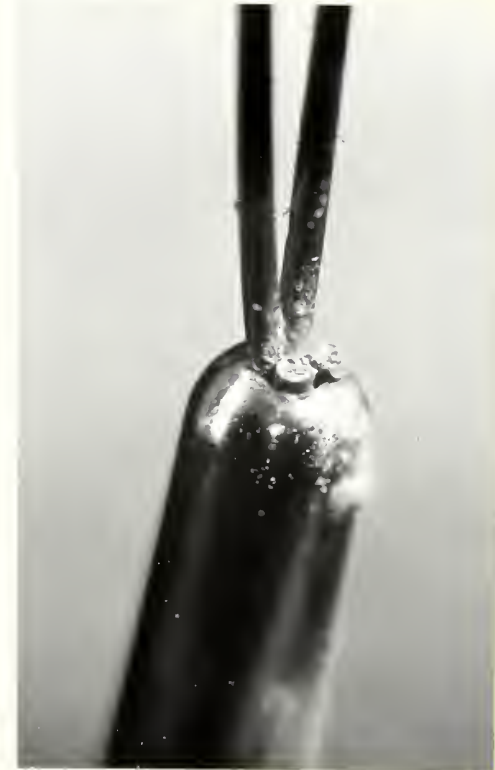
Figure 2. Exterior Views of Soldered Joints.

Examination at magnifications of 10-250 times provides information which serves to identify the possible causes of the typical basket failures appearing in Figures 1b and 1c. For example, Figure 2 shows exterior views at 12X of the soldered joints between basket wires and connectors. Figure 2a shows an intact joint. Figures 2b and 2c show that wires at the filiform connector have fractured. Similarly, Figure 2d shows that wires at the flexible cable connector have fractured. These observations suggest that the cause of wire-basket failure is fracture of the basket wires themselves, and not rupture of the soldered joints.

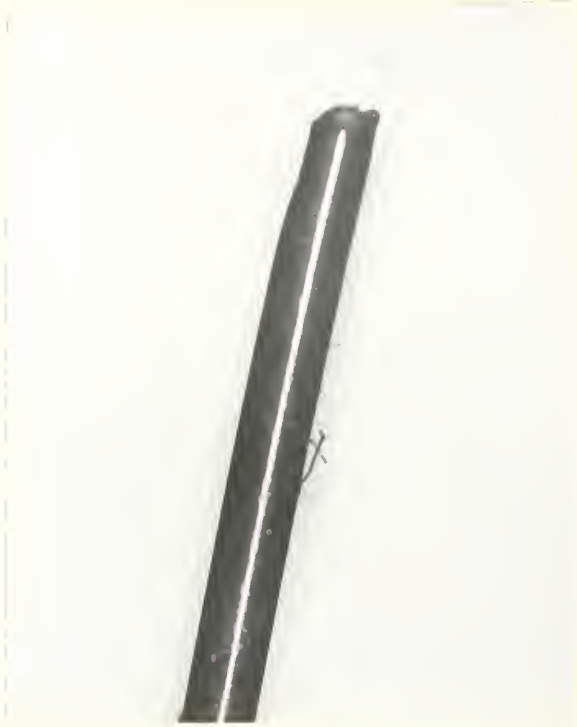
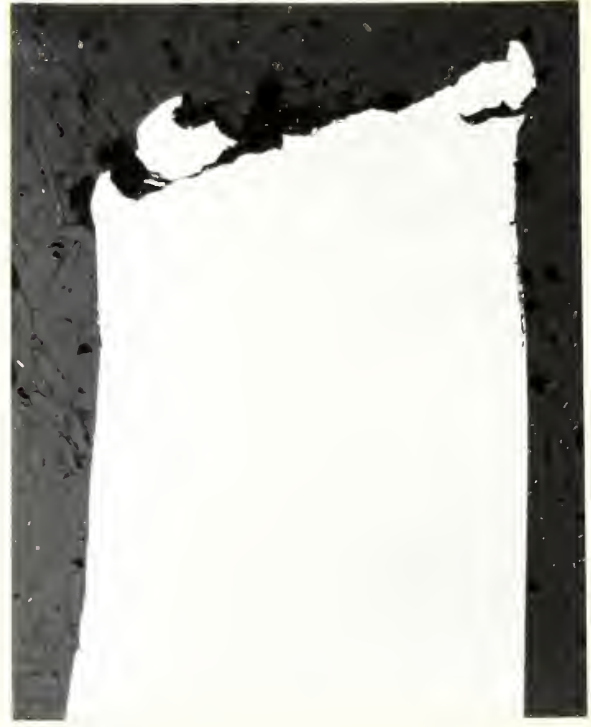
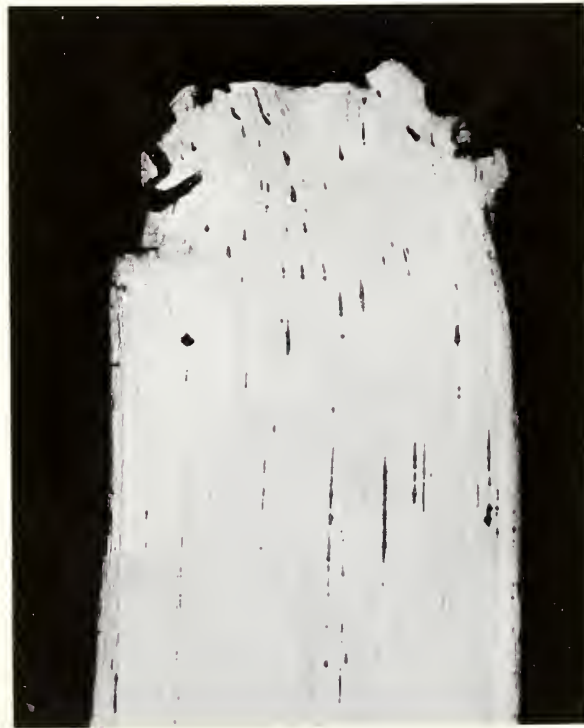
Figure 3. Tip of Fractured Basket Wire Appearing in Figure 1b.

Views of two fractured basket wires appear in Figures 3 and 4. A view at a magnification of 27X appears in Figures 3a and 4a. Close-up views (at 200X magnification) of the fractured tips of these wires are shown in Figures 3b and 4b. These wires have fractured primarily by shear after a small amount of plastic flow. Evidence of a shear failure is the fact that the fracture surface is inclined to the longitudinal axis of the basket wire. Evidence of plastic flow are the shape distortion of the wires themselves and the rounded features of the fracture surface itself. The cracks penetrating the surface of the basket wire shown in Figures 4b originate in the nickel-plated surface layer. The wire shown in Figure 3b does not exhibit such cracks because the wire was not nickel plated.

When sample surfaces such as those appearing in Figures 3b and 4b are etched with 20% HCl-5% HNO<sub>3</sub>, features of the metallurgical structure are revealed. For example, after etching, two failed basket wires appear as in Figures 3c and 4c. The layer of nickel plate and its associated microcracks show up clearly in Figure 4c. It can also be seen in Figure 4c that the microcracks are not restricted to the nickel layer; the microcracks actually propagate into the basket wire itself.

Both Figures 3c and 4c show a typical structure for "spring temper" material, i.e., a fibrous appearance with the fiber direction parallel to the longitudinal axis of the wire. For comparison with Figures 3c and 4c, the fibrous appearance of a basket wire from an unused stone dislodger appears in Figure 5. Shape distortion is also apparent in Figures 3c and 4c. These further observations support the viewpoint that the cause of wire-basket failure is fracture of the basket wires themselves, and not rupture of the soldered joints.

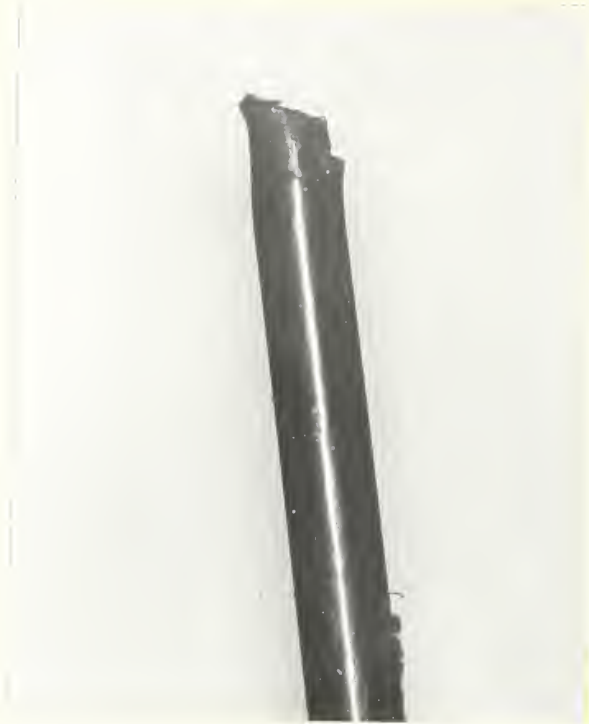
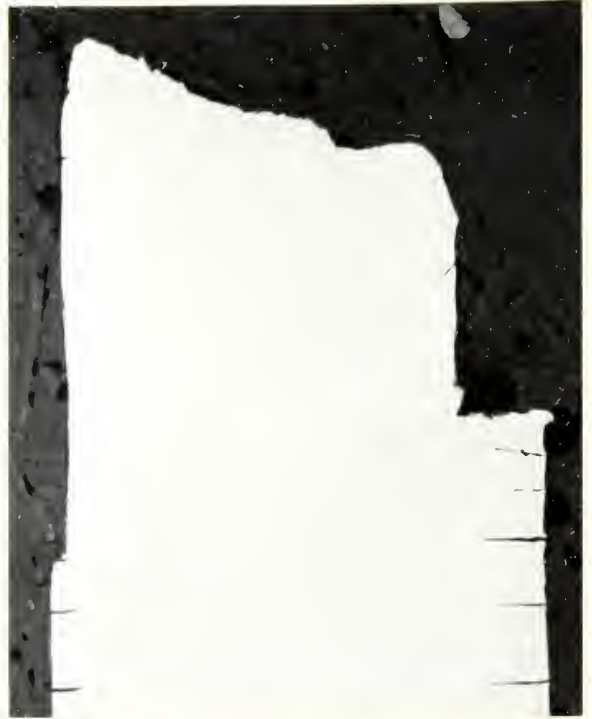
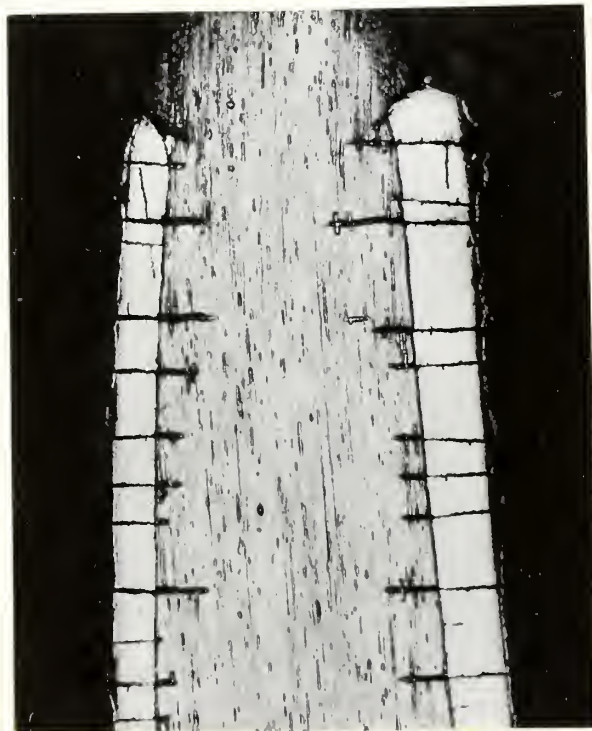
Figure 4. Tip of Fractured Basket Wire Appearing in Figure 1c.

The layer of nickel plate applied to one manufacturer's stone dislodger contributes to weakening, and probably to fracture, of basket wires. This is illustrated in Figures 4b and 4c, where it is seen that the nickel plated wire exhibits surface cracks which penetrate the basket wire itself. These cracks act to decrease the effective cross-sectional area of the basket wire, thereby decreasing its load-carrying capacity. The reason that cracks originate in the nickel layer is not known with certainty. One plausible cause is the difference in average coefficients of thermal expansion of stainless steel and nickel,  $9.3 \times 10^{-6}$  in./in.-°F and  $7.4 \times 10^{-6}$  in./in.-°F, respectively. At typical autoclaving temperatures, an 0.016-inch diameter stainless steel wire expands radially about  $372 \times 10^{-7}$  inches, whereas a 0.0004-inch hoop of nickel expands radially about  $7.4 \times 10^{-7}$  inches. Another possible cause of cracks originating in the nickel layer is that the metallurgical structure of the plated layer is inherently brittle. This is sometimes the case for electroplated metals. Since fractures have been reported for both unplated and plated basket wires, cracks originating in the nickel layer cannot be the sole cause of basket wire failure. However, they represent a potential cause of fracture which should be eliminated.

4. The nickel-plated layer on stone dislodgers produced by one manufacturer acts as a source of cracks which contribute to the fracture of basket wires. It may be desirable to eliminate the nickel plating operation altogether. Stainless steel has an intrinsic corrosion resistance which makes it unnecessary to apply a nickel layer for corrosion resistance. Elimination of the nickel layer would also avoid the problem of flaking associated with the nickel layer, as shown in Figure 10.

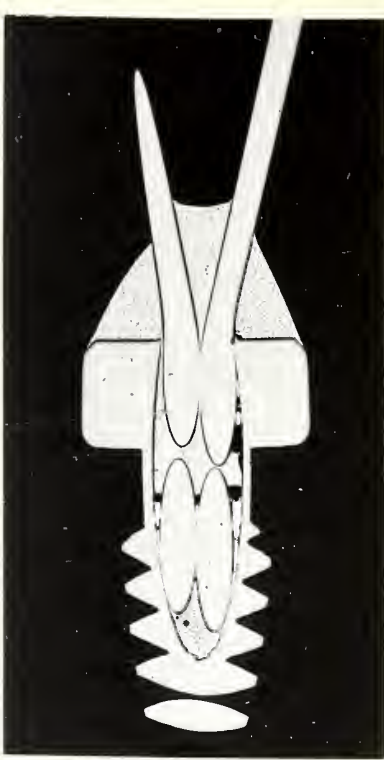
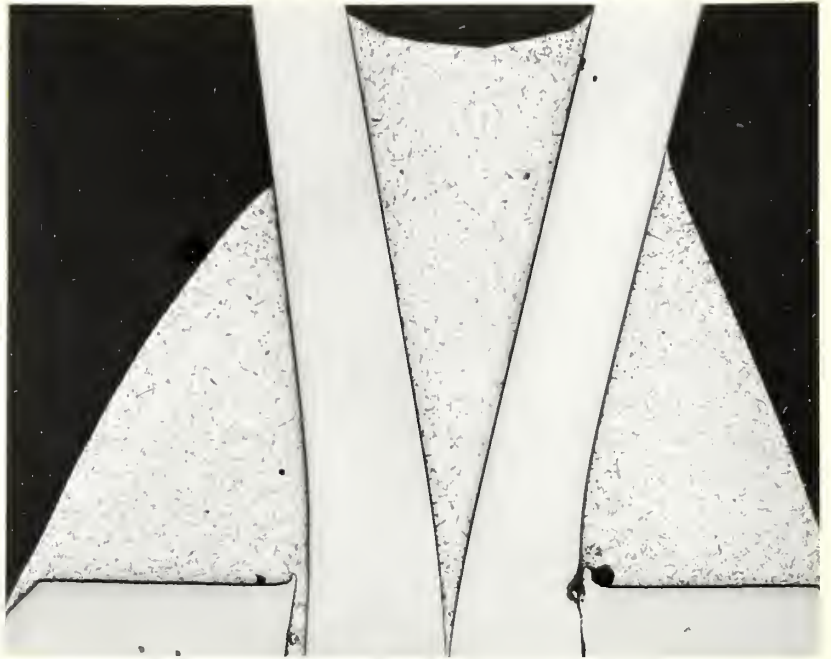
Figure 6. Cross-sectional view of soldered joint within filiform tip. Sample taken from unused stone dislodger appearing in Figure 1a.

The primary feature to be noted in Figures 6 to 8 is the degree of soundness of the soldered joint. It can be seen in Figure 6, obtained on an unused stone dislodger, that although solder has bridged within the body of the connector and created at least seven small pores, there is still a good deal of solder surrounding the basket wires. The bead of solder on the surface of the filiform tip connector, Figure 6, exhibits no pores and completely surrounds the basket wires.

(6a) 9.5X  
Filiform tip and basket  
wires.

(6b) 50X  
Solder bead appearing in Figure 6a at point where  
basket wires enter filiform tip.

- b) Bridging of solder within the connector, as in Figures 6a, 7a and 8a, should be minimized by applying sufficient flux and heat during the soldering operation.

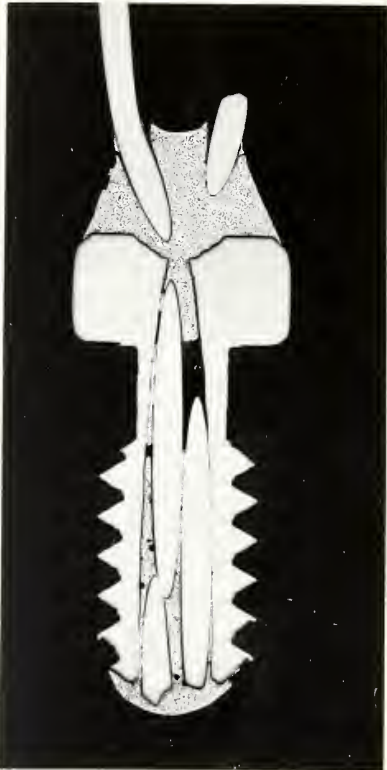
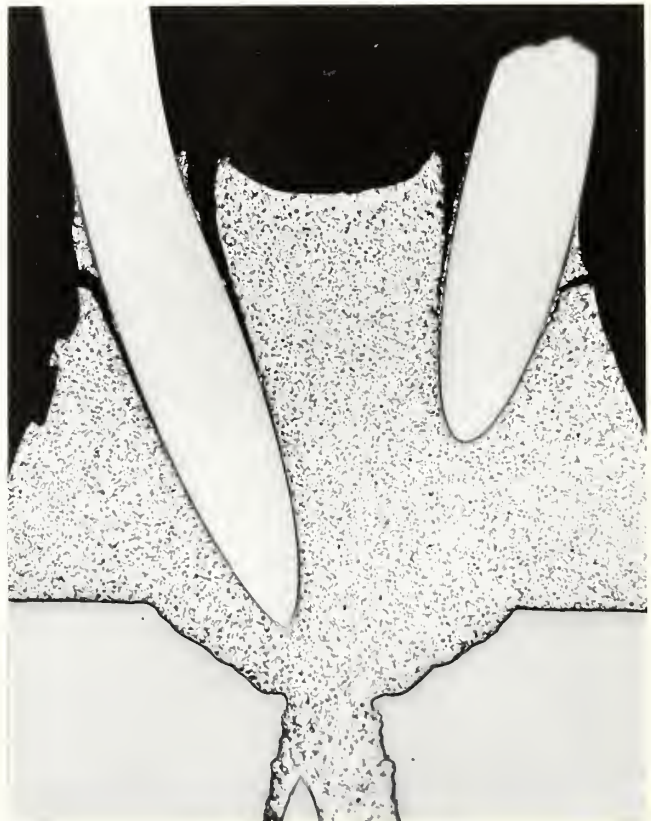
Figure 7. Cross-sectional view of soldered joint within filiform tip. Sample taken from used stone dislodger appearing in Figure 1b.

The used stone dislodger shown in Figure 7 shows the features pointed out in Figure 6. In addition, it shows some separation between the basket wire and the bead of solder on the surface of the filiform tip. The extent of this separation is likely to increase with increased frequency of use of the stone dislodger. The significant point to note in Figure 7, however, is that the basket wire fractured before the separation between wire and solder increased to the point where the wire could pull free of the soldered joint.

(7a) 9.5X  
Filiform tip and basket  
wires.

(7b) 50X  
Solder bead appearing in Figure 7a at point where  
wires enter filiform tip.

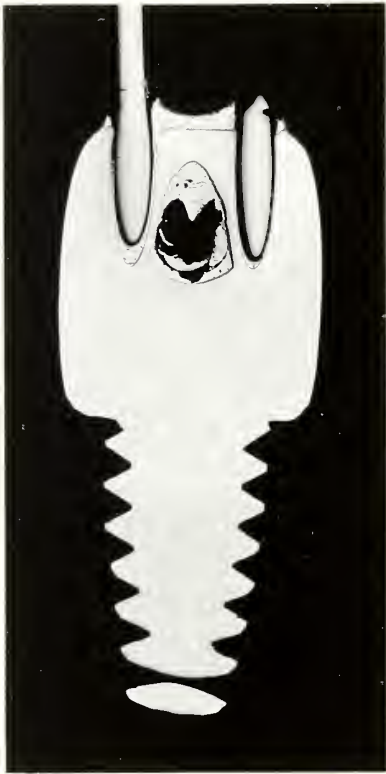
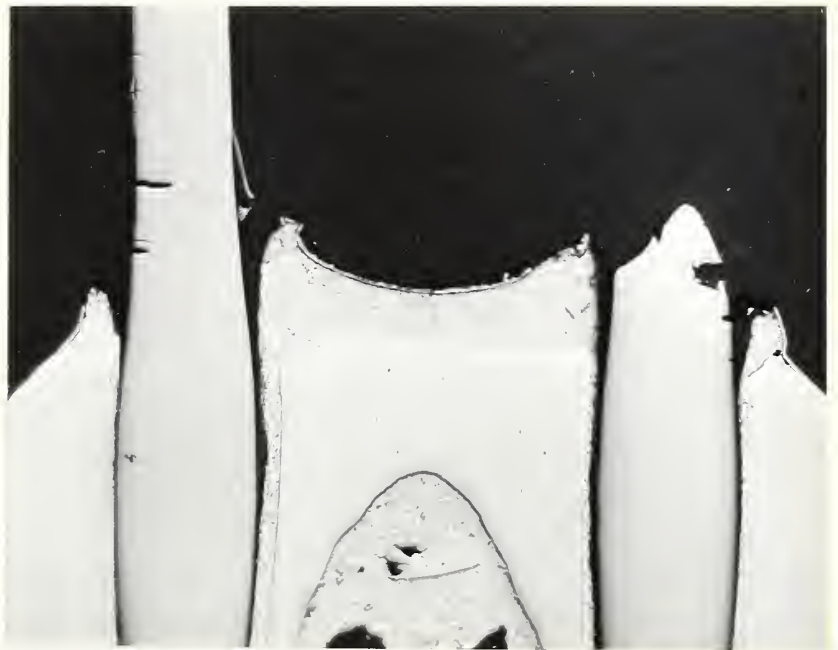
Figure 8. Cross-sectional view of soldered joint within filiform tip. Sample taken from used stone dislodger appearing in Figure 1c.

Since the sectioning plane is sharply inclined to the longitudinal axis of the filiform tip shown in Figure 8, the cylindrical central hole is somewhat obscured. Nevertheless, some bridging of the solder in the central hole can be seen. Moreover, some separation between solder and basket wires appears. Only a small bead of solder on the surface of the filiform tip surrounds the basket wires at this point. (Compare the solder bead size in Figure 8a with that appearing in Figures 6a and 7a.) As in Figure 7, the important point to recognize in Figure 8 is that the basket wires distorted and fractured before the soldered joint failed.

(8a) 9.5X  
Filiform tip and basket  
wires.

(8b) 50X  
Solder bead appearing in Figure 8a at point where  
basket wires enter filiform tip.

6. Although soldered joints do not seem to be a primary cause of failure, features of the soldered joints noted earlier are worth some discussion:
  - a) Maximum mechanical strength of the basket-wire-to-connector joint is achieved if the basket wires pass entirely through the connector, as in Figures 6a and 7a. Purely from the standpoint of maximum achievable mechanical strength, the joints in Figures 6a and 7a have an intrinsically better design than the joint in Figure 8a.

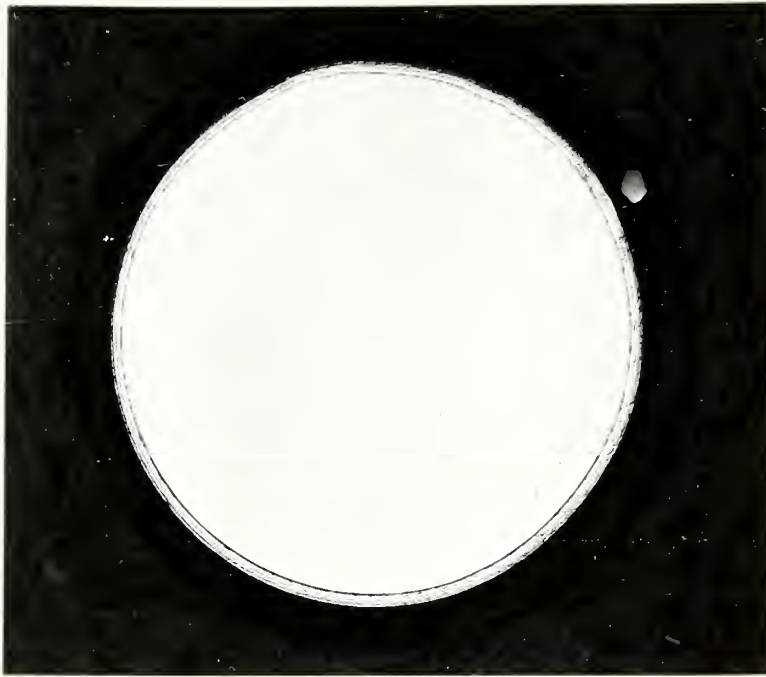
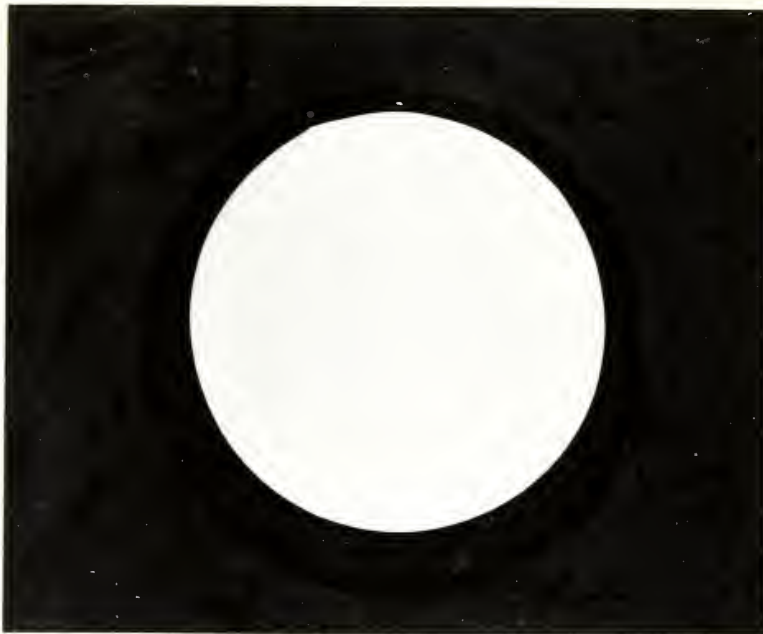
Figure 9. Transverse Sections of Basket Wires.

Some interesting aspects of the nickel-plated basket wires appear in Figures 9 and 10. A transverse section of an unetched nickel-plated wire shown in Figure 9a reveals a sound, reasonably uniform film of nickel completely surrounding the wire. The average thickness of the nickel film is 0.0004 inches. For comparison, an unplated wire appears in Figure 9b.

(9a) 160X  
Nickel-plated basket wire. Sample taken from stone dislodger shown in Figure 1c. The nickel layer shows up as the annular ring surrounding the basket wire. Wire diameter-0.016 inches. Thickness of nickel layer-0.0004 inches.

(9b) 160X  
Unplated basket wire. Sample taken from stone dislodger shown in Figure 1b. Wire diameter-0.014 inches.

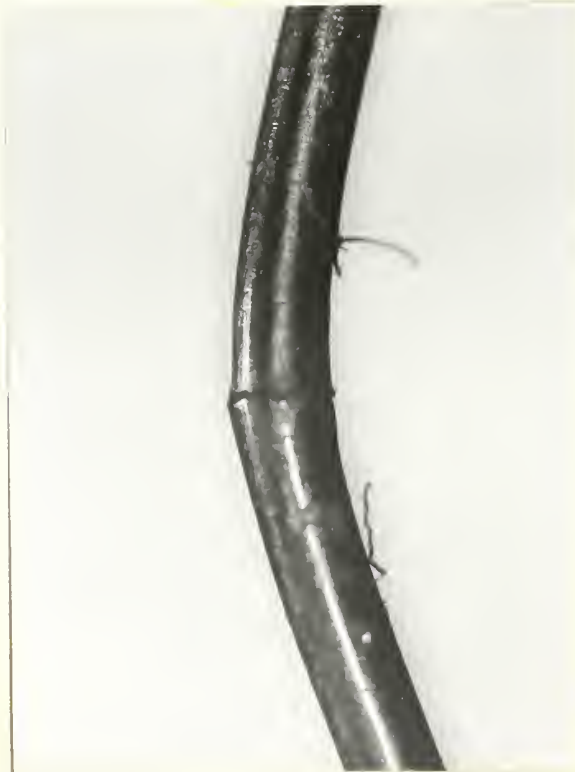
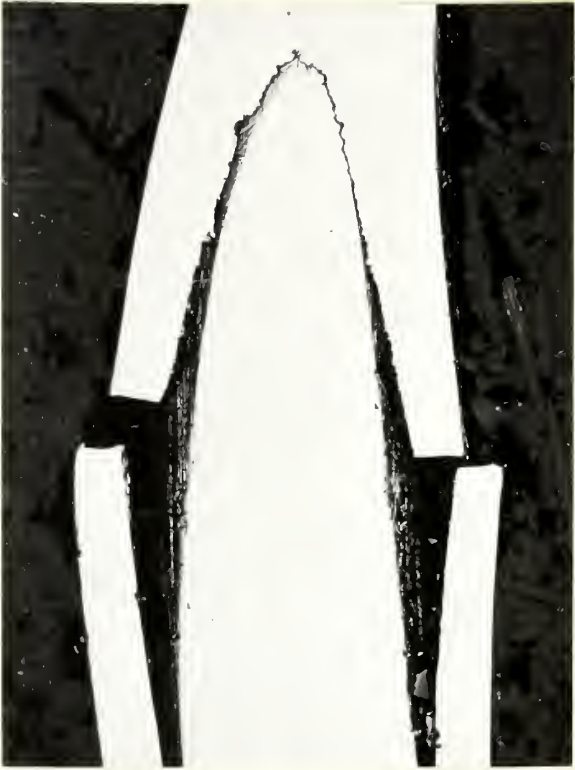
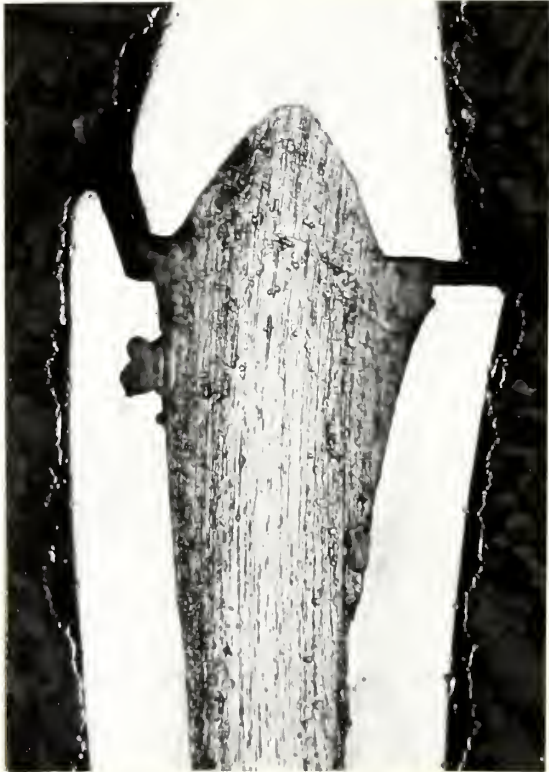
Figure 10. Views of Bent Basket Wire Appearing in Figure 1c.

(10b) 250X  
View of top of bend in wire appearing in Figure 10a. Separation of nickel layer from basket wire is evident.

(10c) 250X  
View of top of bend in wire appearing in Figure 10a, at a different level than that shown in Figure 10b. Etched in 20% HCl, 5% HNO<sub>3</sub>.

5. Examination for flaking nickel layers on basket wires, and elsewhere, is desirable for stone dislodgers presently in use. This could be accomplished simply by looking at stone dislodgers after each use under a low-power binocular microscope. A magnification of 27X, as in Figure 10a, would be appropriate.
