Analysis of the Pneumatic Burst of a Large Seamless Steel Pressure Vessel in Natural Gas Service

NBSIR 78-1589

Failure Analysis Report

Prepared for
Office of Hazardous Materials Regulations
Materials Transportation Bureau
Department of Transportation
Washington, D.C. 20590
Contract No. DOT AS-40034

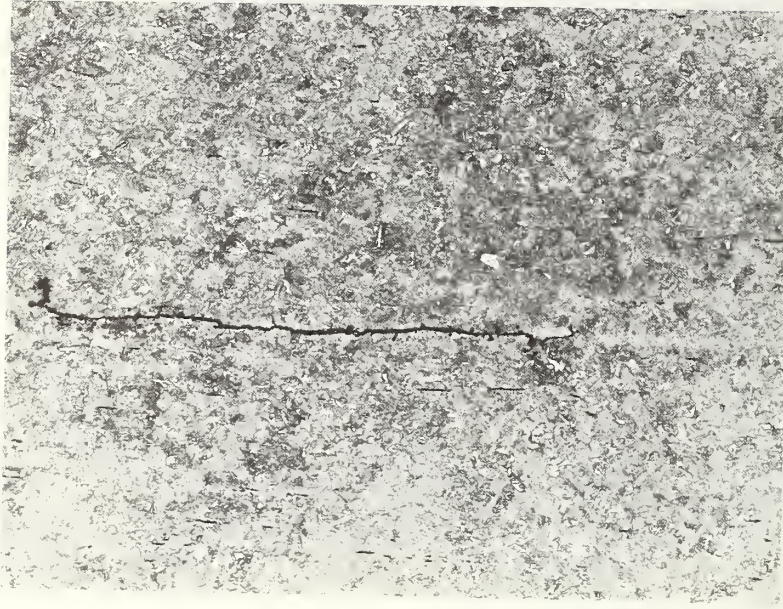
Incipient type L cracks which appear to have originated at radial jogs in a type C crack. This cracking was found in specimen TR-5. (a) As polished section showing cracks, (b) Same section as in 16a after etching with ammonium molybdate.

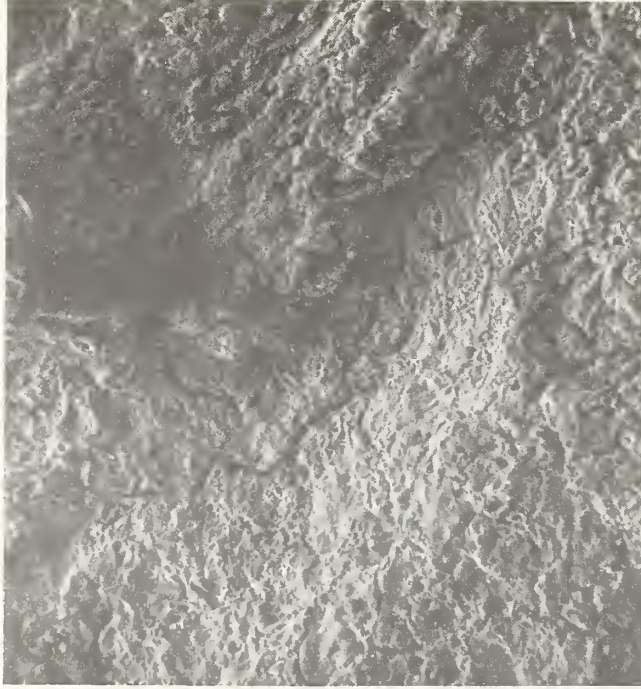
Figure 20. The inside wall of specimen TR-5 near the fracture origin after partial solution cleaning. (a) Low magnification view of uneven regions. (Remaining surface product runs from 2 o'clock to 8 o'clock) (b) Uneven region at higher magnification. (Photo obtained in scanning electron microscope.)

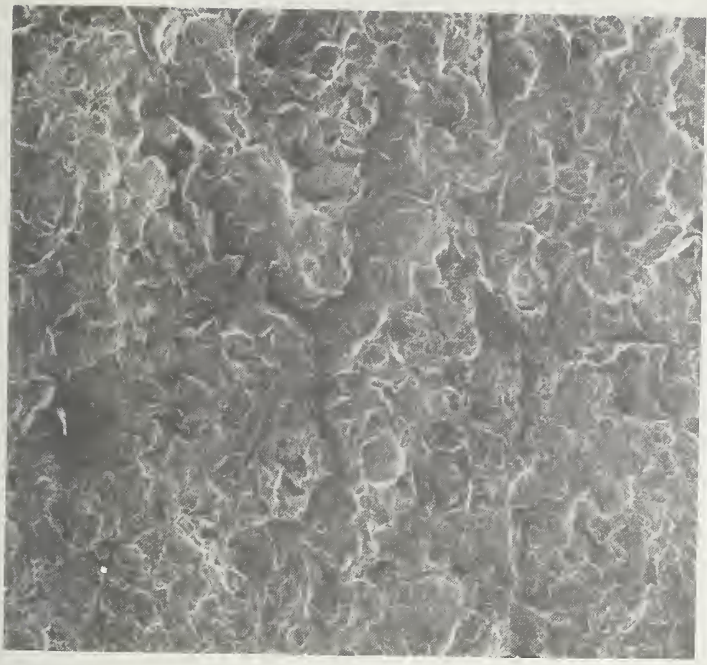
Figure 22. Scanning electron microscope views of fracture origin after cleaning with buffered HCl solution. (a) Region of step, showing a type C crack, (b) Region away from step, showing "plateaus and valleys" structure.
