Engineering Aspects of Cyclone Tracy Darwin, Australia, 1974

NBS Report on Structural Damage
111

Richard D. Marshall

Issued June 1976

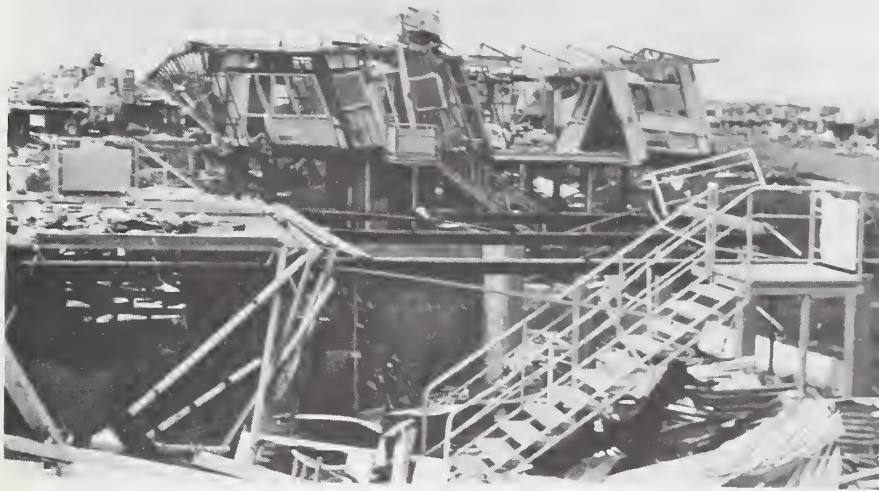
Fig. 5. Severe racking and loss of timber deck

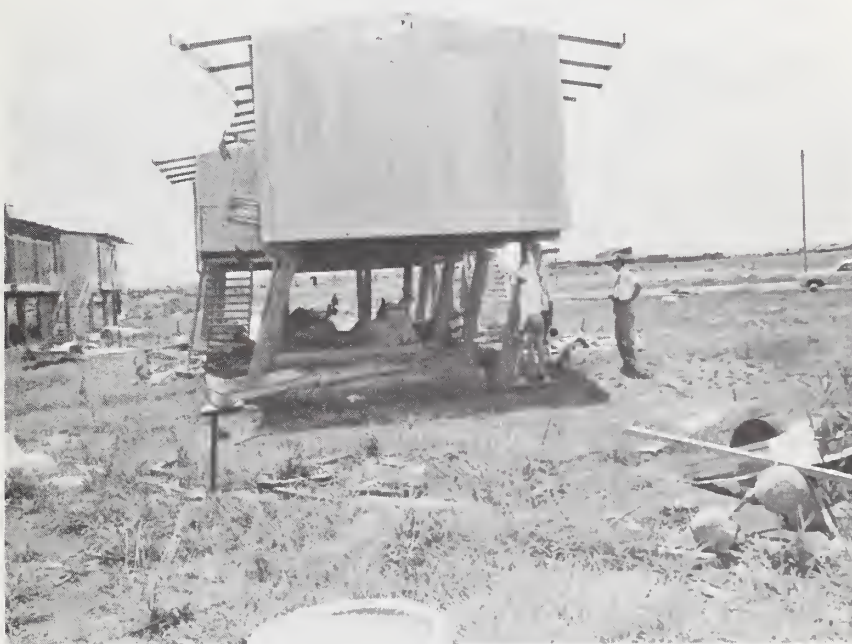
Fig. 6. Failure of concrete block shear walls and racking of concrete piers

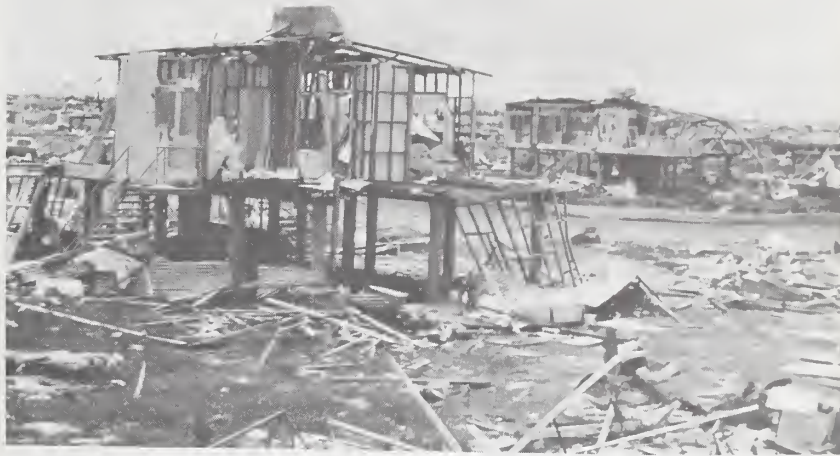
Fig. 9. Failure of endwall

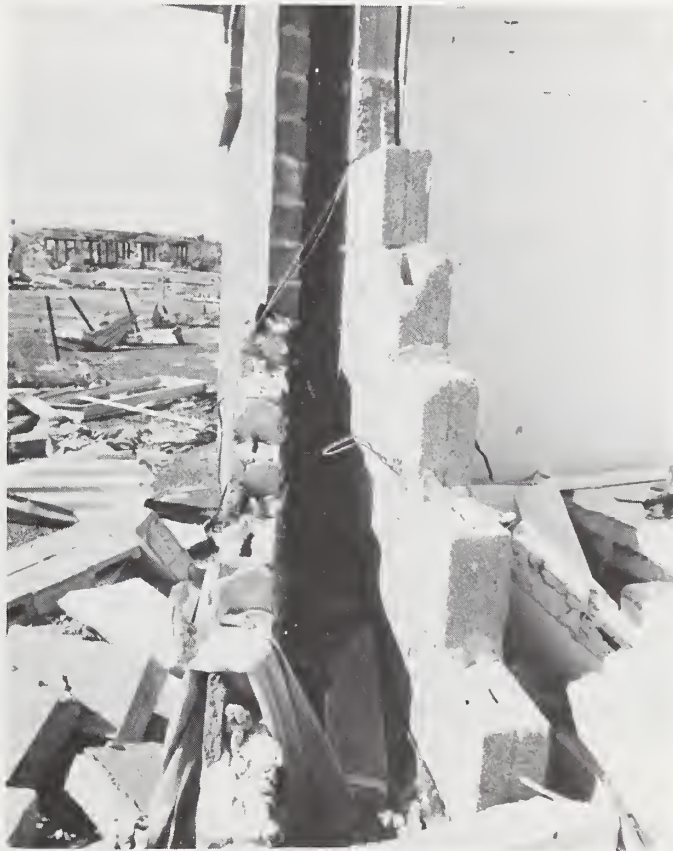
Many failures of masonry cavity walls were observed. Lack of bond beams and lateral loading due to purlin buckling were often the cause of these failures. However, a number of cases were observed where the crossties were either inadequate or improperly installed and the inner and outer wythes did not act together in resisting lateral loading. Since Australian practice with respect to masonry cavity wall construction is quite similar to that here in the U.S., this high incidence of failure is cause for concern. Most load tests on masonry walls have been carried out with vertical compression loads applied to simulate deadload. This load condition overestimates resistance to racking and lateral loads when uplift forces are sufficient to offset the deadload. In many cases observed in Darwin, it is likely that the uplift forces transmitted through the purlins were sufficiently high to place the entire wall in tension.

Fig. 10. Failure of brick and concrete block cavity wall

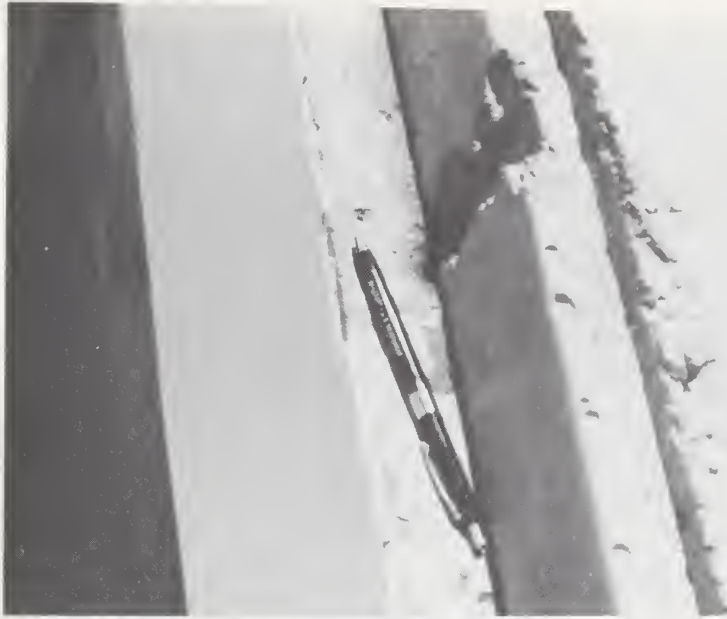
Fig. 13. Ceiling panel anchorage - bolt and adjacent panel missing

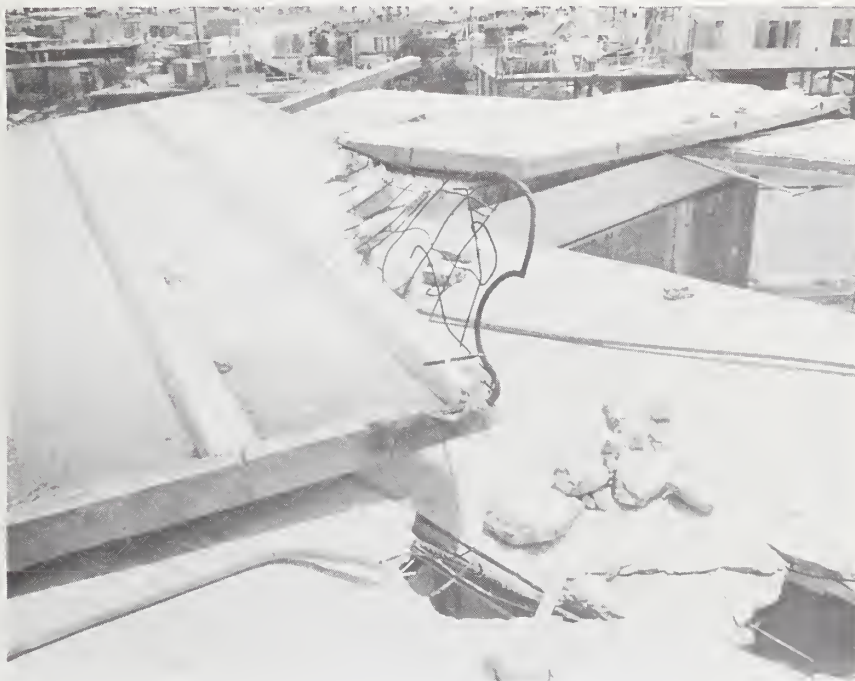
Some of the ceiling panels shifted enough to drop off of their supporting beams, causing damage to wall and floor panels. In some cases the ceiling panels were flipped over and fractured adjacent panels (see Figure 14). This occurred after loss of the CGI roof cladding and roof trusses. One house had obviously received a heavy missile impact, causing failure of a second story corner column. The beam-column connection detail revealed by this failure is shown in Figure 15.

Fig. 14. Overturned ceiling panels - CGI cladding and roof framing completely removed.

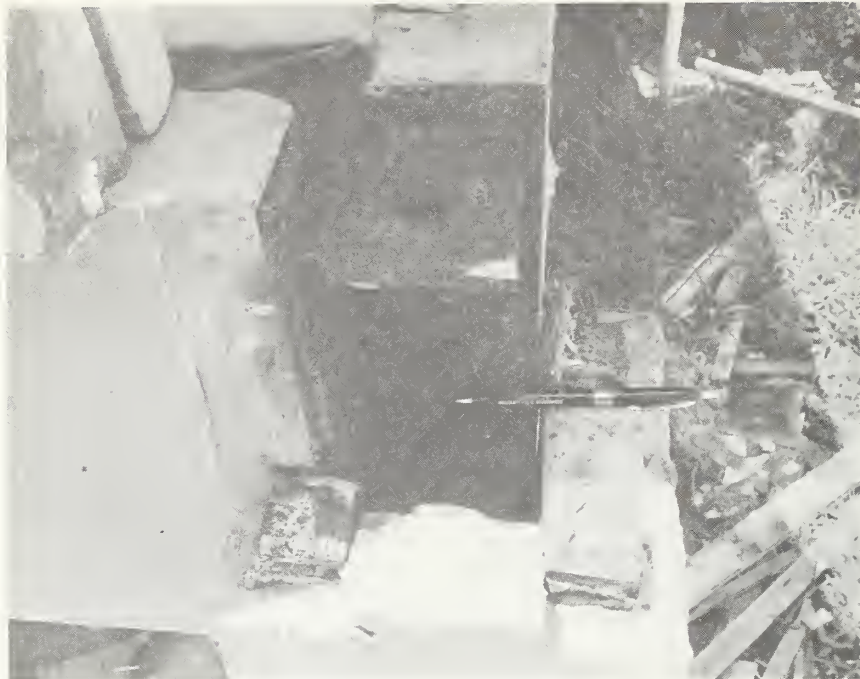
Fig. 15. Beam to column connection - precast concrete high-set

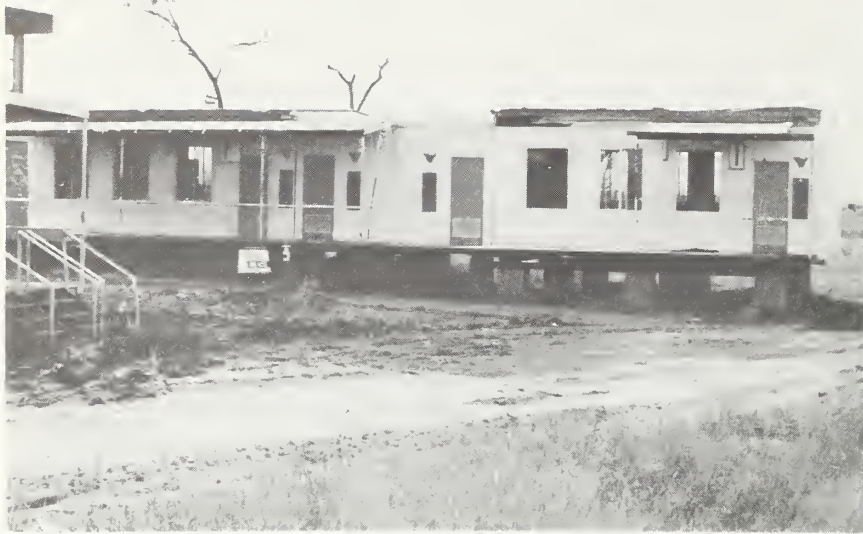
Of particular interest at this school were the temporary classrooms shown in Figure 19. Construction is cold-formed steel frame and steel cladding. They suffered a number of missile impacts and some loss of windows, but remained intact. The anchorage system depended solely on the dead weight of the concrete piers and footings and performed very well. One case of partial anchorage failure due to overturning of the piers was observed. Again, these units would have provided adequate refuge.

Fig. 19. Temporary classrooms - Millner Primary School

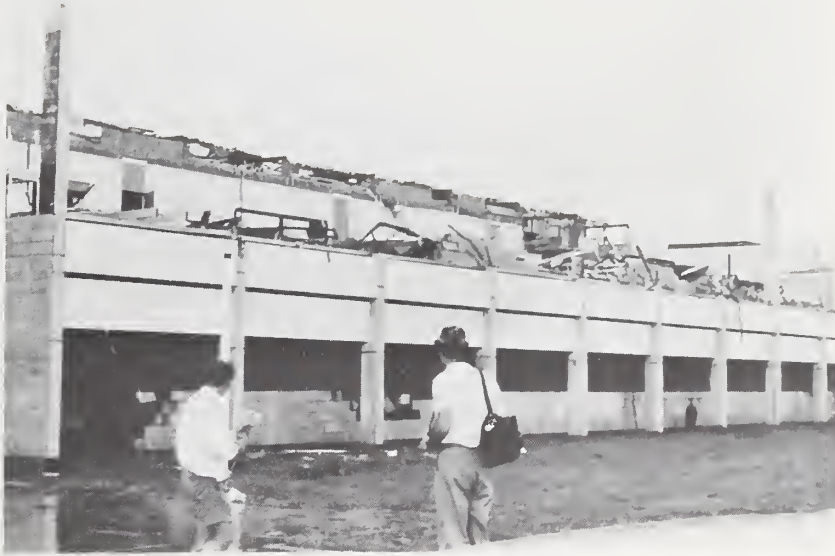
Darwin Community College is located just west of Nakara and was one of the more interesting complexes inspected because of some rather unusual structural failures. The main classroom building is a two-story reinforced concrete structure with masonry spandrel walls. The roof system consists of pan-type steel sheet carried by bar joists which are bolted to the column tops. A view of one-half of the north or windward wall is shown in Figure 20 and it is obvious that cracking has occurred in all of the columns just above the level of the second floor. The other half of the windward face of the building is shown in Figure 21. The roof structure has been folded over the exposed interior wall, and the second-story spandrel wall and several columns have failed. It was originally believed that the column failures were due to a poor splice detail, i.e., insufficient bar lap and column ties. However, a closer inspection revealed a quite different mode of failure. Following loss of the windows and/or spandrel walls the bottom chords of the bar joists failed in compression due to the high uplift pressures on the roof cladding and absence of any lateral bracing of the bottom chords. This, in turn, displaced the column tops and caused them to fail in combined bending and tension. This sequence of events was quite clear, both in the failed section and in the portion which was still standing.

Fig. 21. Failure of second story (view immediately to right of Fig. 20)

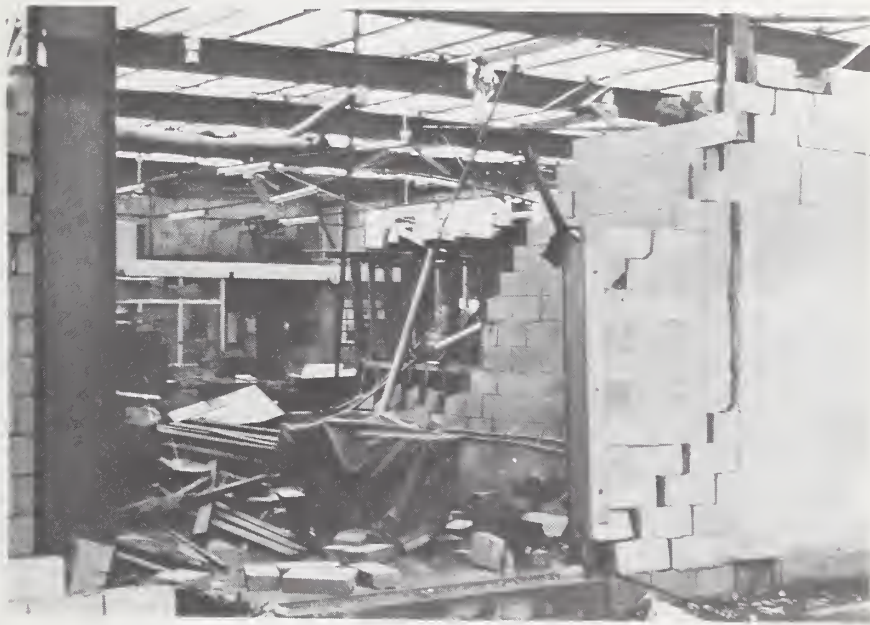
A number of failures of masonry walls were observed in the buildings housing the metal and woodworking shops of Darwin Community College. These buildings have structural steel frames and concrete block walls as seen in Figure 22. The walls were unreinforced and are believed to have failed by direct wind loading since there was no source of debris upwind of these structures. There was no apparent damage to the steel frames.

Fig. 22. Woodworking shop - Darwin Community College

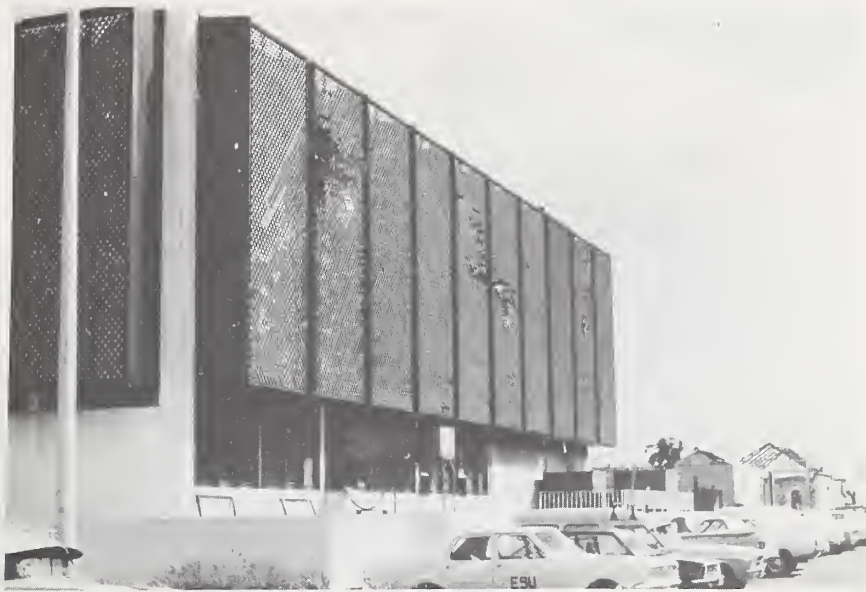
Fig. 25. Sunscreen showing points of missile impact

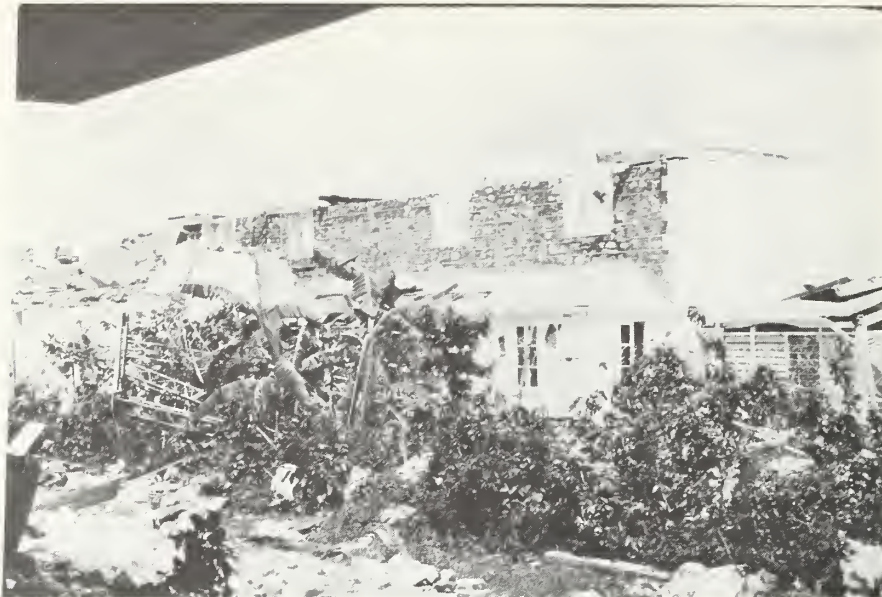
Several buildings constructed prior to 1900 have been preserved as historic buildings and are of interest because of their previous exposure to intense cyclones. These buildings are all quite similar in physical size and type of construction, having timber roof trusses and load-bearing walls of native stone approximately 400 mm thick. Most of these buildings suffered extensive damage in the cyclones of 1897 and 1937. Typical damage is shown in Figure 27.

Fig. 27. Historic building in Darwin City - hip roof completely removed

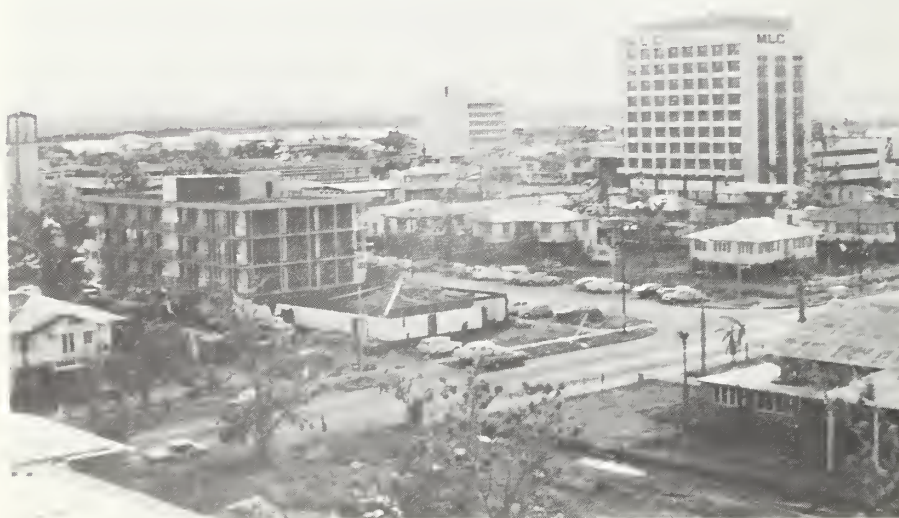
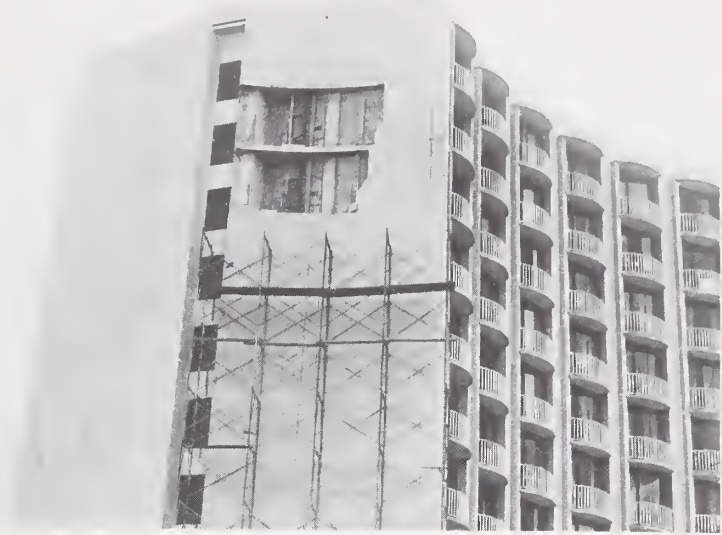
Several new hotels and office buildings have been constructed in Darwin since 1970. These include the 10-story MLC Building and the 11-story Travelodge (Figures 28 & 29) in the Darwin City area. Both are of reinforced concrete flat plate construction with concrete shear walls. Most wind damage was superficial, being limited mainly to loss of pan-type roof cladding and broken windows. There proved to be no substance to the rumor that a large missile caused the partial failure of the brick and concrete block endwalls of the Travelodge (see Figure 29). An identical failure occurred at the same level on the opposite end, undoubtedly due to extremely low surface pressures downstream of the separation points. The change in wind direction in this area would have been sufficient to create identical pressure distributions at each end of the building. The design speeds are not known, but inspection teams reported no evidence of cracking or plastic action in either structural system. Occupants did report noticeable oscillations during the storm passage. Water damage was extensive in these and other tall buildings following loss of roof cladding and glass breakage.

Fig. 28. MLC Building - Darwin City

Fig. 29. Travelodge - Darwin City (similar damage at opposite end)

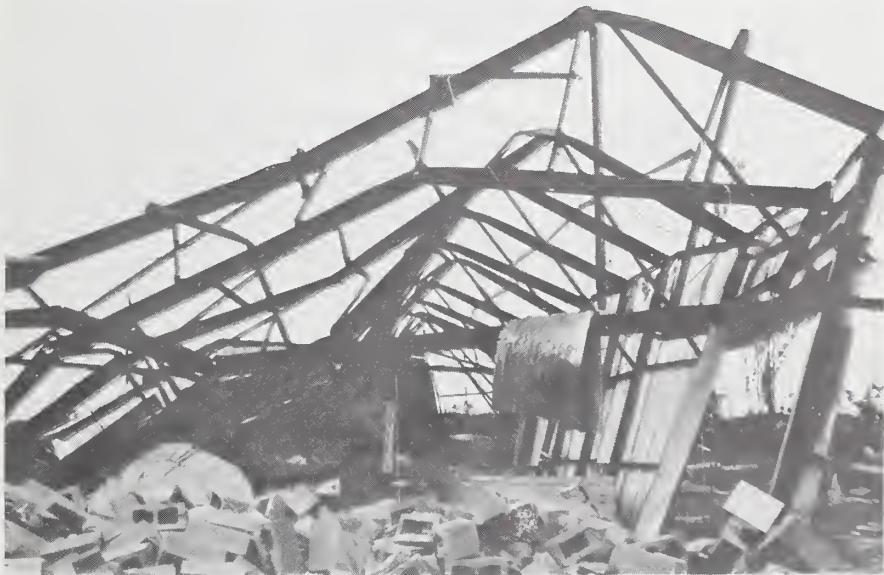
The overall performance of industrial buildings was good, but damage to these light-frame structures in some areas of Winnellie was heavy. It was quite apparent that these buildings had little variation in ultimate load capacity; if one building of a particular type failed, most others of that same type also failed. It is quite likely that failure of rollup doors, windows, and flashing led to gross cladding failure because of sudden increases in internal pressure. Many cases of purlins being buckled upward were observed and this often led to failure of the masonry endwalls to which they were anchored. In other cases the roof cladding was removed by direct pullout of the fasteners, but was more often due to fatigue failure in the material adjacent to the fasteners. This often resulted in total collapse, particularly where the cladding provided the only source of racking strength in the roof planes. A typical failure is shown in Figure 30. Several buildings suffered complete loss of roof and wall cladding without the frame collapsing. In these cases, however, a conventional system of diagonal bracing had been installed in the roof and wall planes.

Fig. 30. Industrial building - Winnellie

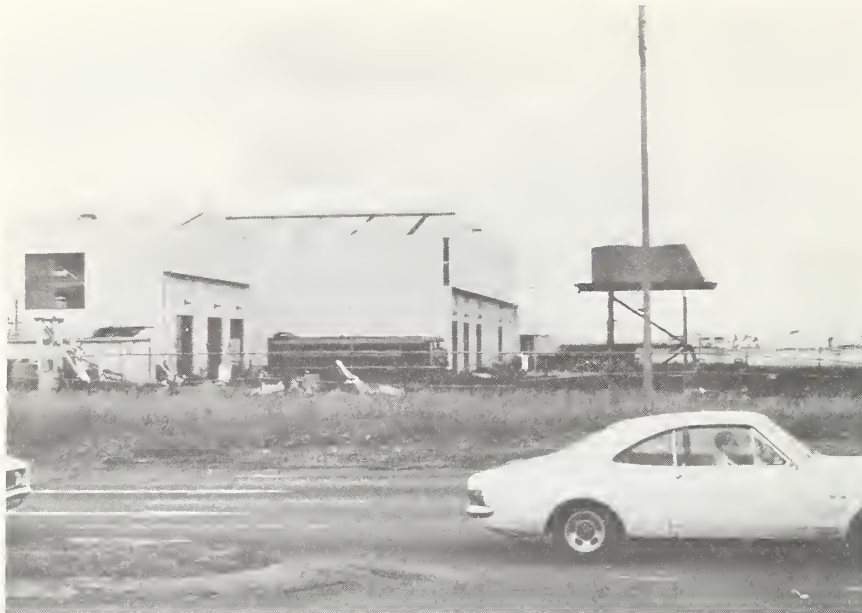
The buildings shown in Figure 31 are located in Stuart Park and, excepting some loss of wall cladding, they performed very well. These buildings have 22 ga. CGI cladding with 16 mm washers under the fastener heads. This detail, in conjunction with the ridge ventilators undoubtedly had much to do with the overall good performance. Ridge ventilators effectively lower the internal pressure and reduce the uplift load on the roof. This observation has been made in previous surveys of wind damage.

Fig. 31. Railway shops - Stuart Park

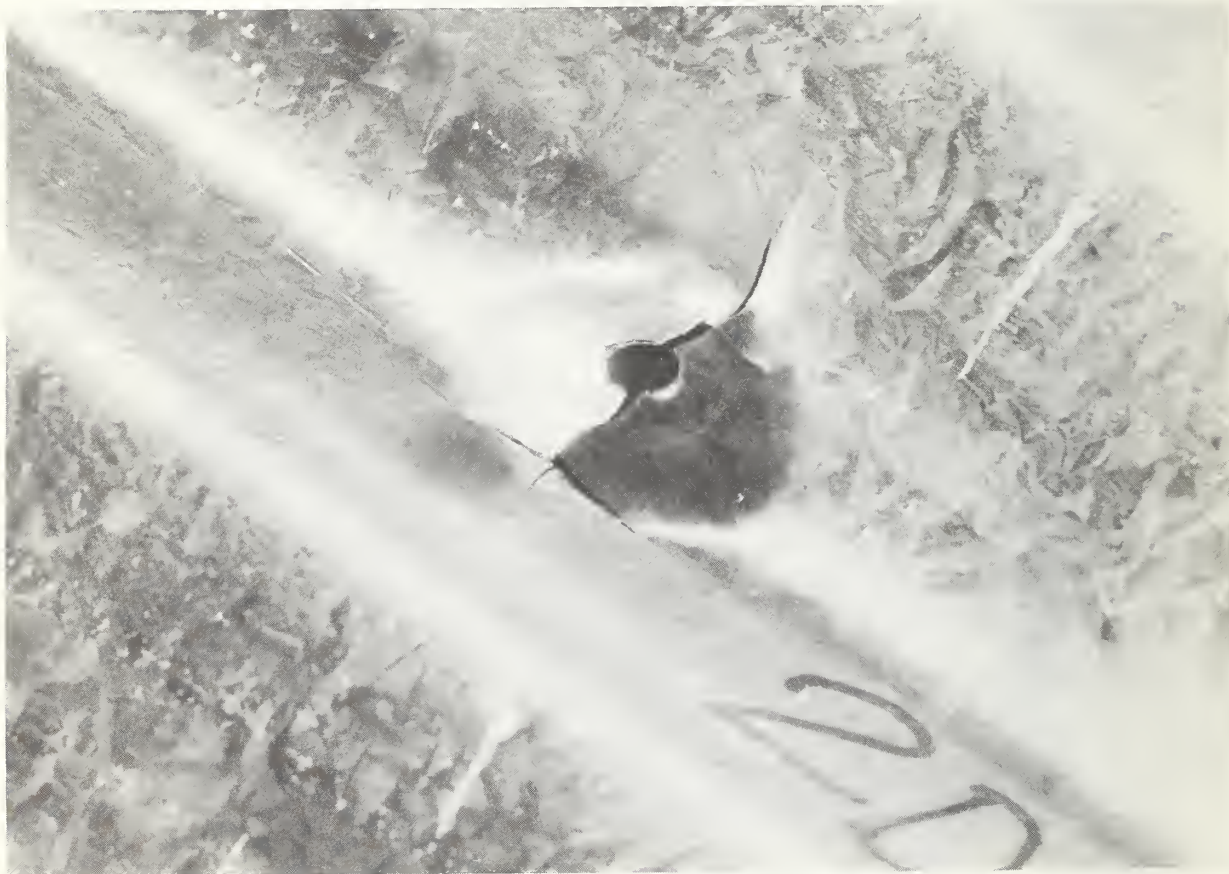
As with other tropical regions of Australia and, in fact, throughout the world, CGI cladding is widely used in Darwin. There are many variations in the sheet profiles and types of fasteners, by far the most common being a sinusoidal cross section with self-drilling, self-tapping fasteners equipped with a neoprene sealing washer. Immediately following Cyclone Tracy, laboratory tests and field inspections of single-family dwellings and industrial buildings were carried out by the Housing Research Branch, Department of Housing and Construction to establish the reasons for the widespread failure of CGI in Darwin [10]. These investigations are continuing, but preliminary findings indicate that low-cycle fatigue was the predominant failure mode. Repeated load tests carried out at approximately 30 percent of the ultimate static load capacity produced failures after 2000 to 3000 cycles. A typical failure is shown in Figure 32. Data obtained in recent full-scale investigations of wind

Fig. 32. Typical fatigue failure of CGI cladding

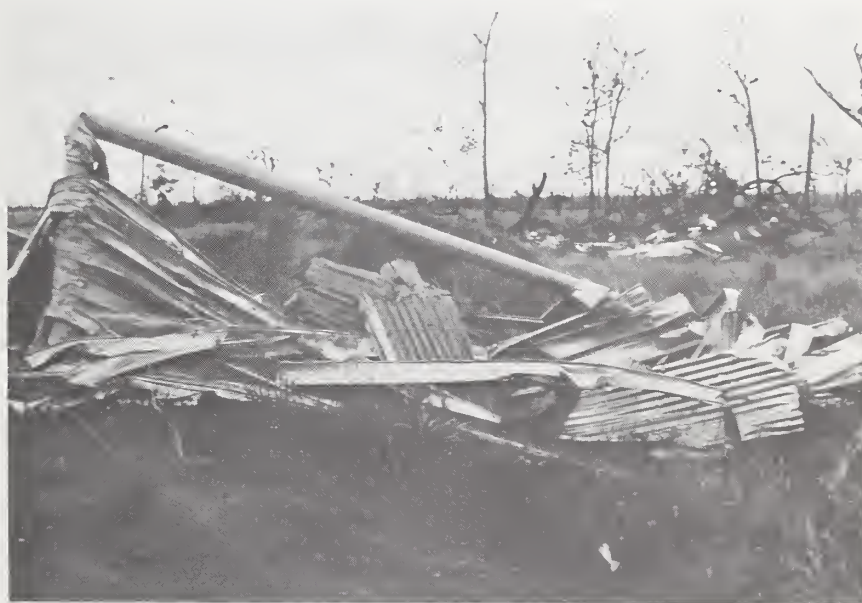
Fig. 34. Failure of lamp standard due to debris loading
