EVALUATION OF NEW ROOFING SYSTEMS ON GUAM, M.I.

30 June 1964

EVALUATION OF NEW ROOFING SYSTEMS ON GUAM, M. I.

William C. Cullen  
Organic Building Materials Section  
Building Research Division

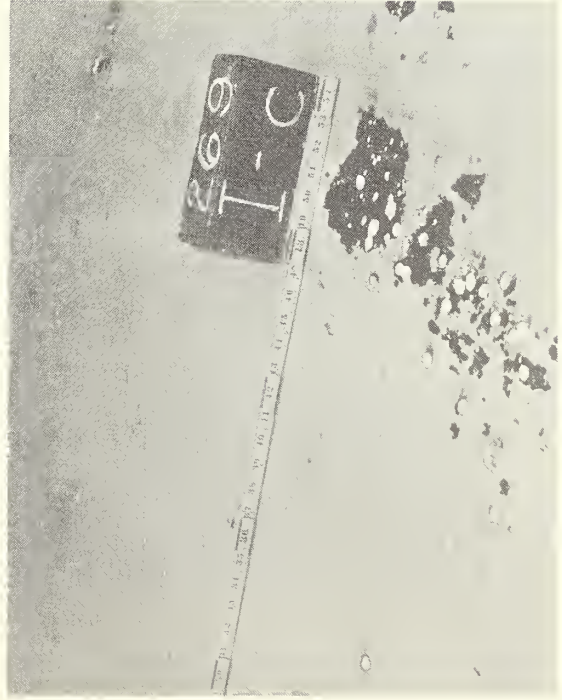
Generally the coatings in this group declined in their ability to waterproof the concrete roof deck with exposure. The prime factors contributing to the decline were blistering, cracking, embrittlement, loss of adhesion to substrate and a general deterioration. Typical examples of failures in the mastic coatings are shown in Figures 2 and 3.

FIGURE 3. GENERAL DETERIORATION OF AN ALUMINUM COATING. AGE 38 MONTHS.

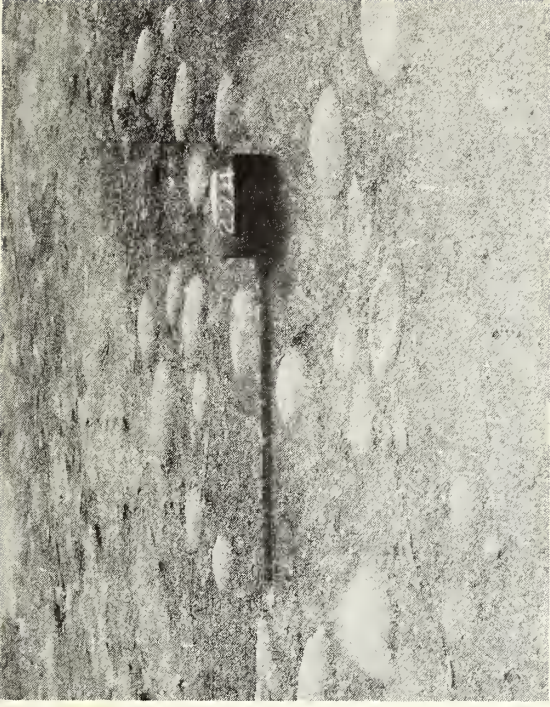
FIGURE 2. SEVERE BLISTERING OF A MASTIC TYPE MATERIAL. AGE 45 MONTHS.

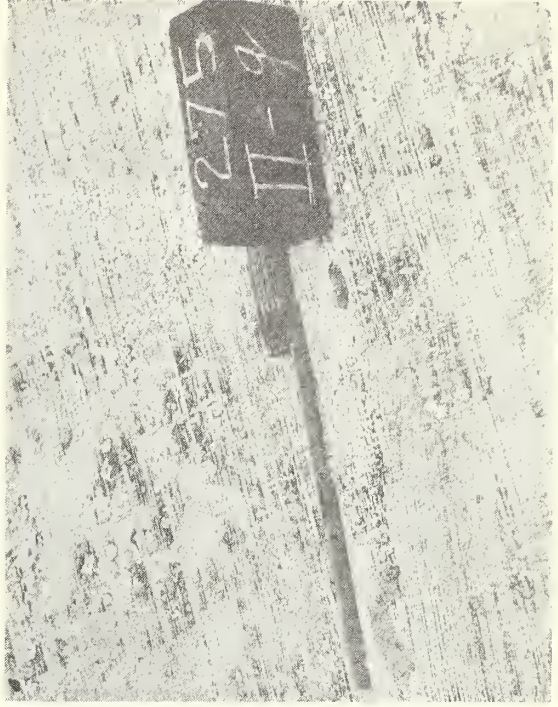
In some cases the materials included in this class initially failed to waterproof the concrete slab due to poor coverage at the high spreading rates recommended for these materials. The remaining materials failed to perform due to peeling, blistering, flaking, and in their ability to bridge even small structural or shrinkage cracks which developed in the concrete deck. Typical examples of failures which were common to coatings of this class are shown in Figures 4 and 5.

FIGURE 4. EROSION OF A PAINT TYPE COATING. AGE 45 MONTHS.

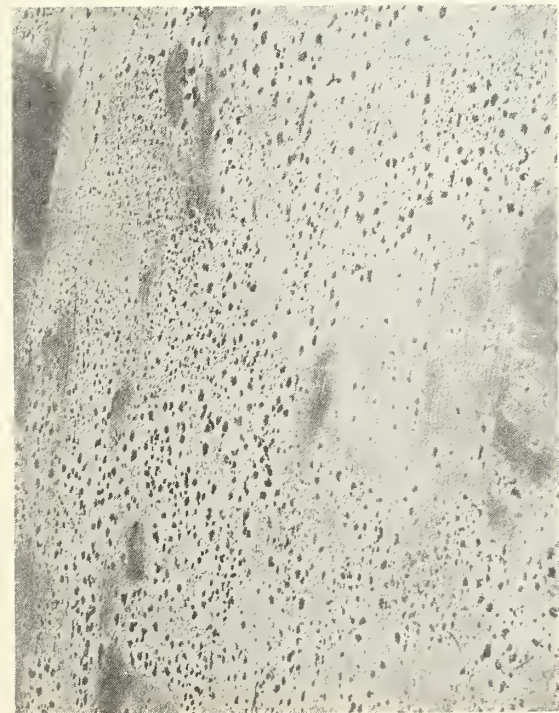
FIGURE 5. FAILED PAINT TYPE COATING.  
AGE 45 MONTHS.

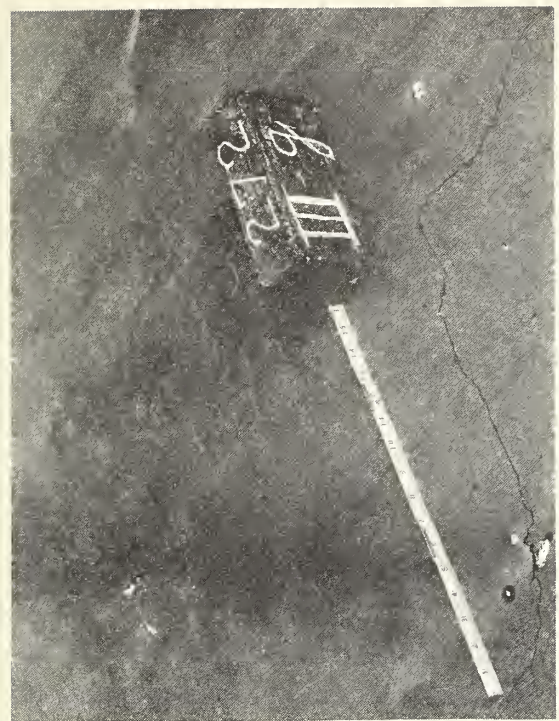
As expected, the bituminous emulsions indicated good weather resistance which is characteristic of this class of coatings. However, they declined rather rapidly in their ability to waterproof the slab due to other factors as: erosion, cracking, and in one case, blistering. Figures 6 and 7 show examples of defects observed.

FIGURE 6. CRACKING AND FLAKING OF AN  
EMULSION TYPE COATING. AGE 45 MONTHS.

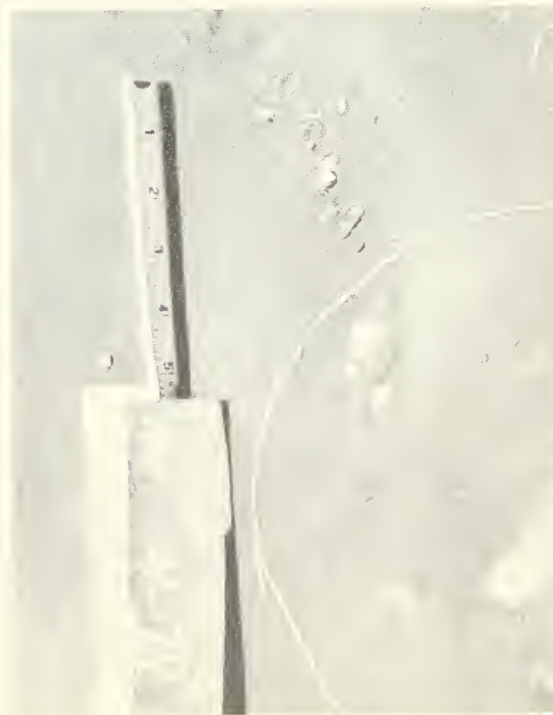
FIGURE 7. BLISTERING AND SALT DEPOSITS  
ON EMULSION COATING. AGE 45 MONTHS.

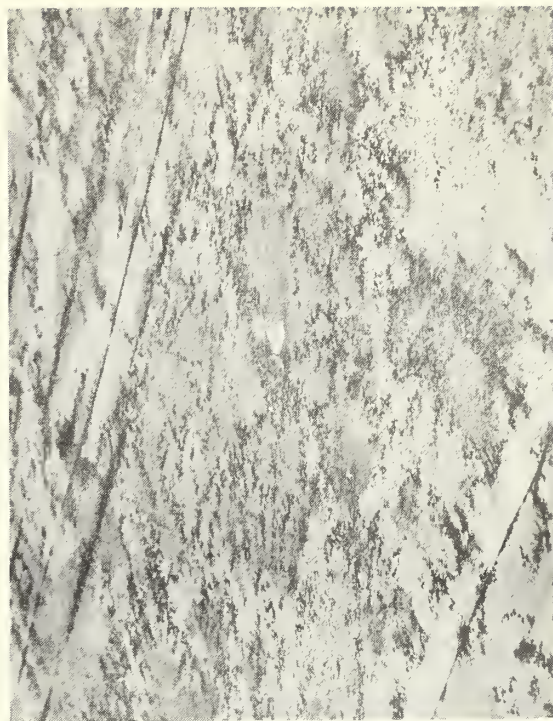
The emulsion-glass felt and the epoxy-glass fabric combinations performed quite satisfactorily, but were rated as failed after 10 years exposure. The former exhibited breaks and small blisters, while the latter indicated erosion of the top coating and an accumulation of mildew as shown in Figure 8.

FIGURE 8. CONDITION OF REINFORCED  
MEMBRANE SYSTEM SHOWING MILDWE GROWTH.  
AGE 75 MONTHS.

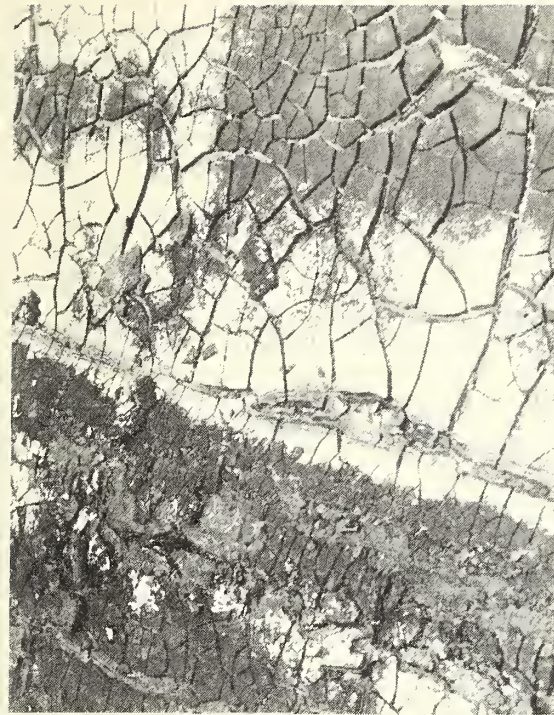
Originally, the roof decks were protected with smooth-surfaced, insulated built-up roofs applied in 1950. Figure 10 shows a typical roof section prior to removal. The old roofing and insulation were removed and the deck was made as clean as possible. Although the prepared decks were suitable for application of the single-ply or multiple-ply membranes, it was questionable whether the decks were sufficiently clean for application of the fluid-applied systems.

FIGURE 10. CONDITION OF WEATHERED  
BITUMINOUS ROOFING BEFORE REMOVAL.

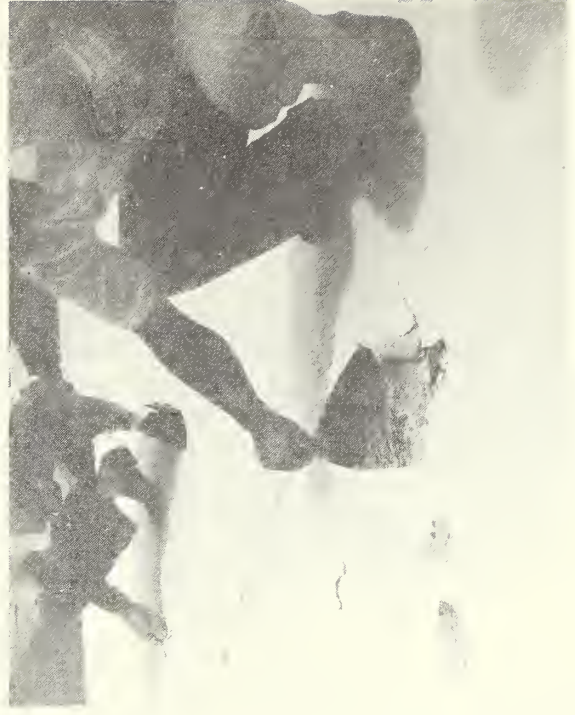
FIGURE 16. DEFECTS IN FLUID-APPLIED SYSTEM ATTRIBUTED TO POOR PREPARATION OF CONCRETE DECK

In light of the experience, we are of the opinion that the fluid-applied systems should be used only on roof decks which have not been previously covered. It is not considered economical to attempt to clean a used deck to such a condition that will provide an acceptable surface. Further, we believe that emulsion-type systems (not including easily-dried surface coatings) should be applied only during dry seasons when relative humidities are low and the chance of unexpected showers is minimal.
