NISTIR 8077

Investigation of PMU Response to Leap Second: 2015

August 2015

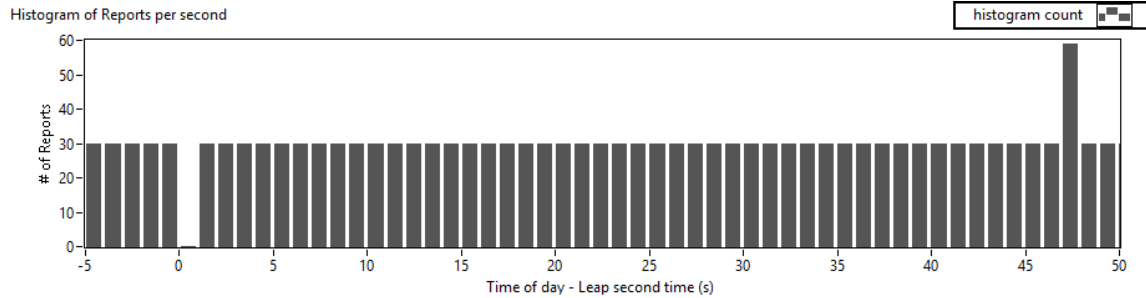
Figure 5: Histogram of Reports per SOC for PMU ID 2

Summary of PMU ID 2 Response: PMU did not repeat SOC 1435708799 and remained 1 second ahead of UTC for 47 seconds after leap second occurs, then returns to synchronization thereafter. No Time Quality bits were set.

Figure 5 shows a histogram of the number of reports per TOD second versus TOD relative to the leap second for PMU 2. There were no reports for Time of Day 23:59:60 because the PMU did not repeat the LS SOC. The SOC repeated the SOC 47.0 seconds after the start of leap second, so there are 60 reports during that time. Note that PMU ID 2 was configured for reporting rate of 30 frames per second.

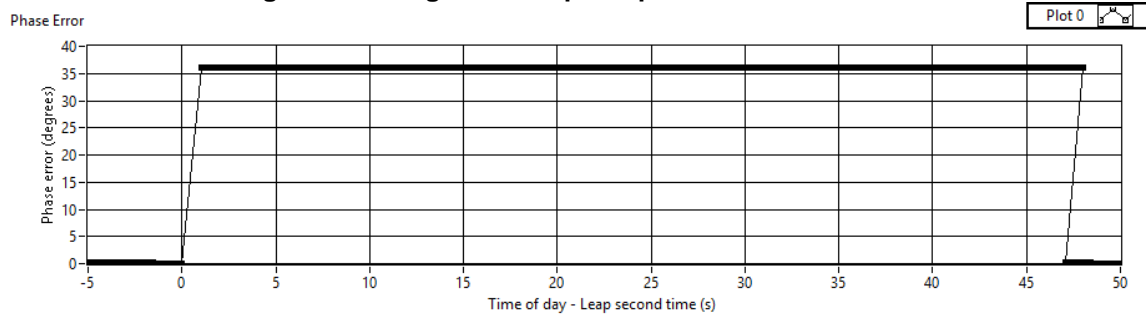
Figure 6: PMU ID 2 Phase Error

Figure 6 shows the phase error in degrees for PMU ID 2. When each PMU report is aligned and compared with the actual input phase at the time of the PMU timestamp the plotted phase errors result. The input signal was set to a steady state power system frequency of 59.9 Hz. Since the synchrophasor rotates at 36 degrees per second, a one-second error in reporting time will result in a 36 degree error in phase. There are no data between 0s (LS) and LS + 1s because the PMU did not output any reports with a repeated SOC 1435708799 (TOD 23:59:60). There are two sets of data for the time from LS + 47 to LS + 48 seconds.

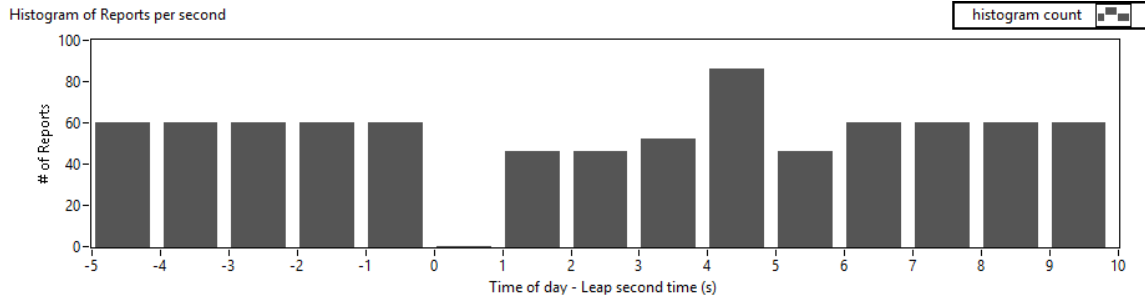
Figure 7: Histogram of reports per SOC for PMU ID 3

Summary of PMU ID 3 Response: PMU did not repeat SOC 1435708799; the Pending and Occurred bits are set at incorrect times; SOC was one second ahead of UTC for 4 seconds, then portions of SOC 1435708802 and 1435708802 are repeated; following the leap second, some SOC's had only 46 rather than 60 reports per second; the PMU continues to sporadically output 46 reports per second while primarily outputting 60 reports per second.

Figure 7 shows a histogram of the number of reports per TOD second versus TOD relative to the leap second for PMU ID 3. There were no reports during TOD 23:59:60 because the PMU did not repeat the LS SOC. Beginning one second after the leap second, the PMU only transmitted 46 reports for the following 3 seconds. However, following 00:00:03.8833, the PMU SOC skipped back to 00:00:02.9000; thus for 00:00:02 there were 50 reports but 4 of them occurred 1 second later. The SOC 00:00:03 had 88 reports (2 seconds worth of 46 reports per second minus the four reports from 00:00:02), then 00:00:04 had 46 reports. After that there were 60 reports per SOC for a while but the PMU began to sporadically output 46 reports per SOC for the following 8 days. After 8 days, the PMU was power cycled but continues to sporadically output 46 reports per SOC with 14 reports missing.

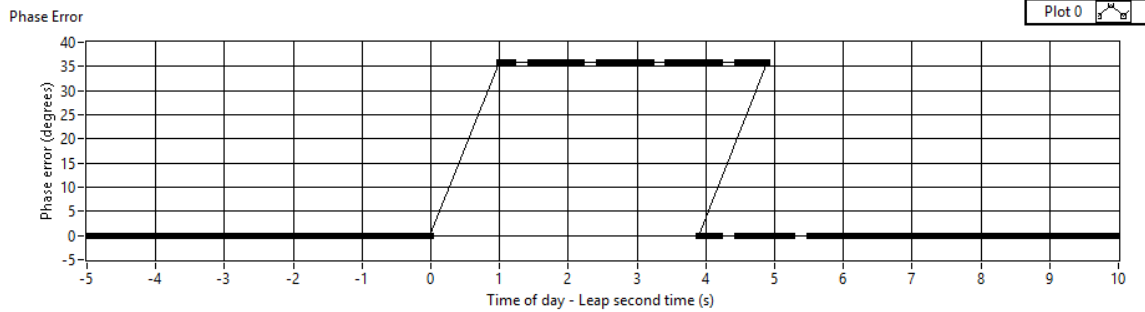
Figure 8: PMU ID 3 Phase Error

Figure 8 shows the phase error in degrees for PMU ID 3. When each PMU report is aligned and compared with the actual input phase at the TOD of the PMU timestamp the plotted phase errors result. The input signal was set to a steady state power system frequency of 59.9 Hz. Since the synchrophasor rotates at 36 degrees per second, a one-second error in reporting time will result in a 36 degree error will result in phase. Note that there are no data between 0s and 1s because the PMU did not repeat the LS SOC. There are two sets of data for the time from LS + 2.900 to LS + 4.900 seconds. Also, note also that there are gaps in the data from those seconds where only 46 reports were output.

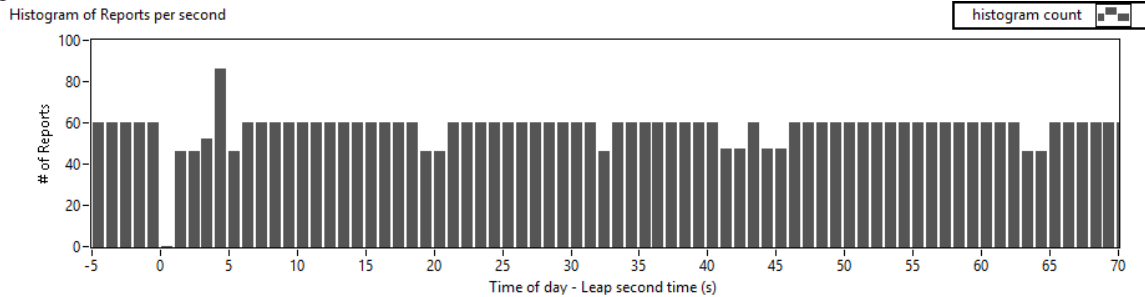
Figure 9: Histogram of reports per SOC for PMU ID 3 showing sporadic lost reports

Figure 9 shows how PMU 3 sporadically outputs 46 reports during some SOCs. The PMU continues to do this even though it has been shut down and re-started.

†† PMU ID 3 Beginning at the leap second and continuing at the time of writing, PMU ID 3 has sporadic periods where there are only 46 reports during a second. 14 reports are missing during these seconds.

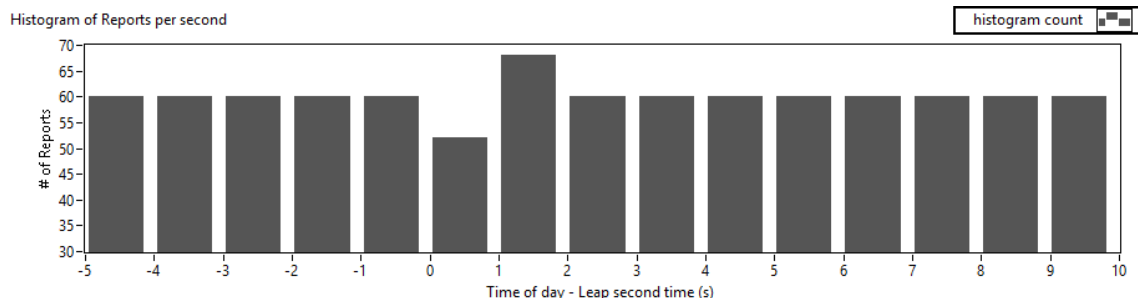
Figure 10: Histogram of reports per SOC for PMU ID 4

Summary of PMU ID 4 Response: SOC 1435708799 did not repeat immediately after TOD 23:59:59. After 8 reports with SOC 1435708800 (TOD 00:00:00) SOC changed back to 1435708799 (TOD 23:59:60); so for 0.15 seconds, the SOC was one second ahead of UTC. There were 52 reports during TOD 23:59:60. The leap second Pending flag was reset and the Occurred flag was set at 1.333 seconds after the leap second.

Figure 10 shows a histogram of the number of reports per TOD second versus TOD relative to the leap second for PMU ID 4. At the time of the leap second, instead of reporting TOD 23:59:60, the PMU rolled over to 00:00:00 for 8 reports then skipped back to 23:59:60.1333. There were 68 reports for TOD 00:00:00 and 52 reports for TOD 23:59:60 (8 of which occurred at the incorrect time).

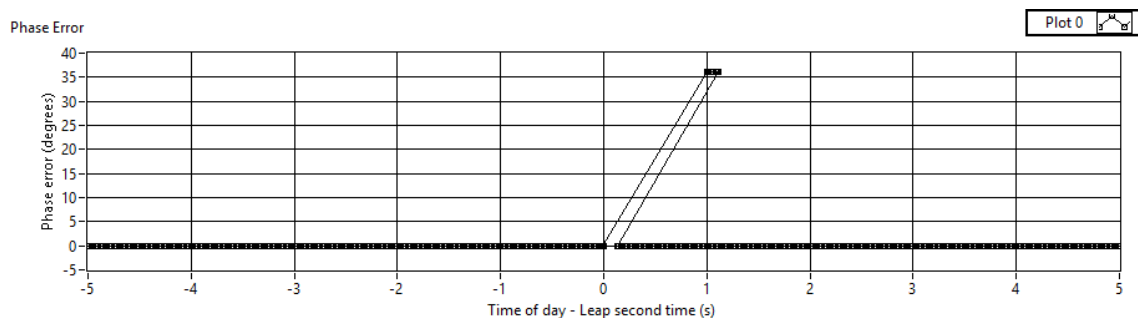
Figure 11: PMU ID 4 Phase Error

Figure 11 shows the phase error in degrees for PMU ID 4. When each PMU report is aligned and compared with the actual input phase at the time of the PMU timestamp the plotted phase errors result. The input signal was set to a steady state power system frequency of 59.9 Hz. Since the synchrophasor rotates at 36 degrees per second a one-second error in reporting time will result in a 36 degree error in phase. Note that there are no data between 0.0000 s and 0.1667 s because the PMU rolled over to 00:00:00 (1 second after Leap Second). After 7 reporting periods, the SOC skipped back to UTC time at 23:59:60.1667. There are two sets of data for the relative LS + 1.000 s to LS + 1.1667 s.

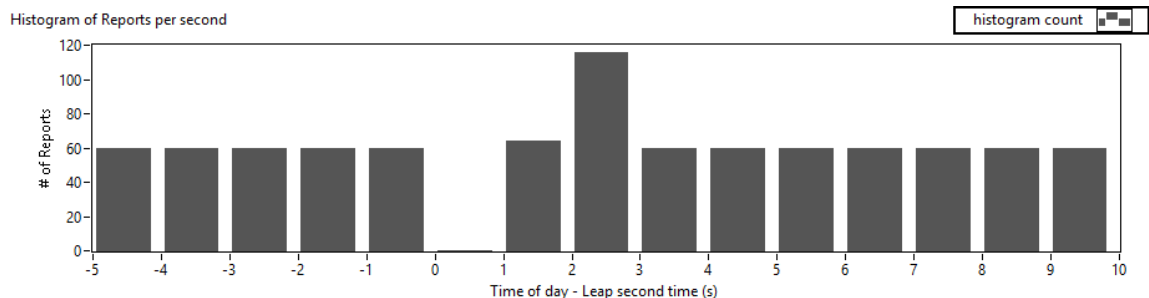
Figure 12: Histogram of reports per SOC for PMU 5

Summary of PMU ID 5 Response: LS bits did not get set. SOC 1435708799 did not repeat following TOD 23:59:59 and remained one second ahead of UTC for 1.933 seconds after LS but gets synchronized thereafter.

Figure 12 shows a histogram of the number of reports per TOD second versus TOD relative to the leap second for PMU ID 5. There are no reports for TOD 23:59:60 because the PMU did not repeat the LS SOC. The PMU rolled back the SOC by 1 second at 1.9333 seconds after LS so there are 64 reports for TOD 00:00:00 and 116 reports for TOD 00:00:01.

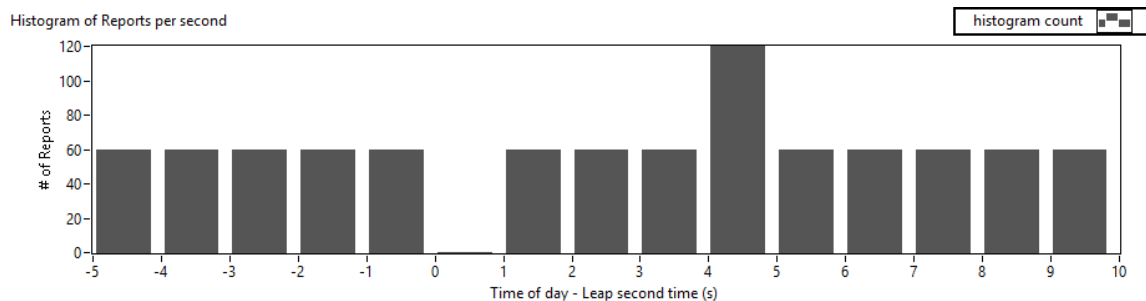
Figure 13: Histogram of reports per SOC for PMU ID 6

Summary of PMU ID 6 response: LS bits do not get set. SOC did not repeat after TOD 23:59:59 and remained 1 second ahead of UTC for 4 seconds after LS but gets synchronized thereafter.

Figure 13 shows a histogram of the number of reports per TOD second versus TOD relative to the leap second for PMU ID 6. The SOC repeated 4 seconds after the leap second so there are no reports for TOD 23:59:60 and 120 reports for TOD 00:00:03.

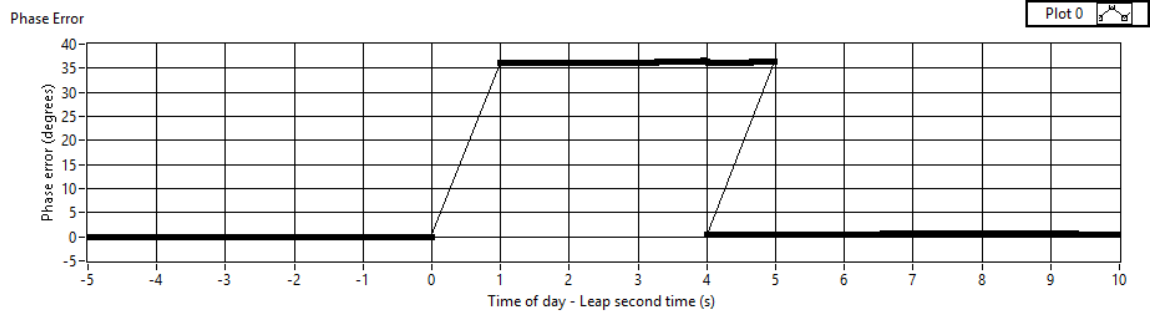
Figure 14: PMU ID 6 Phase Error

Figure 14 shows the phase error in degrees for PMU ID 6. When each PMU report is aligned and compared with the actual input phase at the time of the PMU timestamp the plotted phase errors result. The input signal was set to a steady state power system frequency of 59.9 Hz. Since the synchrophasor rotates at 36 degrees per second, a one-second error in reporting time will result in a 36 degree error in phase. Note that there are no data from LS to LS + 1 s because the PMU did not repeat the LS SOC. There are two sets of data for the LS + 4 to LS + 5 seconds.

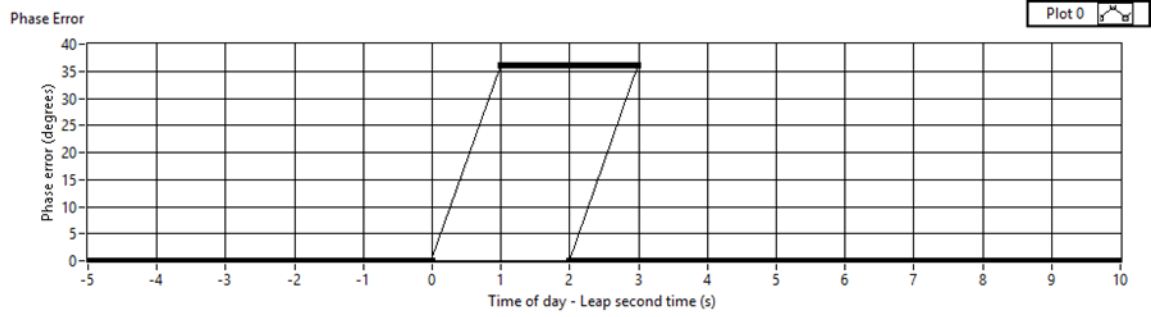
Figure 16: PMU ID 7 phase error

Figure 16 shows the phase error in degrees for PMU ID 7. When each PMU report is aligned and compared with the actual input phase at the time of the PMU timestamp the plotted phase errors result. The input signal was set to a steady state power system frequency of 59.9 Hz. Since the synchrophasor rotates at 36 degrees per second, a one-second error in reporting time will result in a 36 degree error in phase. Note that there are no data from LS to LS + 1 s because the PMU did not repeat the LS SOC. There are two sets of data for the LS + 2 s to LS + 3 s.

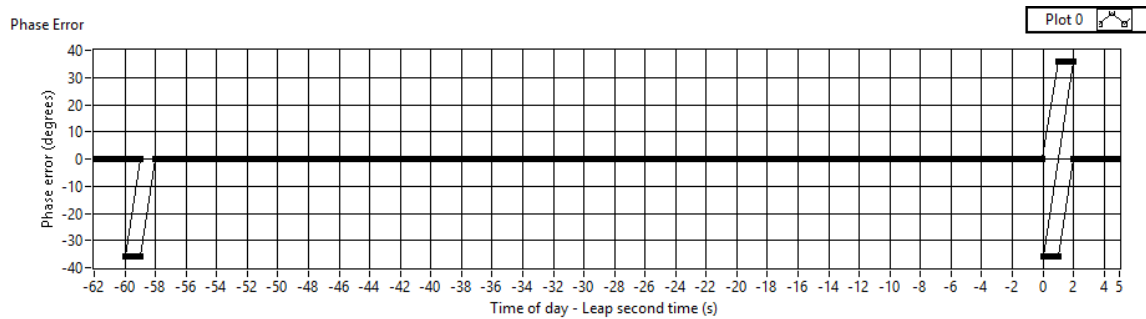
Figure 18: PMU ID 8 Phase Error

Figure 18 shows the phase error in degrees for PMU ID 8. When each PMU report is aligned and compared with the actual input phase at the time of the PMU timestamp the plotted phase errors result. The input signal was set to a steady state power system frequency of 59.9 Hz. Since the synchrophasor rotates at 36 degrees per second, a one-second error in reporting time will result in a 36 degree error in phase. The phase error plot shows the effect of skipping back by one second at relative LS - 59 seconds, then skipping ahead one second later. During the leap second, the histogram shows that there were 60 reports per second, but the phase error plot shows that for 2 seconds after LS the timestamps reported were incorrect. The reports from the time of leap second to 1 second after were actually taken 1 second late, thus there was a -36 degree error, then the SOC skipped ahead by 2 seconds causing one second of +36 degree error before returning back to synchronization with UTC.
