NATIONAL BUREAU OF STANDARDS REPORT

9947

FAILED MCCAULEY PROPELLER HUB

T. R. Shives
Engineering Metallurgy Section
Metallurgy Division

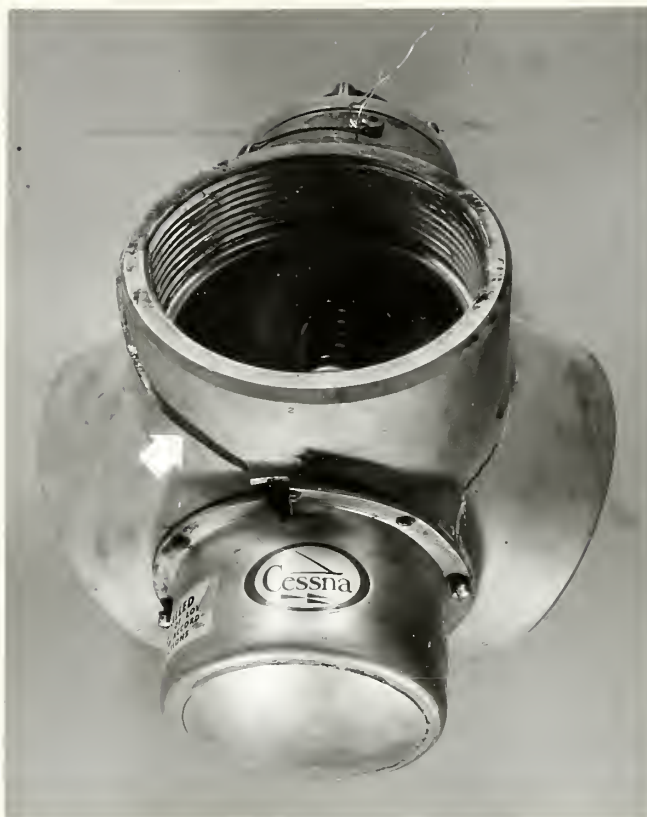
Metallographic Examination: The fracture originated at a fatigue crack near the root of the innermost thread in blade socket No. 2 and extended across the socket (fig. 1). The fracture surface is shown in figures 3 and 4. The fracture was sectioned adjacent to the fatigue crack origin and examined metallographically. Figure 5 shows a representative area of the material in the unetched condition near the crack origin. The material is clean and shows little or no porosity. Figures 6 and 7 show

Figure 1. McCauley Propeller Hub as received. Arrow on photograph points to approximate location of fracture origin on inside of hub. X 3/8

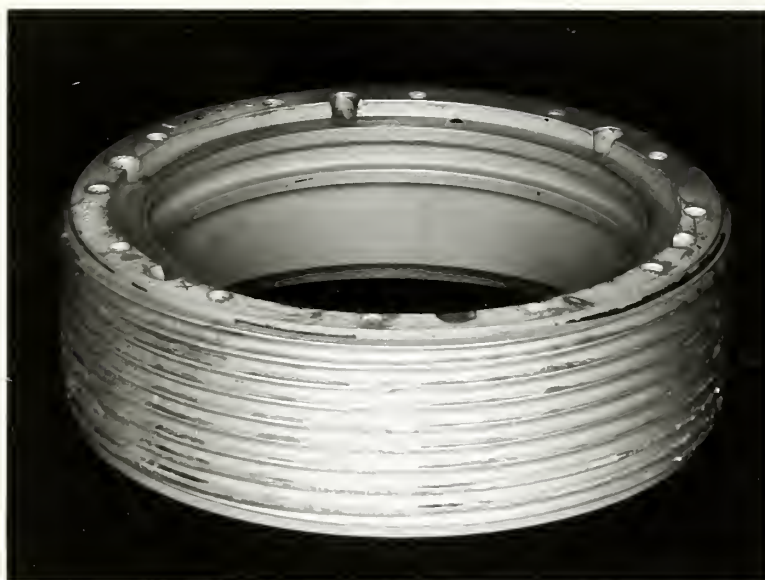
Figure 2. Blade retention nut from blade socket No. 2 as received. X 2/3

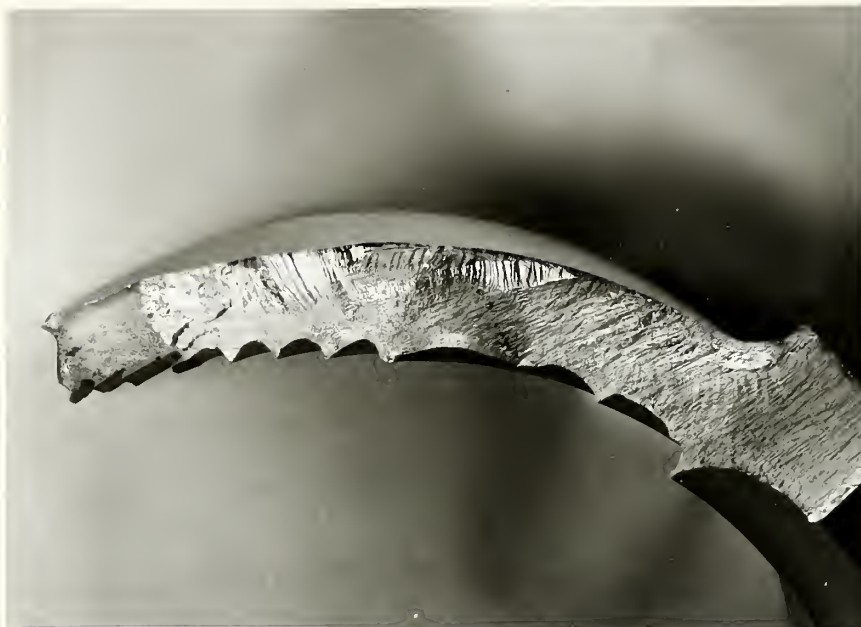
Figure 3. Fracture surface of failed hub socket, No. 2. X 1

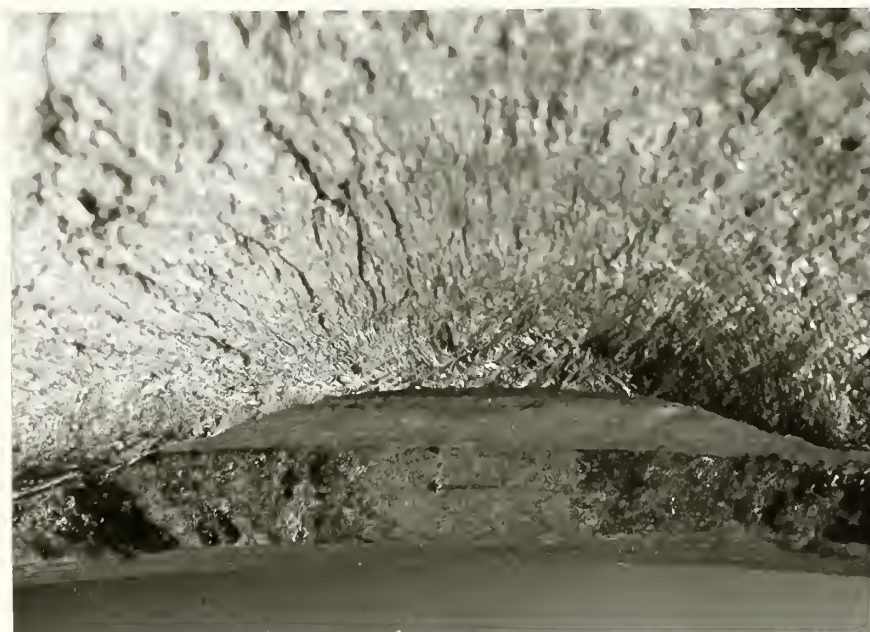
Fretting is indicative of cyclic stressing and it is possible that this stressing could have initiated the fatigue crack that propagated to cause the failure of the hub in socket No. 2. Fatigue cracks may be associated with fretting, and their origins, as in this case, are sometimes found not directly in a fretted area, but adjacent to it.

Figure 4. Origin of fatigue crack in failed hub socket, No. 2. X 10

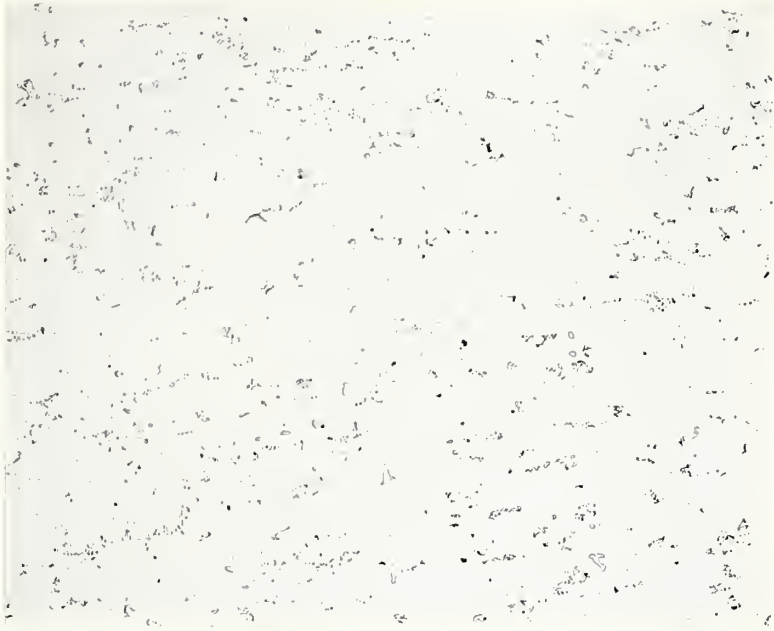
Figure 5. Representative longitudinal area adjacent to origin of fracture. Unetched. X 100

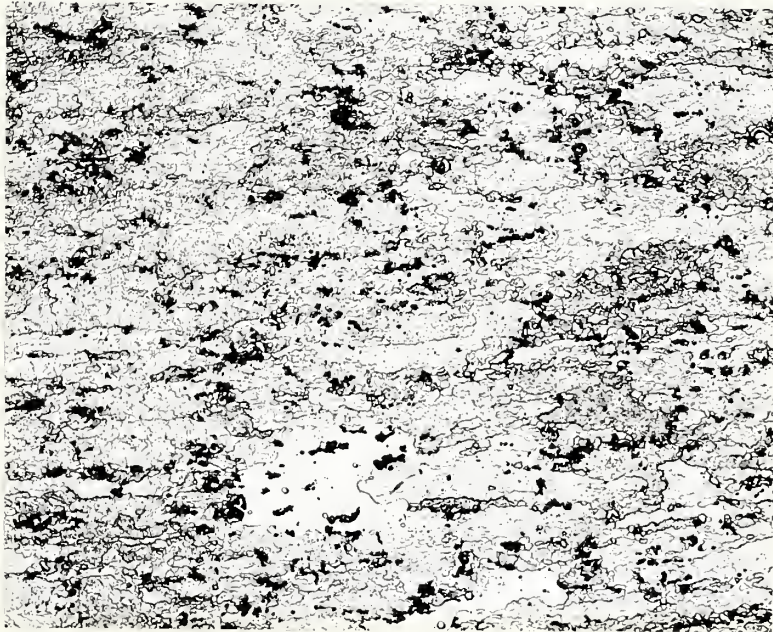
the microstructure of the hub socket adjacent to the crack origin and away from the origin, respectively. There appears to be nothing abnormal or detrimental in the 2014-T6 heat treated structure shown. The smaller grain size observed immediately adjacent to the fracture origin may have resulted from relatively faster cooling after forging in this area. No unusual material condition that may have contributed to crack initiation was found at the origin.

Figure 6. Longitudinal microstructure immediately adjacent to origin of fracture. Keller's etch. X 100

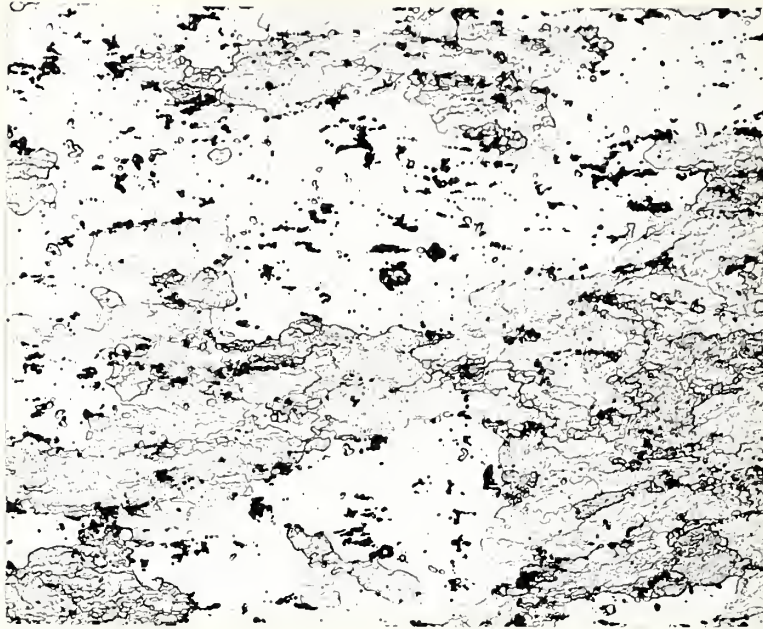
Figure 7. Microstructure of longitudinal section away from fracture. Keller's etch. X 100

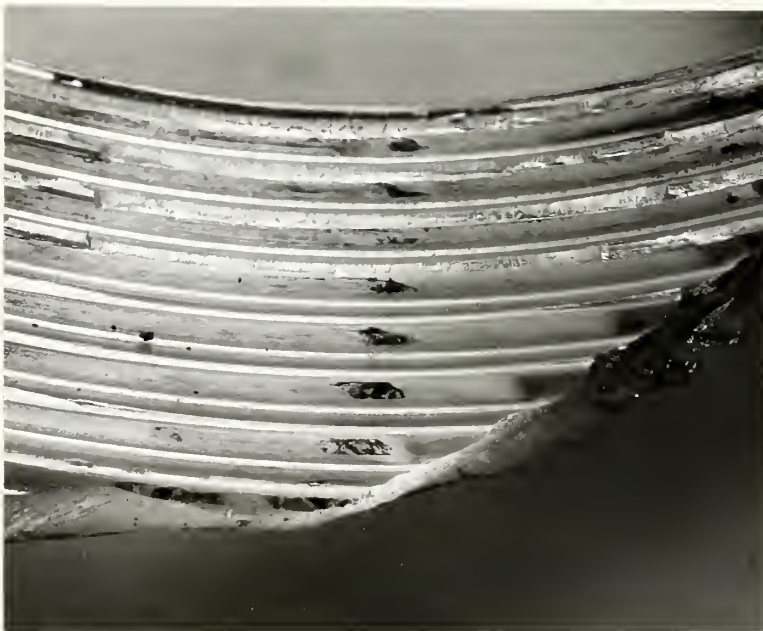
Thread Examination: There was a good deal of fretting in the threads of all three blade sockets as well as in the threads of the retention nut from socket No. 2 (figs. 8 and 9). (The other two retention nuts were not available for examination.) Fretting occurred adjacent to, but not directly at the fatigue crack origin.

The oversize minor diameter found in measuring socket No. 3 indicates a possible mismatch between this socket and its related retention nut. It is conceivable that the mismatch is responsible for the fretting observed in the threads of socket No. 3. Inasmuch as fretting was also observed in the threads of sockets No. 1 and No. 2, it would seem that a mismatch condition was also present in these sockets.

Figure 8. Threads of failed hub socket showing fretting. X 2

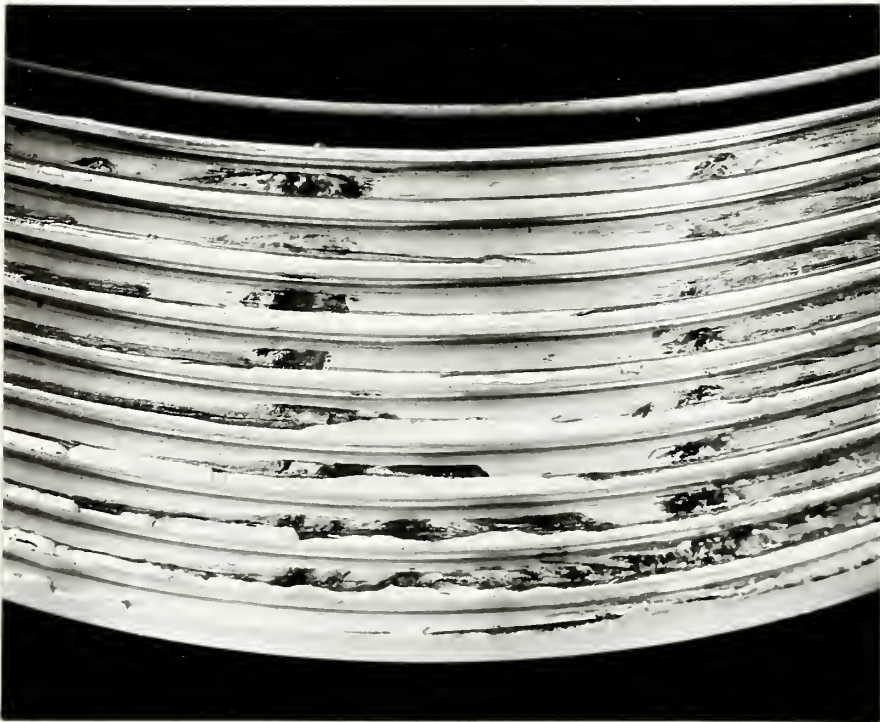
Figure 9. Threads of blade retention nut showing fretting. X 2

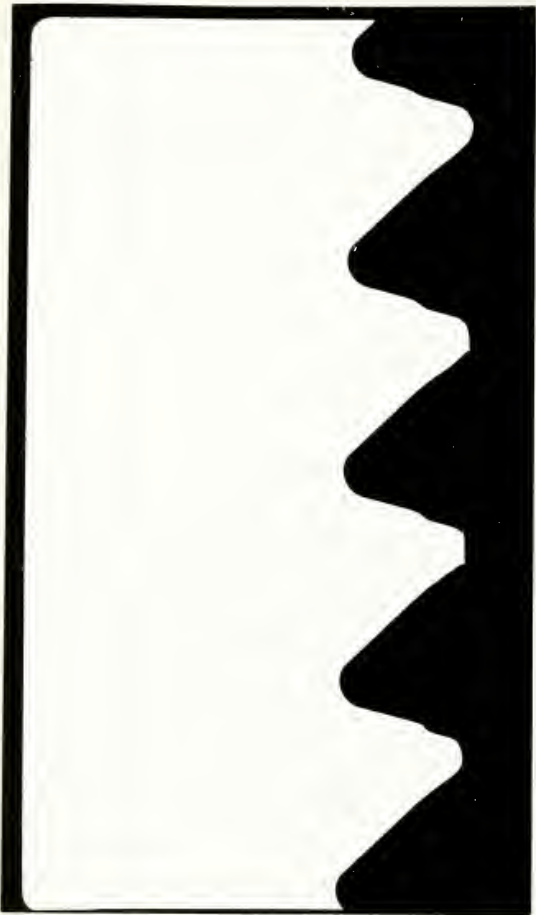
The threads over a large portion of the blade retention nut were rather badly damaged. Figure 10 shows the thread profile in a damaged area as well as in an area where the threads are intact. The thread profile appears satisfactory in the undamaged area.

Figure 10a. Thread profile of
damaged threads of
blade retention nut.
X 7

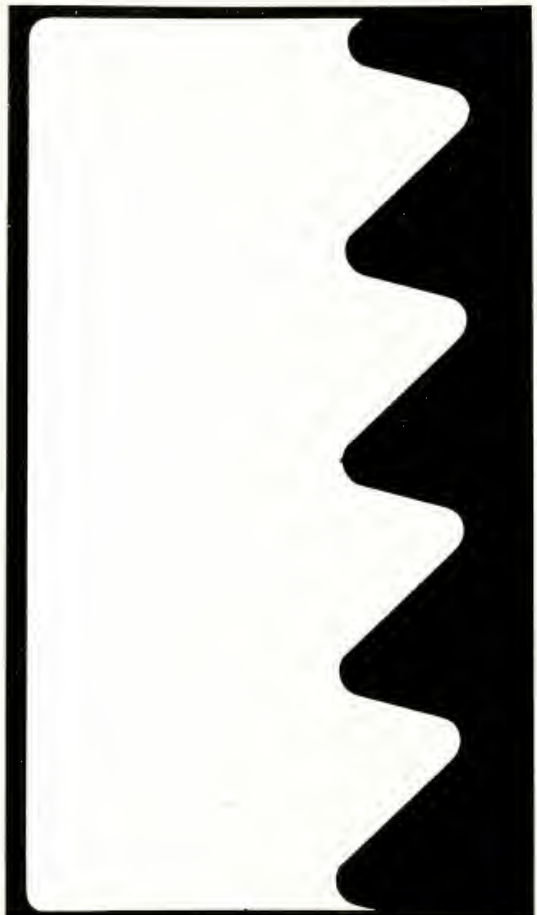
Figure 10b. Thread profile of
undamaged threads of
blade retention nut.
X 7

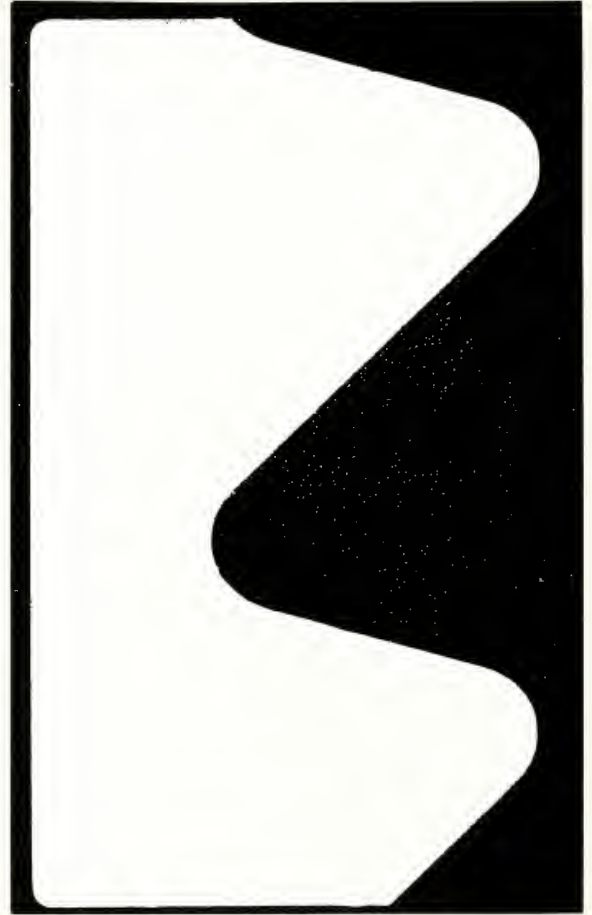
The threads of the failed hub socket were also damaged badly as is shown by the profile of two threads adjacent to the fracture (fig. 11a). Figure 11b shows the thread profile of socket No. 1 which was not damaged and the threads appear to be satisfactory. In figure 12, the thread nearest to the fracture is shown at a higher magnification. The material has been deeply etched to show flow. The top of the thread has been severely deformed. Other damaged threads exhibited deformation of this nature.

Figure 11b. Thread profile of hub socket No. 1 showing undamaged threads. X 18
