9911

FRACTOGRAPHY OF A 7178-T6 ALUMINUM FAILED WING PLANK

NATIONAL TRANSPORTATION SAFETY BOARD

Three sections which had been cut from the top surface of a fractured right wing plank adjacent to the forward edge of the access door (in the area of station 119) of Braniff Electra N-9707 were submitted by Mrs. R. Mayner of the National Transportation Safety Board, Bureau of Aviation Safety on 24 June 1968 for fractographic analysis. Two additional pieces of wing plank from the same accident (location unknown) were submitted by Mr. W. L. Holshouser on 22 July 1968 for comparison of fracture surface with the first three specimens.

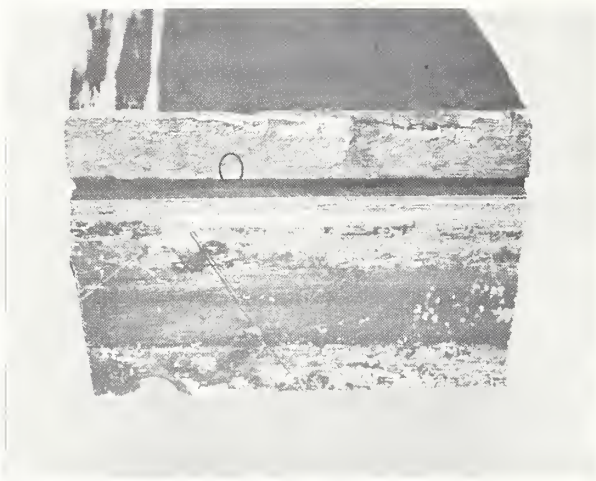
Photomicrographs of the first three fracture sections (1-1, 1-2, 1-3) are shown in Figs. 1, 2, and 3. The area examined by Electron Microscopy is indicated by the circle on each figure. Figures 4 and 5 show the additional fractured sections of wing plank and the location of fracture surfaces. Photomicrographs of the replicas of these fractures (#4, #5, #6) and areas examined by Electron Microscopy are shown in Figs. 6, 7, and 8. In all cases except fracture (1-2) a particular effort was made to place the replica on the microscope grid so as to observe the topography

Fig. 1. Fracture Section (1-1)  
Encircled area replicated for  
electron fractography. X2

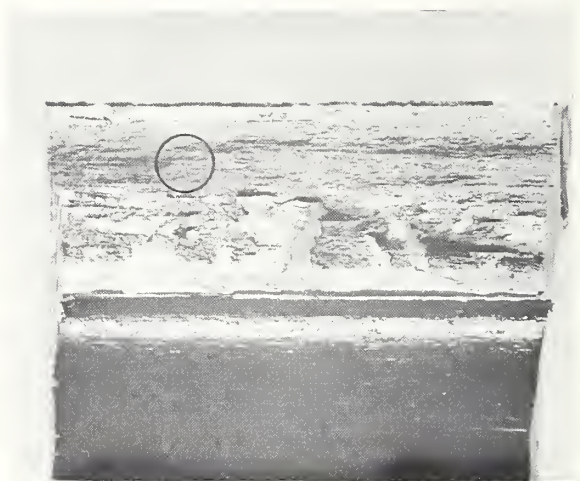
Fig. 2. Fracture Section (1-2)  
X4

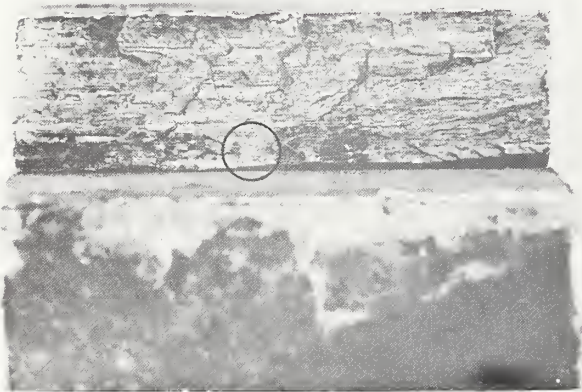
Fig. 3. Fracture Section (1-3)  
X4

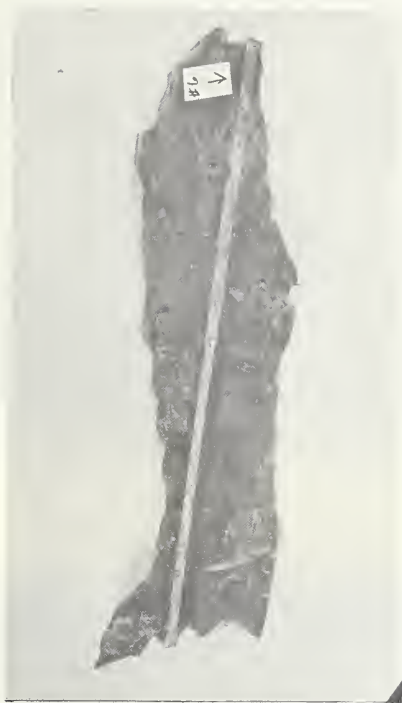
Fig. 5. Fracture location #6  
X1/5

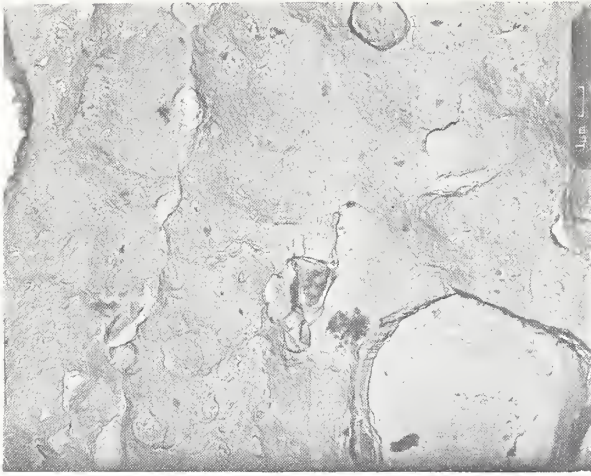
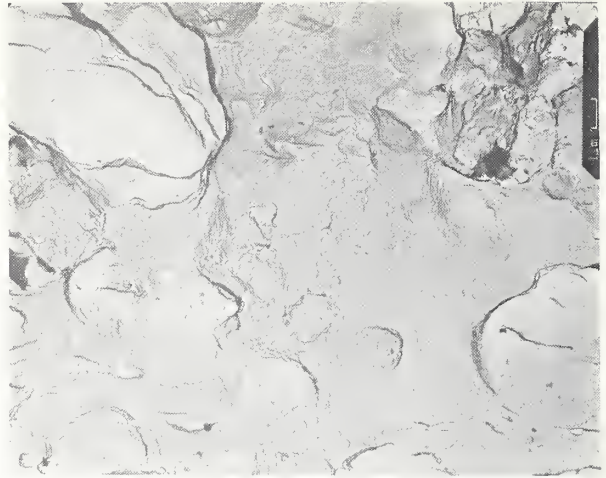
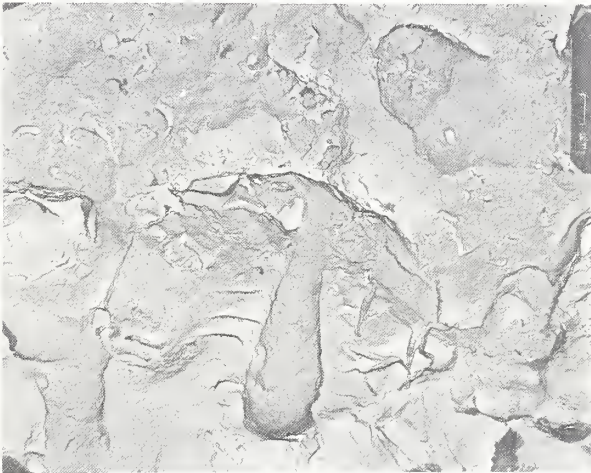
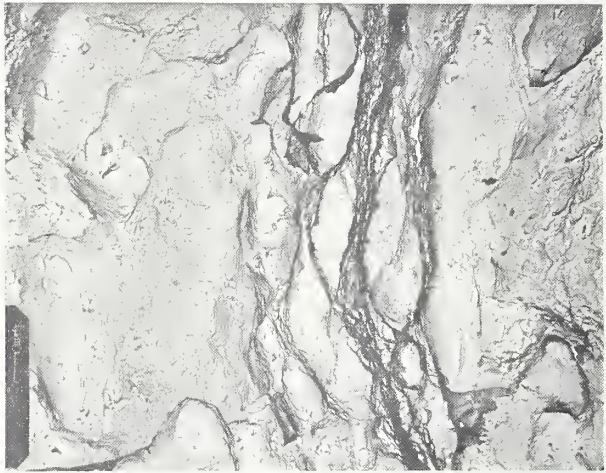
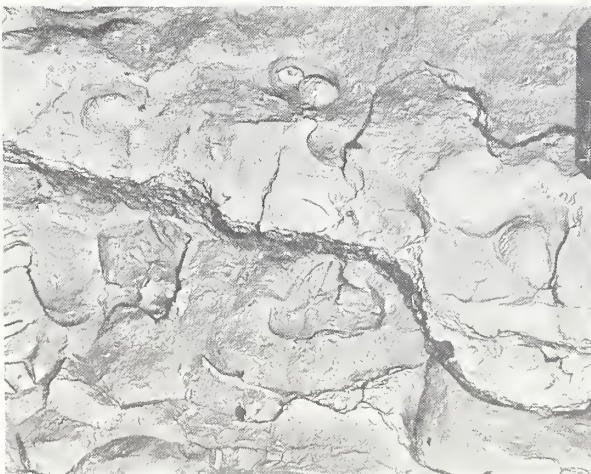
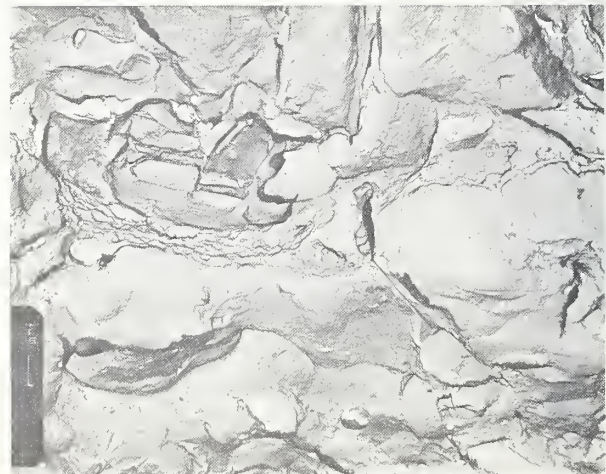
Fracture Section (1-1)

Fractographs of specimen (1-1) are shown in Figs. 9a thru 9f. The original magnification is indicated by the length of the micro meter mark included in each electron photomicrograph. The two photomicrographs 9a and 9b were taken adjacent to the fillet on the fracture surface. The general surface topography is typical of intergranular fracture which usually indicates stress corrosion cracking. Superimposed on the grain facets can be seen a fine dimple-like surface indicating low ductility fracture. There is a small increase in surface roughness in Fig. 9c which was adjacent to Figs. 9a and b but more distant from fillet edge. The first evidence of transgranular ductile fracture is shown in Fig. 9d as narrow bands of dimpled rupture parallel to the long axis of the fracture between areas of low ductility. These features are shown again in Figs. 9e and 9f and are typical of the fracture surface approximately 0.5 mm away from the edge of fracture.

1. Dimpled rupture, as an indication of ductility, was found at the fillet edge of all fractures except fracture section (1-3). This section had evidence of severe corrosion at the fillet edge of fracture.

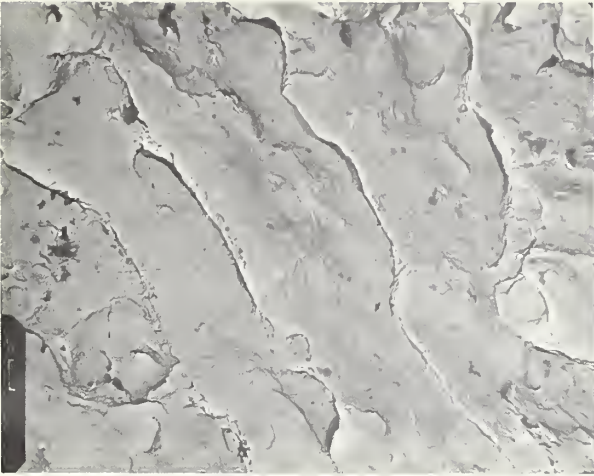
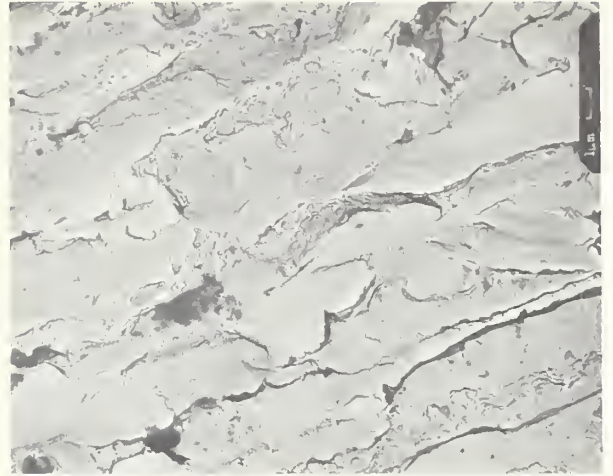
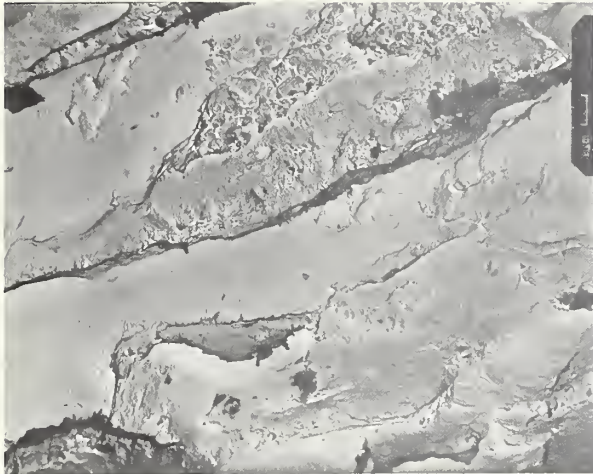
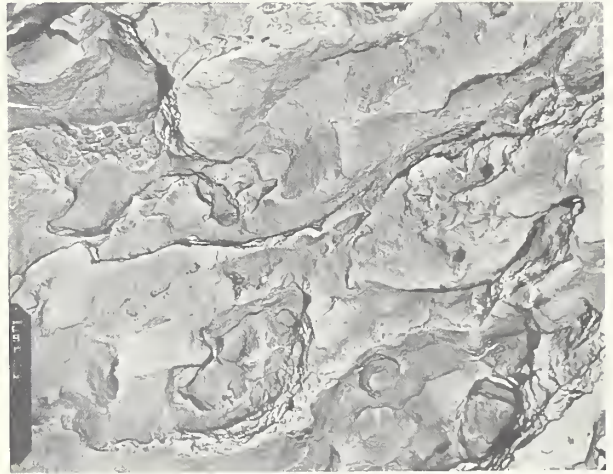
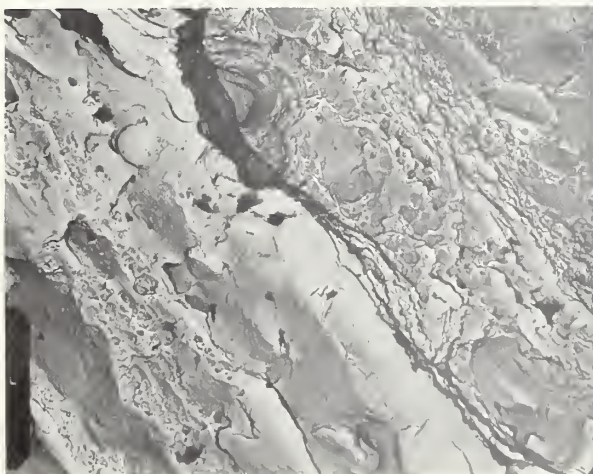
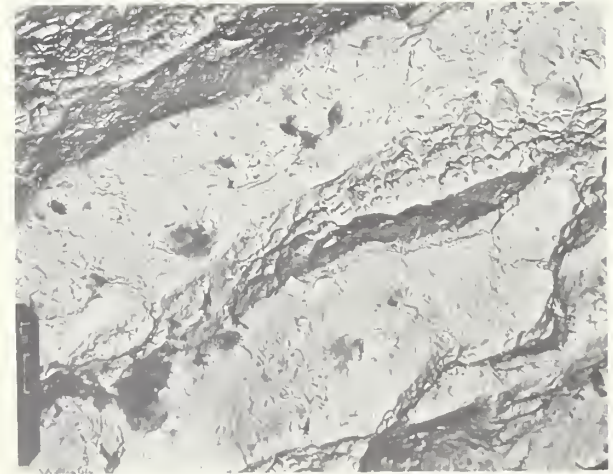
Fracture Section (1-2)

Visual examination of the section (1-2) showed that the fracture edge adjacent to the fillet was mechanically abraded and all original fracture surface was destroyed. Therefore an undamaged area was chosen at a location approximately half the distance across the fracture. Figures 10a through 10f show microstructure typical of this area. In general the surface shows an elongated transgranular fractured grains of low ductility bounded by narrow bands of dimpled rupture. The amount of dimpled rupture shows a significant increase of ductility over the fracture edge of (1-1).

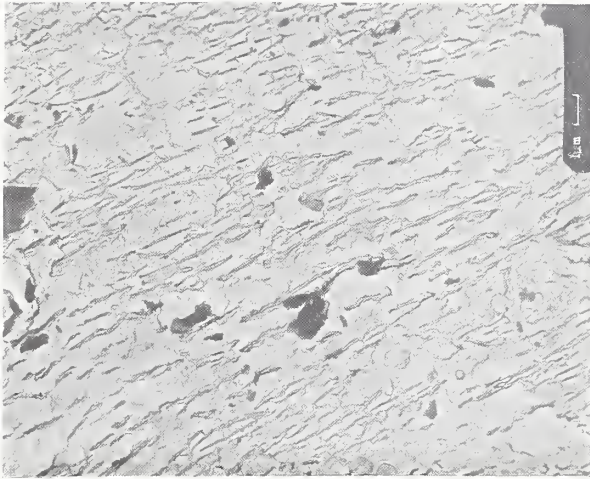
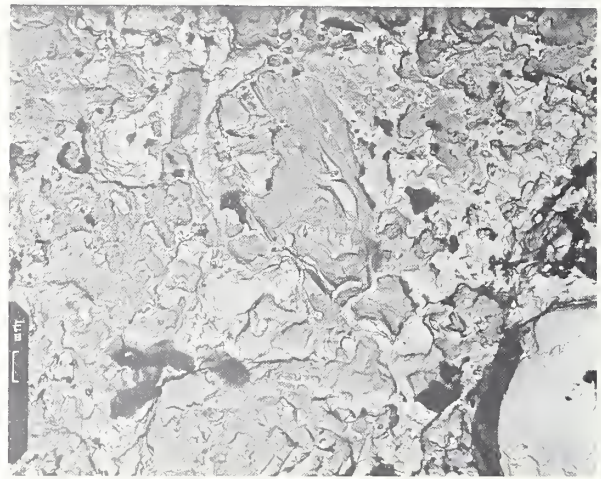
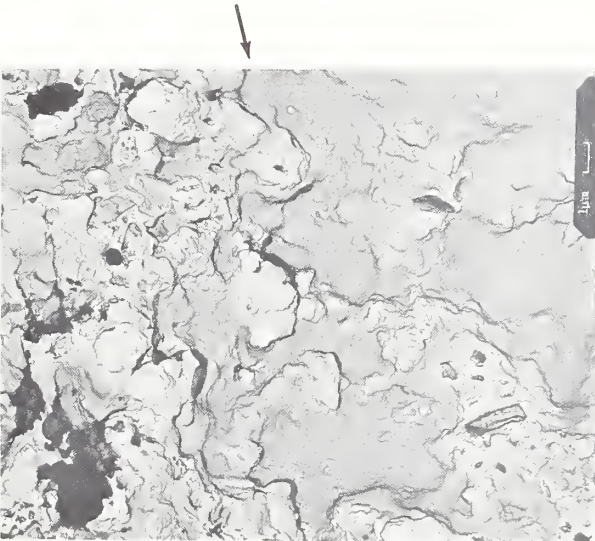
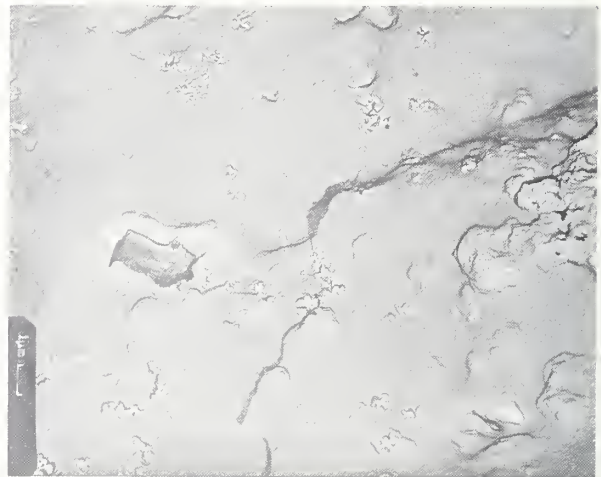
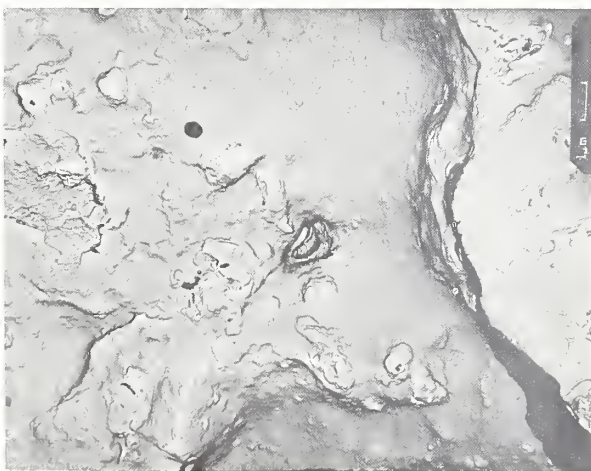
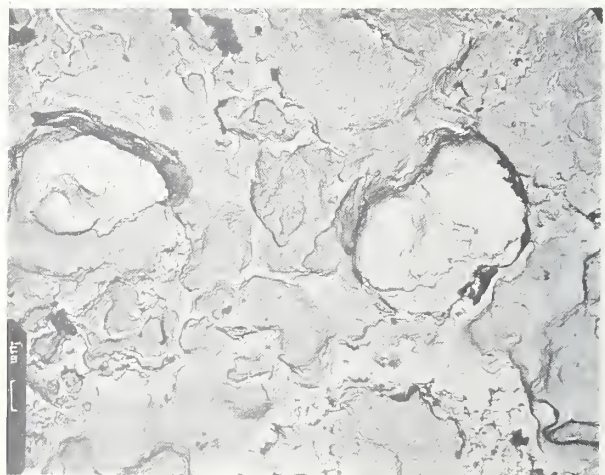
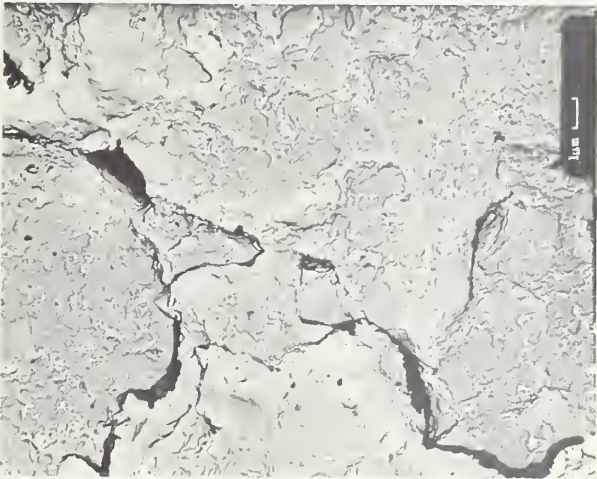
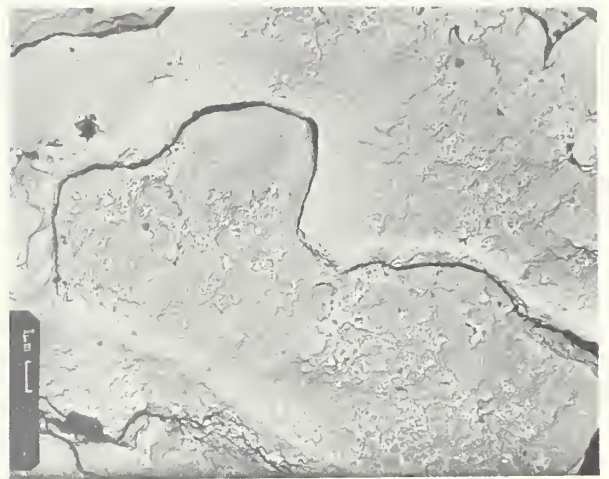
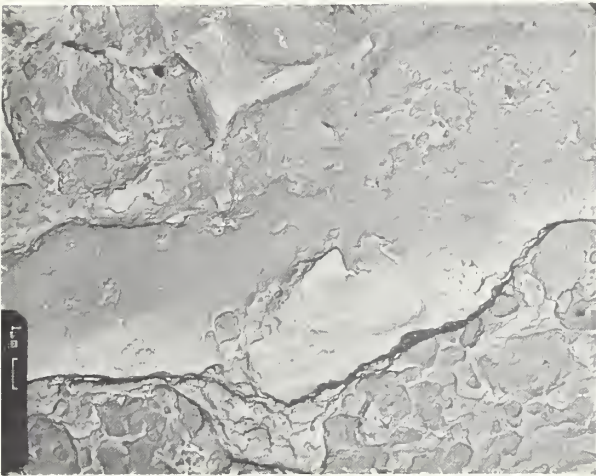
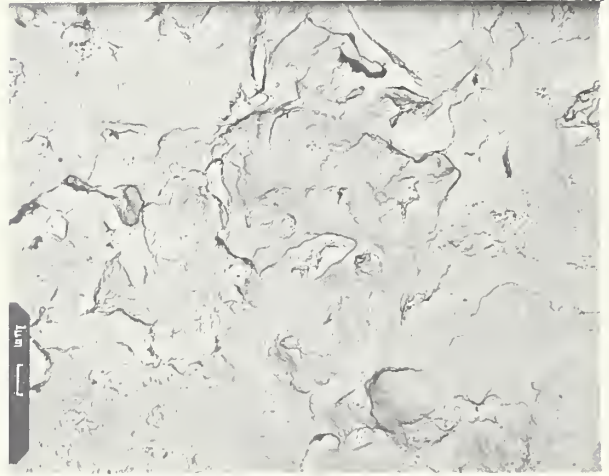
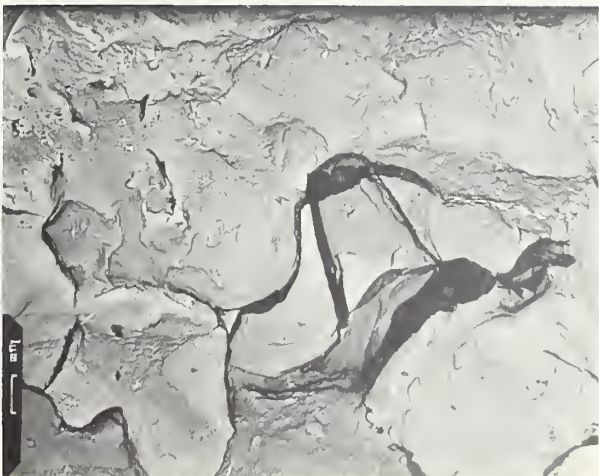
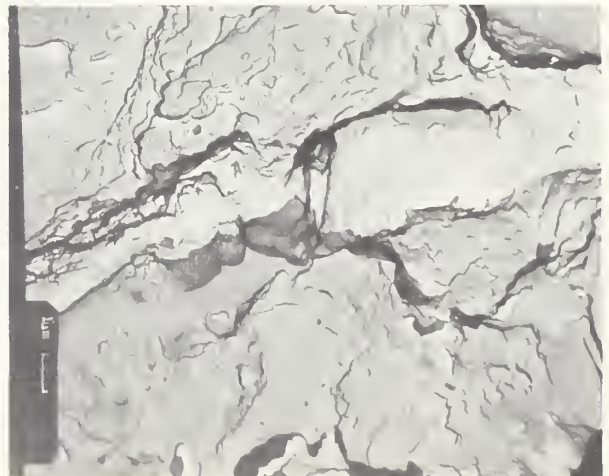
Fracture Section (1-3)

The surface of fracture section (1-3) was coated in places by a dark brown debris. This was removed by successive cleaning replicas until a clean metal surface in the area of interest was obtained. The outside exposed surface in the area of the fillet is shown in Figs. 11a and b. Identification of the lamellar structure is unknown. (It may be the partially corroded anodized coating). The fillet edge of the fracture is shown in Figs. 11c, d, e. Severe corrosion or oxidization has changed the surface and altered the original fracture surface features. A smaller amount of surface corrosion appears to have occurred on the areas shown in Figs. 11g and 11h. This surface area was approximately 1 mm distant from the fillet edge and appears to retain some of the original fracture topography. At a distance of 1.5 mm the surface appears as in Figs. 11k and 11l. Little or no corrosion is noted and the small amount of dimpled rupture is evident.

2. There is a possibility that a stress corrosion crack approximately 1.5 mm deep and of unknown length may have existed in section (1-3) prior to final overload failure.

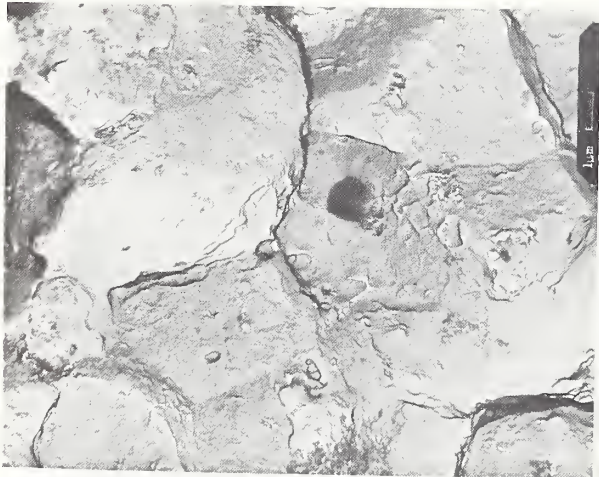
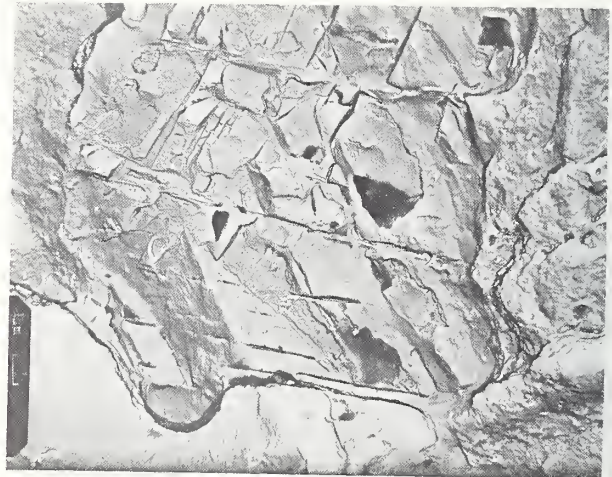
Fracture Surface #4

Fracture #4 was, by visual examination, similar to (1-3); that is, a flat semi lustre surface. The outside surface at the fillet is shown

in the upper left corner of Fig. 12a. The edge of fracture begins at the diagonal, progresses to lower right, and exhibits a flat surface with fine traces of corrosion. The large irregular shapes in Fig. 12b may be a thick oxide or surfaces which have been deeply corroded. A fine dimpled structure can be seen on all Figs. (a) through (f) indicating a low ductility fracture. An indication of intergranular fracture is shown in Fig. 12e. The mud crack pattern in Fig. 12f is probably the result of rapid corrosion of an exposed large second phase particle or an inclusion.

Fig. 12f. Corrosion on second phase, or inclusion.

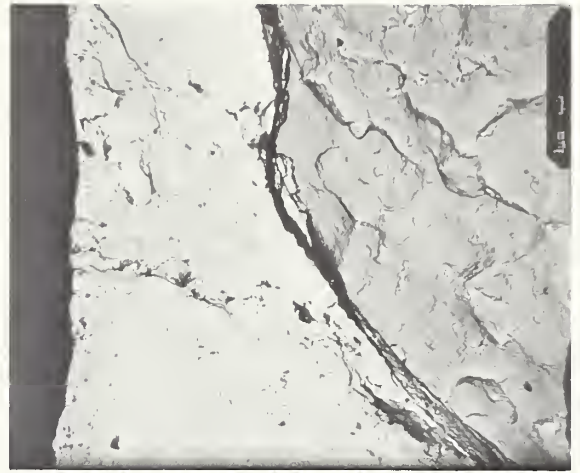
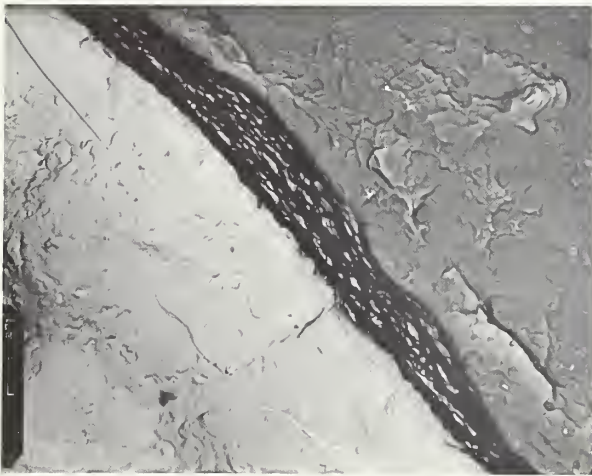
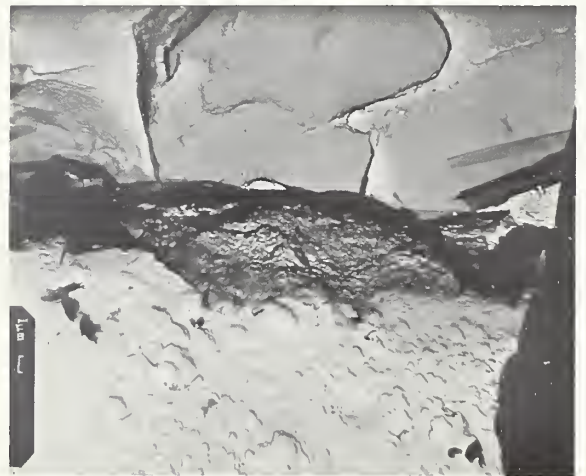
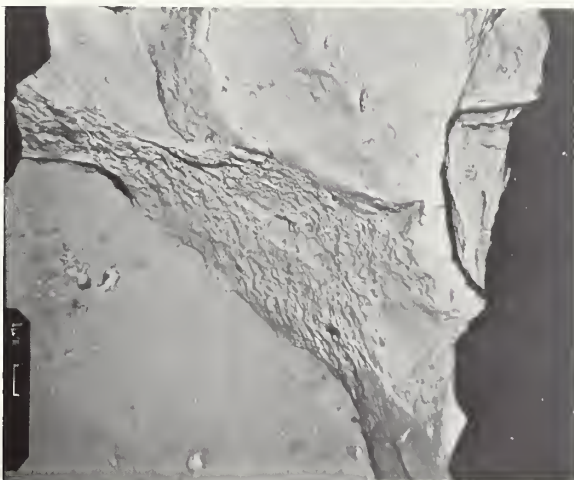
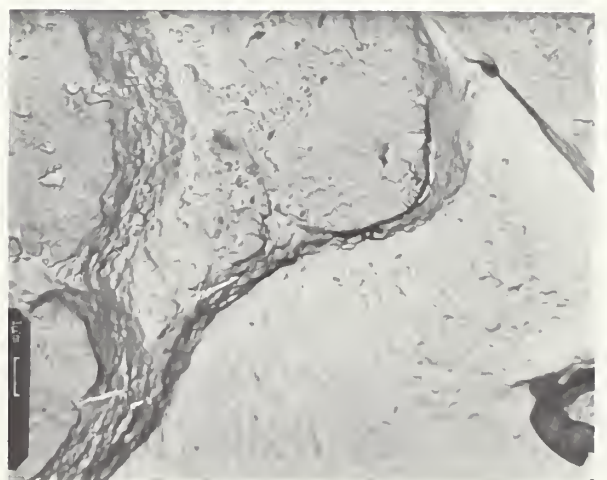
Fracture Surface #5

Macroexamination of fracture #5 revealed the presence of a small flat brittle region between the fillet and the fibrous woody fracture surface. Fractographs of this flat area and part of the outside surface are shown in Figs. 13a through 13e. Two small areas of corrosion are noted at arrows, these are adjacent to smooth areas which extend to the outside surface. This may indicate the presence of a pre-existing stress corrosion crack before overload. A steep sloping step is also noted by a dark band that extends through the center of the photographs and connects the fillet edge with the flat fracture. This may indicate the fracture initiated by shear failure in these areas. Fig. 13f is typical of the fracture surface away from the edge. The fracture is transgranular with a small amount of dimpled rupture and few small areas of initial corrosion.

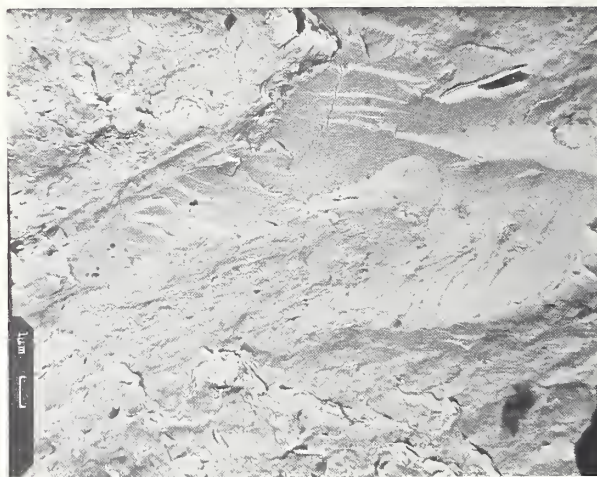
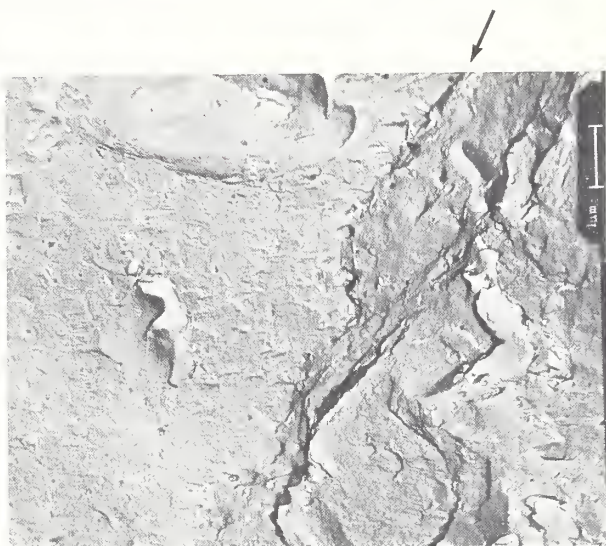
Figure 14b is an example of cleavage at the fracture edge as compared with low ductility shear in Fig. 14c. Cleavage and evidence of corrosion can be seen in Figs. 14d and 14e. Evidence of mud cracks can be noted in both Figs. 14e and f. In Fig. 14f the prior fracture surface details have been covered or removed by corrosion or oxidization.
