NBS MONOGRAPH 158

Corrosion and Protection of Steel Piles in a Natural Seawater Environment

This report describes the first eight years of a long term program in which twenty-three coating systems and five cathodic protection systems are evaluated on their ability to protect steel piles in offshore conditions. These systems are made up of nonmetallic coatings, metallic pigmented coatings, nonmetallic coatings on metal filled coatings, nonmetallic coatings on metallic coatings, metallic coatings, and cathodic protection on bare and coated piles.

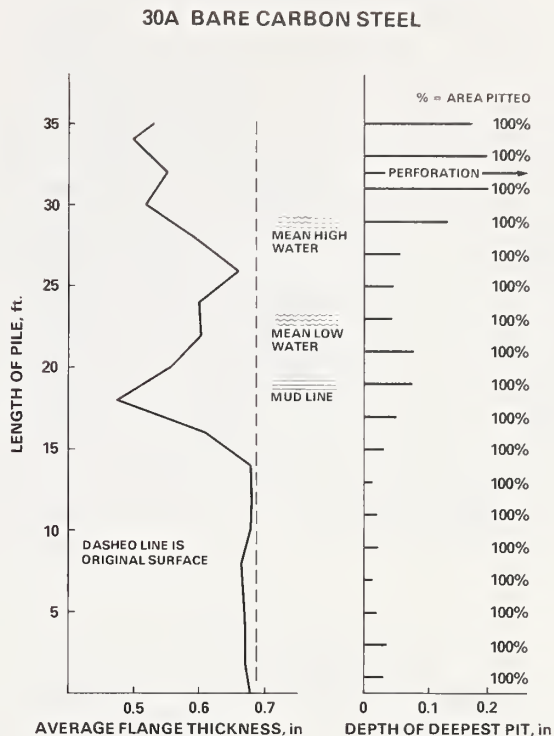
FIGURE 7

Specimen 30A is practically identical in behavior to 1A as illustrated in figure 7. This figure also displays data on the deepest pits found along the length of the pile. This data indicates that a perforation of the pile developed at about the thirty-two foot level within the six years of exposure. This perforation occurred in the web which is the portion of the pile between the two outer flanges. Pitting

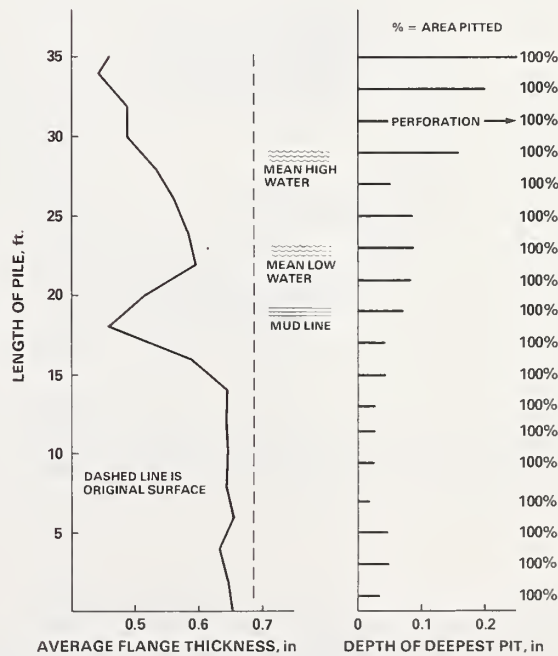
FIGURE 8

Figure 8 illustrates the corrosion deterioration observed on Specimen 31A. The bare carbon steel H-pile has developed more metal loss below the mud line than either 1A or 30A, and is of the order of 2 to 3 mils per year (10 to 15 mdd). Its pitting characteristics are very similar to those of 30A even to the perforation.

31A BARE CARBON STEEL

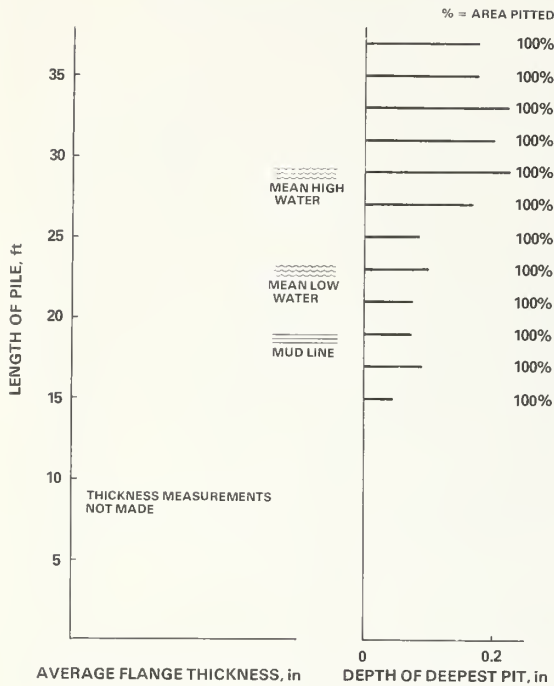
FIGURE 9

The bare pipe pile, 26A, developed pitting very similar to that found in the bare H-piles with the exception that pitting did not develop below the mud line (fig. 9). Electrochemical measurements were not made on this pile. However, measurements made on 26B indicate that the corrosion rate on the bare pipe piles is slightly higher (25%) than that of the H-piles. Because of the geometry of the pipe pile, thickness measurements could not be made.

26A BARE CARBON STEEL (PIPE)

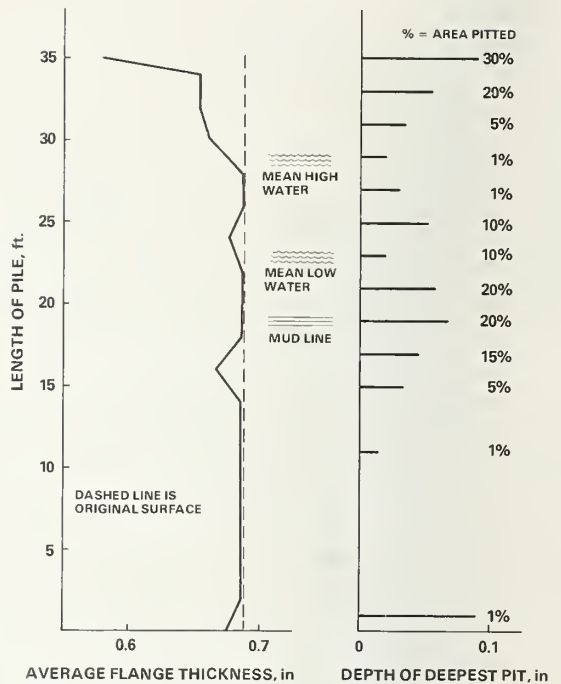
FIGURE 11

6A COAL TAR EPOXY

still has a coating effectiveness of 60 after five years of exposure. Figure 11 displays the average flange thickness of pile 6A with accompanying pitting. Specimen 6A is typical of the coal tar epoxies in that the greatest attack occurred above the high water line. The deepest pit in this region was less than 0.1 in (0.2 cm). Below the waterline, sand impingement in the erosion zone caused severe damage to the coating. In the atmospheric zone, undercutting of the windows in the coating system is difficult to appraise on this pile because of the extensive general failure of the coating as shown in figure 12. In the tidal zone, undercutting resistance is much improved, but general attack is still apparent (fig. 13). Below the mud line undercutting of the coating is minor. Mechanical damage to the coating during installation of the pile has caused most of the damage seen in figure 14.

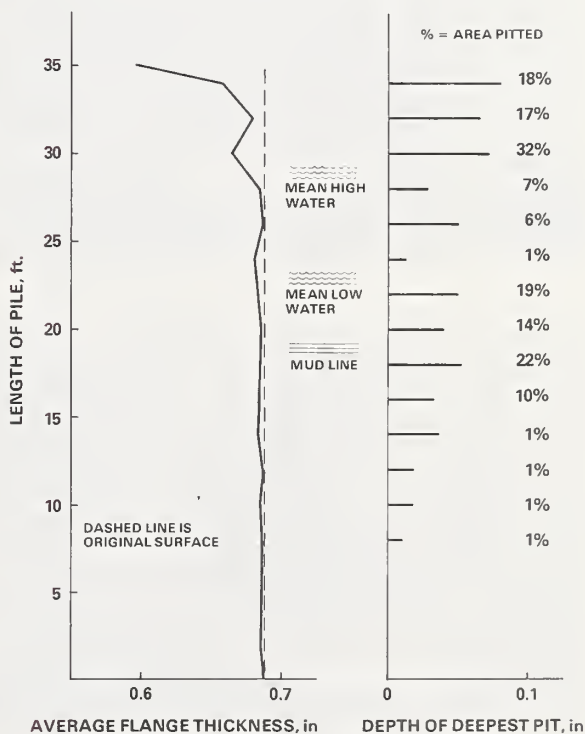
FIGURE 15

trochemical measurements. The physical measurements of these three piles are illustrated in figures 15, 16, and 17. The poor resistance of the coal tar epoxy coatings in the atmospheric and splash zones is well indicated in these drawings. Below the waterline, however, they have performed well. Pile 7A shown in figure 16 indicated that the armor coat did reduce the rate of coating deterioration in the erosion zone. Figure 18 is a photograph of the window in the atmospheric zone of pile 7A. Note the severe undercutting extending half the width of the pile. The window in the tidal zone, that zone between mean high water and mean low water, reveals only a slight amount of undercutting that extends 0.25 in (0.7 cm) as shown in figure 19. Pitting due to coating failure is evident. Below the mud line undercutting resistance is even better as shown in figure 20. Generally the coal tar epoxy looks good in this region.

4A COAL TAR EPOXY

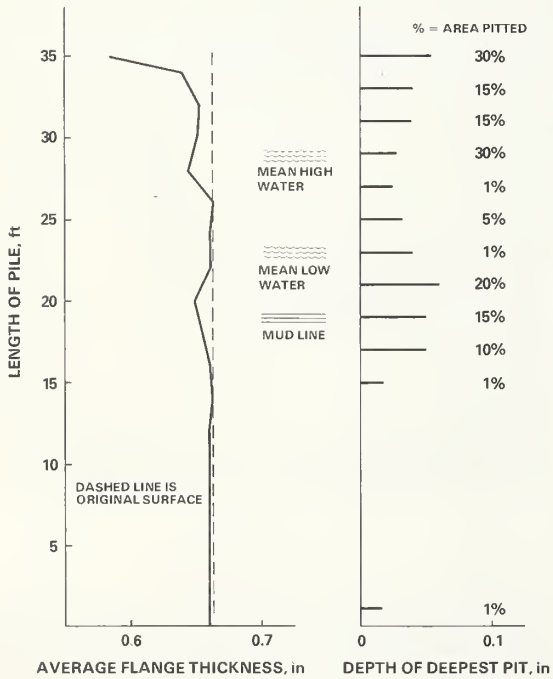
FIGURE 17

25A COAL TAR EPOXY ON MARINER STEEL

In the erosion zone, the coal tar epoxy on mariner steel, System 25, has not fared as well as the same coating on carbon steel (System 4A). Figure 17 indicates loss of metal at the flange in this area. Its pitting resistance below the mud line, however, is far better than any of the other similarly coated piles. Undercutting of the coating in the atmospheric zone is severe as illustrated in figure 24. Coating damage in the tidal zone is also very extensive (fig. 25). Below the mud line, however, figure 26 illustrates that the coal tar epoxy on mariner steel has not been undercut.

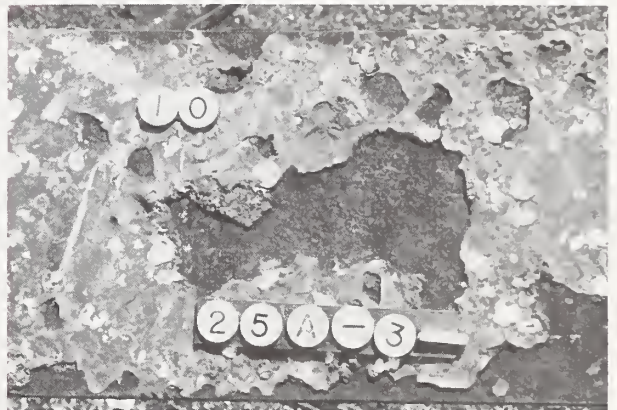
FIGURE 23

in the atmospheric zone of pile 4A is similar to that of 7A after six years of exposure as figure 21 shows. In the tidal zone, however, the window on 4A has undergone considerable damage not readily seen in figure 22. Undercutting in this area extends almost 1 in (2.5 cm) beneath the coating. General damage to the coating in the surrounding area is also apparent. Below the mud line the coating is in excellent condition with practically no undercutting as shown in figure 23.

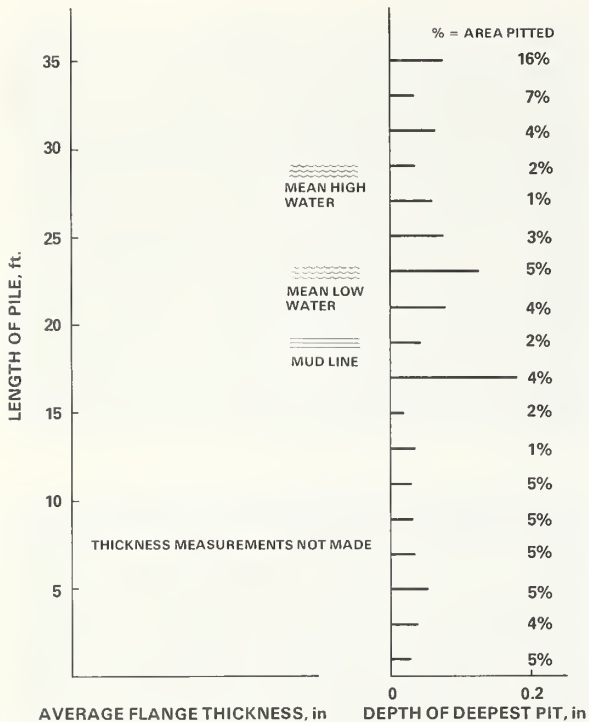
FIGURE 27

27A COAL TAR EPOXY (PIPE)

The physical measurements on the pipe piles consists only of pit depth measurements (figs. 27 and 28) as meaningful wall thickness measurements were not practical. These observations indicate that though there were fewer coating failures on the pipe piles, (% area pitted) as compared to the H-piles, the resulting pits were deeper on the pipe piles. The deepest pit in the erosion zone of 27A was almost 0.2 in (0.5 cm) deep. Undercutting of the coating on pile 27A extends about 2 in (5 cm) beyond the edge of the window as shown in figure 29, and is considered severe. In the tidal zone undercutting resistance is improved. Undercutting extends 0.5 in (1 cm) at the most (fig. 30). Figure 31 illustrates that below the

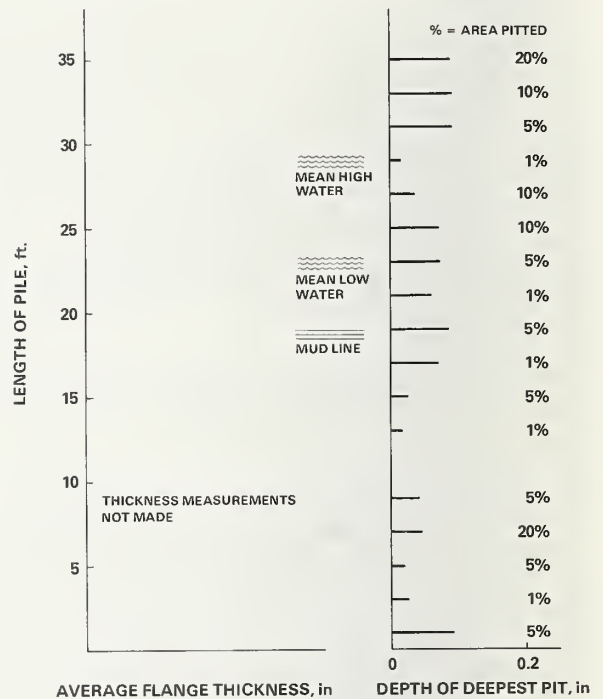
FIGURE 28

28A COAL TAR EPOXY WITH ARMOR (PIPE)

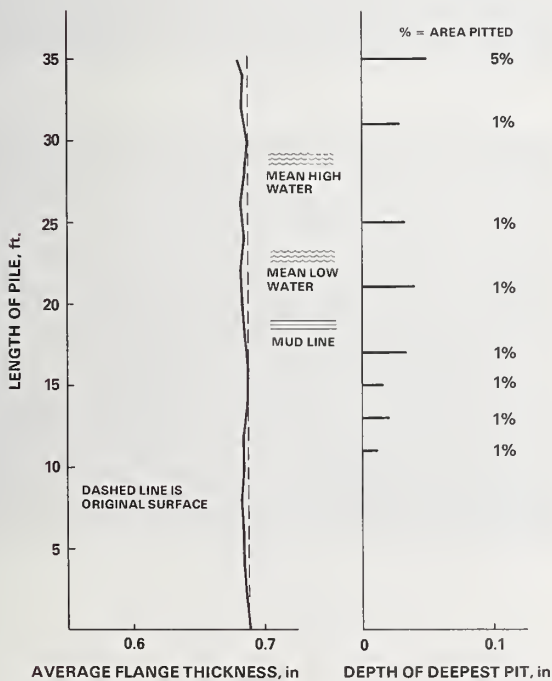
FIGURE 58

The physical measurements on System 18A are illustrated in figure 58. The deterioration of the steel pile has been slight. The coating system has performed well in all of the zones of exposure. Average corrosion rate for the pile has been less than 0.2 mils per year (1 mdd). In the atmospheric zone, damage of the coating at the window has been severe as shown in figure 59. Undercutting of the coating extends almost 2 in (5 cm) beyond the window. Undercutting of the coating in the tidal zone has been

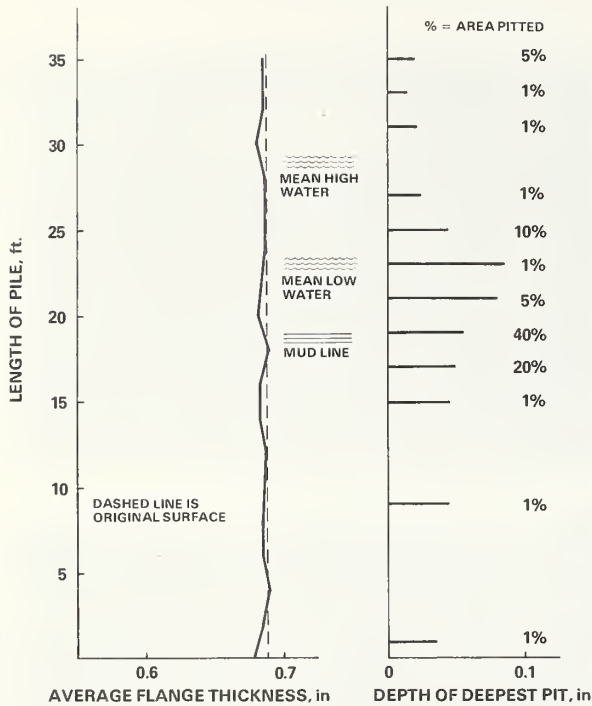
FIGURE 70

of both is slightly over 60. The physical measurement data for pile 19A is plotted in figure 70. Attack of the pile has been general over its length. However, there was more attack in the erosion zone than this data, taken 1 in (2.5 cm) from the edge, indicates. The corrosion extended from the 15-ft mark to the 20-ft mark on the inner surface of the flanges and 2 to 3 in from the edge. This attack is indicated by the pit depth measurements of figure 70. Its average corrosion rate is about 0.2 mils per year (1 mdd). Undercutting in the atmospheric zone shown in figure 71 extends less than 0.5 in (1.2 cm) beyond the window with some edge deterioration evident. General deterioration has been extensive in the tidal zone. Figure 72 is a photograph of the window in this region that reveals less than 0.1 in (0.2 cm) undercutting. Below the mud line undercutting was also less than 0.1 inches (0.2 cm) as shown in figure 73. The coating was damaged mechanically, but no undercutting was found under the surrounding encrustation.

19A VINYL/ ZN RICH INORGANIC

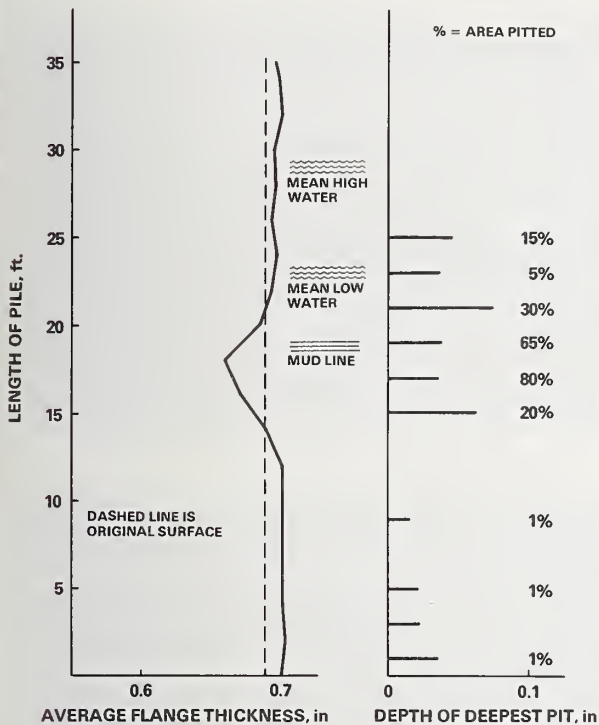
FIGURE 74

Pile 22A, vinyl mastic over inorganic zinc rich, has a relative coating effectiveness slightly above 60 after six years. The flange thickness measurements are illustrated in figure 74.

22A VINYL MASTIC / ZN RICH INORGANIC

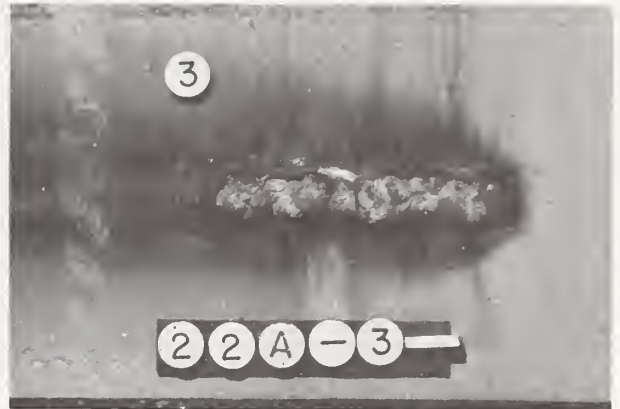
FIGURE 75

There is very little attack in the atmospheric zone. Undercutting in this area is less than 0.1 in (0.2 cm) as shown in figure 75. In the tidal zone general deterioration of the coating has taken place, but with very little actual metal loss. This is illustrated in figure 76. Undercutting here is also less than 0.1 in (0.2 cm). Below the mud line undercutting extends about 0.2 in (0.5 cm) beyond the window as figure 77 shows. Notice the blistering of the coating in the surrounding area. The overall average corrosion rate for pile 22A is less than 0.25 mils per year (1.4 mdd).

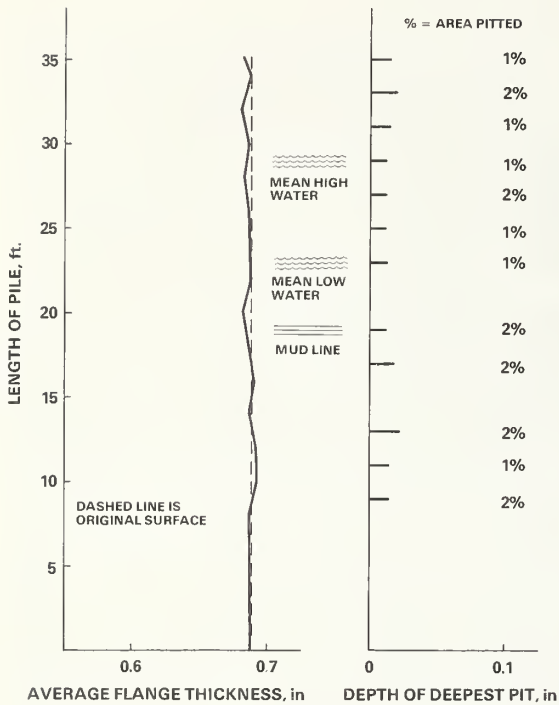
FIGURE 83

Pile 15A, polyvinylidene chloride over zinc flame spray, is unusual in that the electrochemical readings indicate that initially its coating effectiveness decreased as the non-metallic coating failed, but then the metallic zinc coating proceeded to provide protection. Consequently, the coating effectiveness of the system improved as illustrated in figure 78. Total coating effectiveness below the water line is well above 85. In general, the zinc seems to have developed some nonconducting film, probably an oxide, that has brought this improvement about. The average flange thickness measurements are plotted in figure 83. Total metal

15A POLYVINYLIDENE CHLORIDE/
ZINC FLAME SPRAY
