Case Study

U.S. Chemical Safety and Hazard Investigation Board

E.I. DuPont de Nemours & Co Inc.

Flammable Vapor Explosion

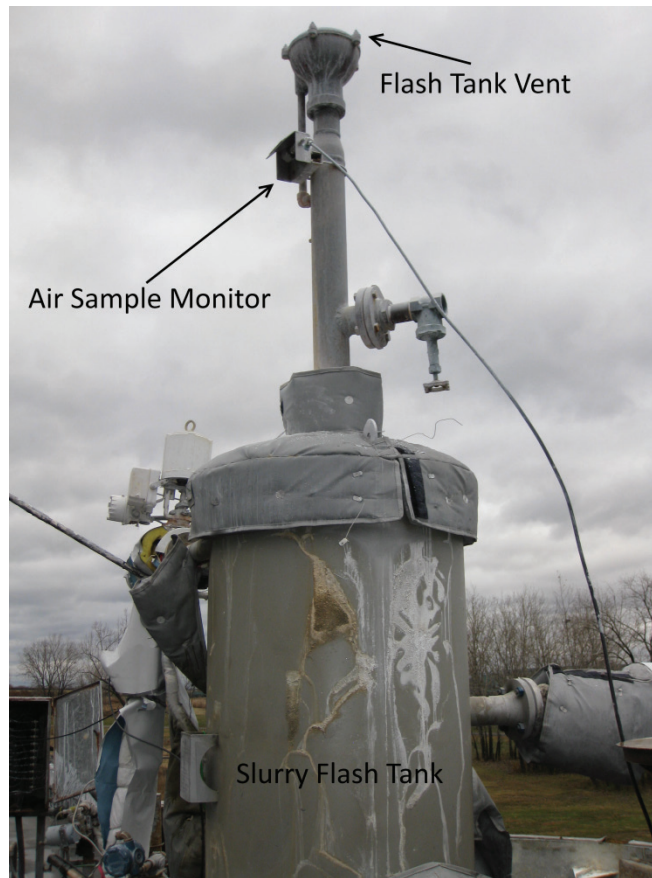
FIGURE 3

Slurry flash tank (left).
Agitator and open
manway on tank.
Second air monitor is
located on catwalk near
tank 3 (lower right).

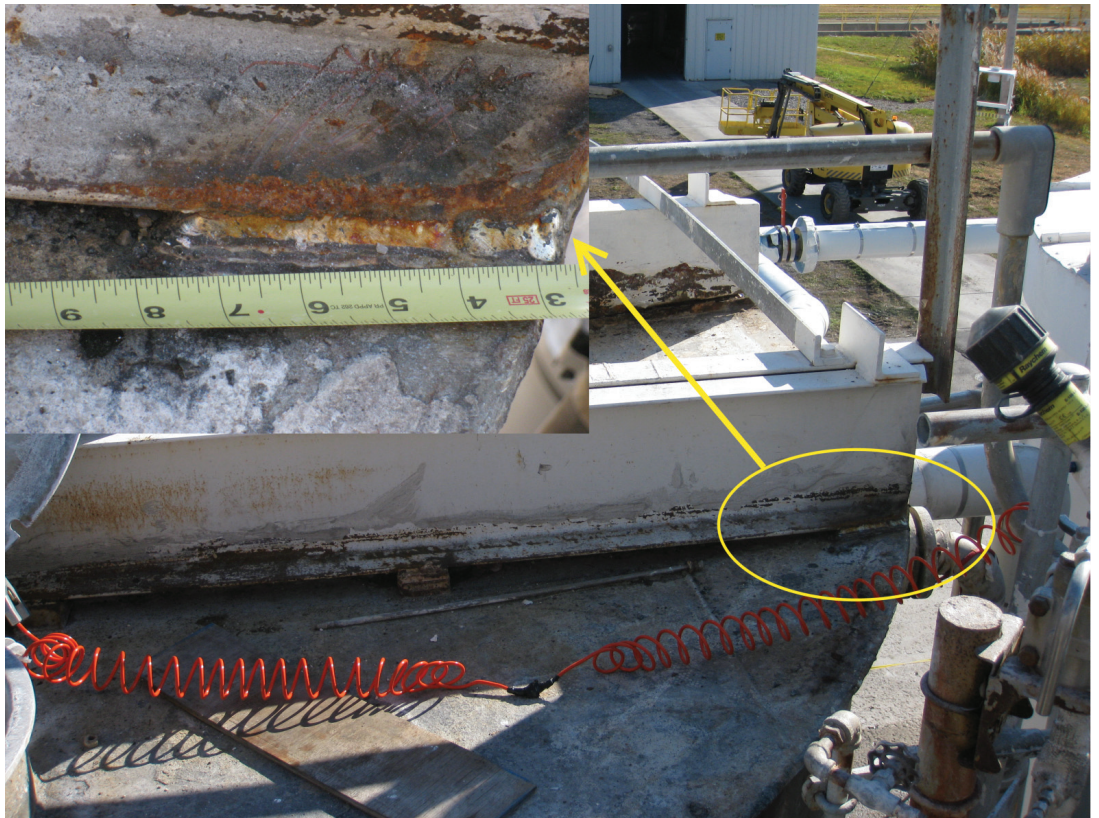
FIGURE 4.

Repair weld on agitator support beam to the slurry tank 2 top plate

support after the insulation was removed from the slurry tanks 1 and 2. A DuPont engineer wrote up a work order for the repair of the agitator supports and had the construction field engineer in charge of contractors begin writing a work scope and gather contractors and materials. DuPont hired Mollenberg-Betz to repair the agitator support based on the fact that they were already engaged in hot work on site and could be quickly made available.

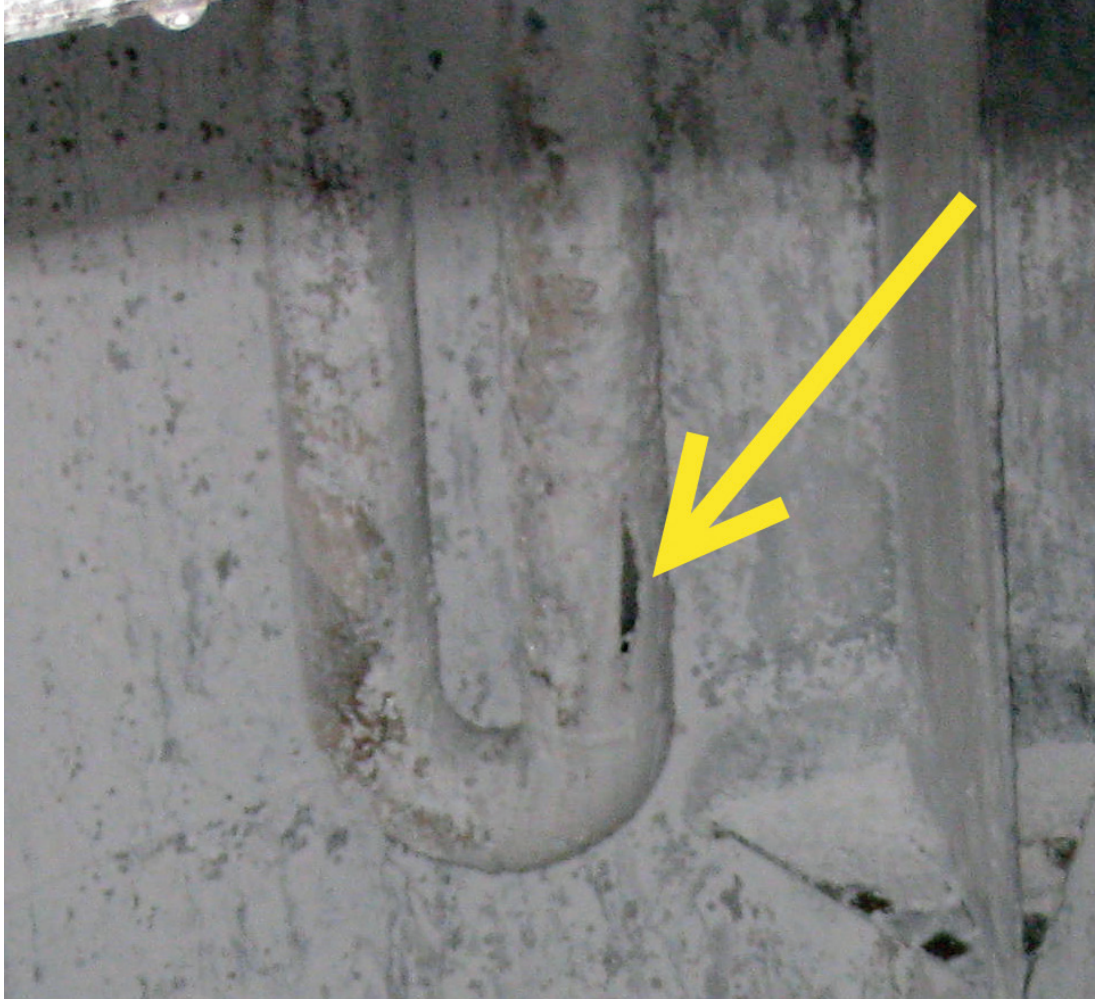
FIGURE 5.

During the tank 2 internal inspection on November 3, DuPont engineers discovered that the U-leg seal loop on the flash tank overflow line had a “fishmouth” split in the pipe (Figure 5), likely the result of the PVF water slurry freezing in the line. The engineers concluded that the slurry tank could be returned to service without repairing the split. DuPont engineers who saw the broken seal loop concluded its likely purpose was to limit steam in the flash tank from flowing into the slurry tanks. They further concluded that the operation was safe and that the broken seal loop presented no hazards. No acknowledgement was given to the fact that flammable VF gas had a pathway into the slurry tanks, an area classified as “low hazard” and not expected to contain any flammable materials. DuPont engineers scheduled a repair on this seal loop during the next planned unit outage. No management of change (Section 4.7.2) was carried out for the process to continue with this compromised seal loop.

Fishmouth split on seal loop pipe inside tank 2

the flash tank had an open path to slurry tank 2 through the cracked seal loop. VF from the flash tank was the main source of flammables on the day of the incident.

After DuPont personnel noticed the cracked seal loop, DuPont technical engineers decided not to repair the loop until the next turn around. If DuPont had included the slurry tanks and slurry flash tank overflow line in their PSM program they would have been required to fix the cracked seal loop before restarting the unit or ensure that the cracked seal loop posed no safety hazard.
