[Docket No. 95-SW-06-AD]

Airworthiness Directives; Robinson Helicopter Company Model R22 Series Helicopters

ACTION: Notice of proposed rulemaking (NPRM).

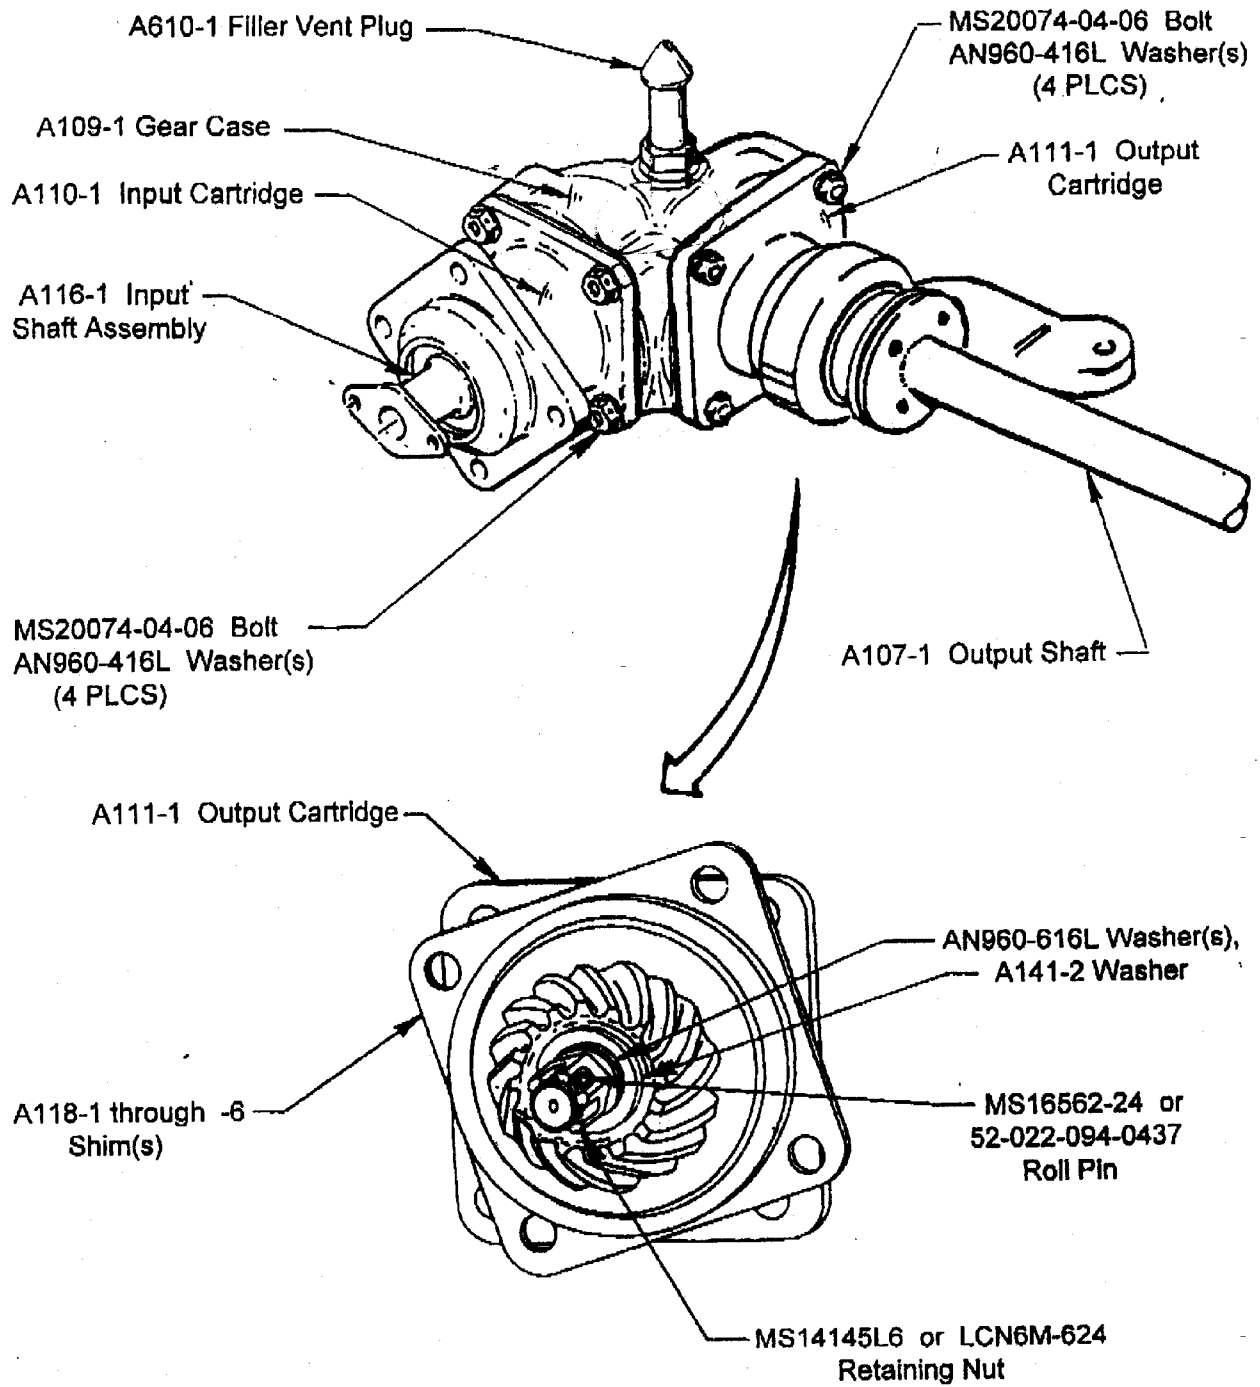
Figure 1

(ii) Cut and remove the safety wire around the four MS20074-04-06 bolts, securing the output cartridge to the gear case. Remove the four bolts and AN960-416L washer(s). Separate the output cartridge from the gear case (see figure 1).

(ii) Cut and remove the safety wire around the four MS20074-04-06 bolts securing the input cartridge to the gear case. Remove the four bolts and AN960-416L washer(s). Separate the input cartridge from the gear case (see figure 1).

(iii) Secure the input cartridge to a block of wood through the two bolt holes in the input shaft assembly, P/N A116-1 (see figure 1). Place the block of wood in a vise. Remove and discard the safety wire, roll pin, and retaining nut. Remove the AN960-616L washer(s), and washer, P/N A141-1, noting the washer(s) location for reassembly. Do not damage the input shaft or shim(s), P/N A118-1 through -6, located next to the flange of the input cartridge.

Note: The safety wire has been removed for clarity

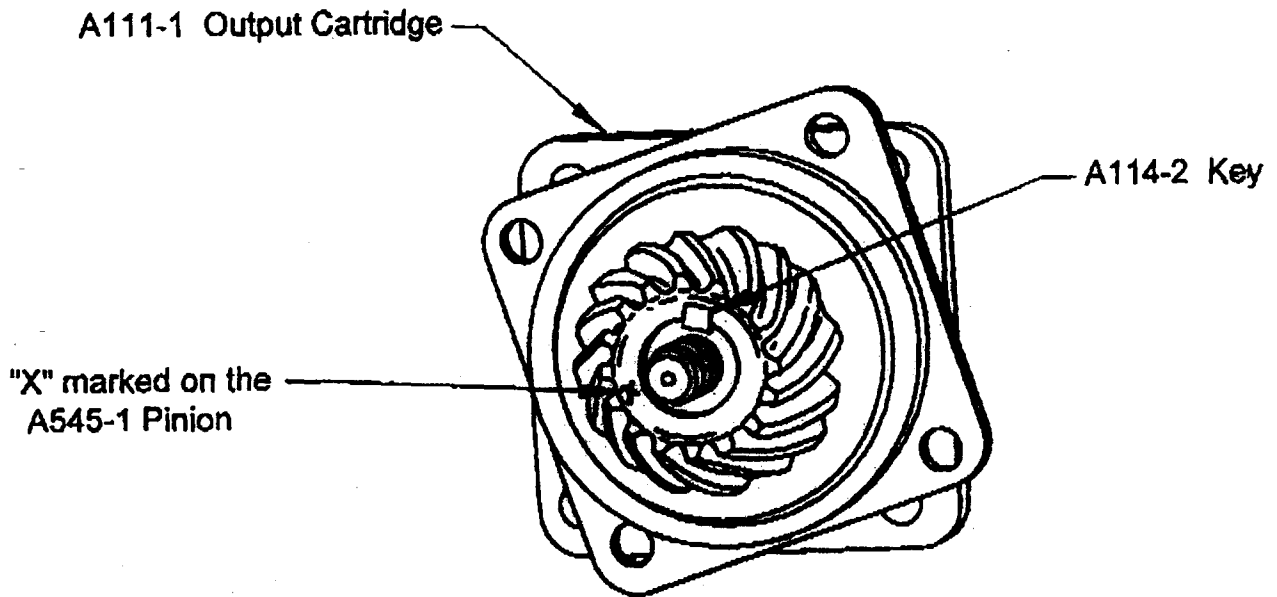
Figure 2

(iv) Visually inspect for the presence of the output shaft key, P/N A114-2, between the pinion gear, P/N A545-1, and the output shaft (see figure 2).

(iv) Visually inspect for the presence of the input shaft key, P/N A114-1, between the gear, P/N A545-2, and the input shaft (see Note on figure 2).

Note: The A114-1 Key for the A110-1 Input Cartridge is located similar to the A111-1 Output Cartridge depicted above

(v) If the output shaft key is missing, replace the T/R gearbox with an airworthy

(v) If the input shaft key is missing, replace the T/R gearbox with an airworthy one that has been determined to have the input key installed. Report any T/R gearbox that has a missing key within 10 days after the inspection to the Manager, Los Angeles Manufacturing Inspection District Office, FAA, Northwest Mountain Region, 3960 Paramount Blvd., Lakewood, California 90712, telephone (310) 627-5290, fax (310) 627-5293. Reporting requirements have been approved by the Office of Management and Budget, and assigned OMB control number 2120-0056.

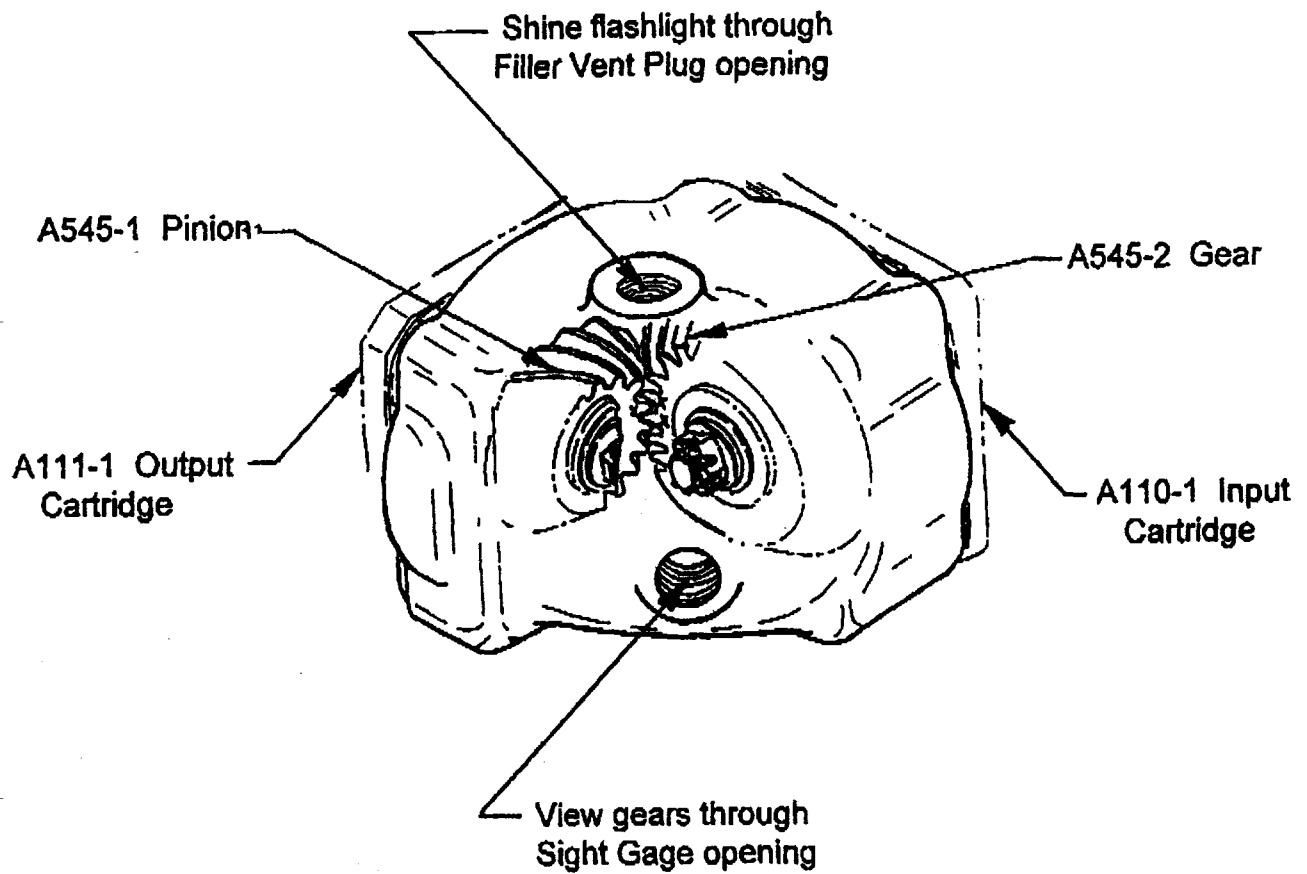
Figure 3

(i) Color the "X" marked on the pinion gear, P/N A545-1, (one tooth only) of the output cartridge and on the gear, P/N A545-2, (located on two consecutive teeth) of the input cartridge with a red marker to make reinstallation easier. Note that these three gear teeth may already be colored (see figure 3).

(v) Look through the sight gage opening while using a flashlight pointed into the filler vent hole to verify the gears are meshed properly. Gears are properly meshed when the "X" marked on the pinion gear of the output cartridge is between the two "X's" marked on the gear of the input cartridge (see figure 3). Do not torque the bolts until both cartridges are installed on the case and the gears are properly meshed. Torque the output cartridge first, then the input cartridge to 60 in.-lbs. Safety wire with 0.032-inch stainless steel safety wire.
