[Docket No. 93-CE-61-AD; Amendment 39-9386; AD 95-20-07]

Airworthiness Directives; The New Piper Aircraft, Inc. (Formerly Piper Aircraft Corporation) PA24, PA28R, PA30, PA32R, PA34, and PA39 Series Airplanes**AGENCY:** Federal Aviation Administration, DOT.**ACTION:** Final rule.

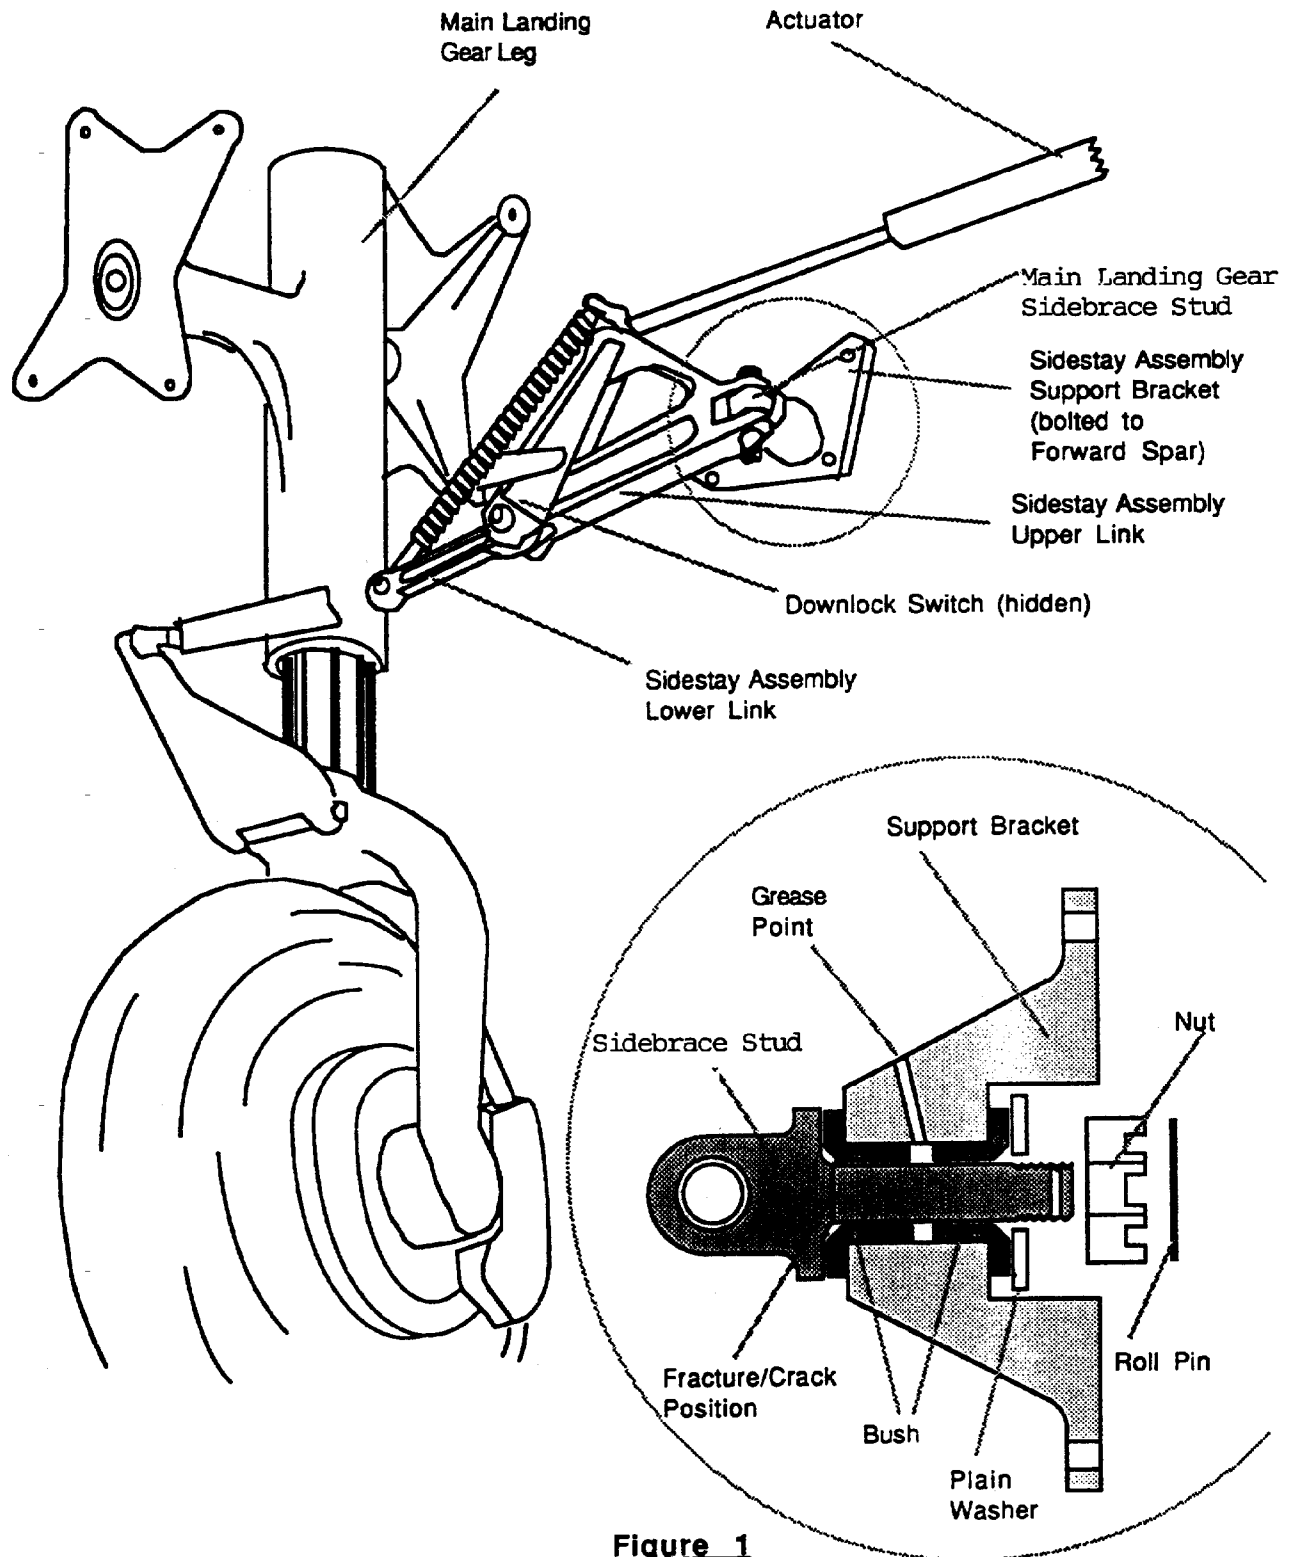
(a) Remove both the left and right main gear side brace studs from the airplane in accordance with the instructions contained in the Landing Gear section of the maintenance manual, and inspect each main gear side brace stud for cracks, using Type I (fluorescent) liquid penetrant or magnetic particle inspection methods. Inspections must be accomplished by a facility approved by the FAA to accomplish the applicable inspection method. Figure 1 of this AD depicts the area where the sidebrace stud is to be inspected.

Note: This figure is provided to depict the area of the sidebrace stud to be inspected. This is not intended to represent the configuration of all models affected.

(1) For any main gear side brace stud found cracked, prior to further flight, replace the cracked stud with an FAA-approved serviceable part (part numbers referenced in the table in paragraph (c) of this AD) in accordance with the instructions contained in the Landing Gear section of the applicable maintenance manual, and accomplish one of the following, as applicable:
