[Docket No. 95-SW-04-AD]

Airworthiness Directives; Societe Nationale Industrielle Aerospatiale and Eurocopter France Model AS 350B, BA, B1, B2, and D, and Model AS 355E, F, F1, F2, and N Helicopters

AGENCY: Federal Aviation Administration, DOT.
ACTION: Notice of proposed rulemaking (NPRM).

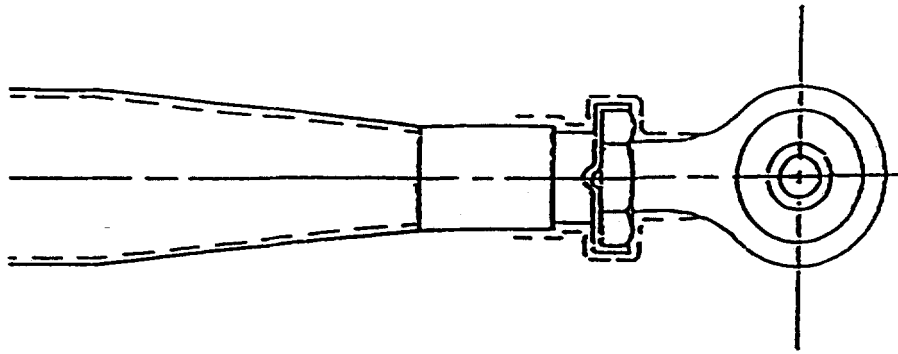
DETAIL 1

(a) Within 100 hours time-in-service (TIS) after the effective date of this AD, remove the forward lower fairing and visually inspect the cyclic pitch change control rod (rod), P/N 704A34-113-279, to determine whether the end fittings have been safetied (see Figure 1, Detail 1, tabs bent around the adjustment nut).

(b) If the visual inspection indicates that the rod end fittings have been safetied, reinstall the forward lower fairing.

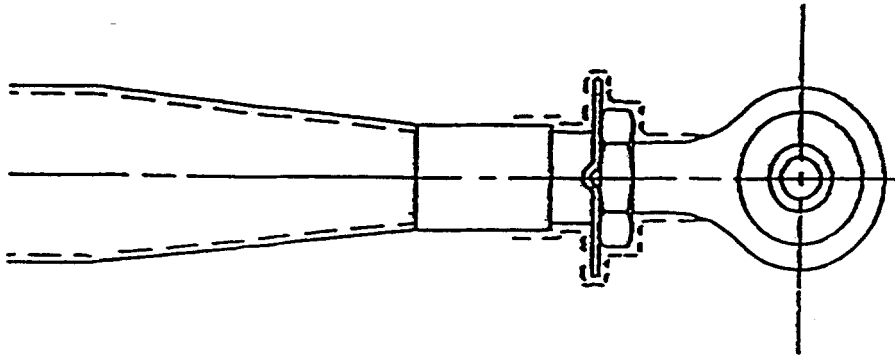
DETAIL 2

(c) If the visual inspection indicates that the rod end fittings have not been safetied (see Figure 1, Detail 2, tabs not bent around the adjustment nut), accomplish the following in accordance with the applicable maintenance manual:

(1) Immobilize the cyclic control.

(2) Remove the rod and replace it with an airworthy rod on which the rod end fittings have been safetied.

(3) Reinstall the forward lower fairing.

(4) Verify proper operation of the cyclic control.
