[Docket No. 96-CE-09-AD]

Airworthiness Directives; The New Piper Aircraft, Inc. PA-24, PA-28R, PA-30, PA-32R, PA-34, and PA-39 Series Airplanes

ACTION: Notice of proposed rulemaking (NPRM).

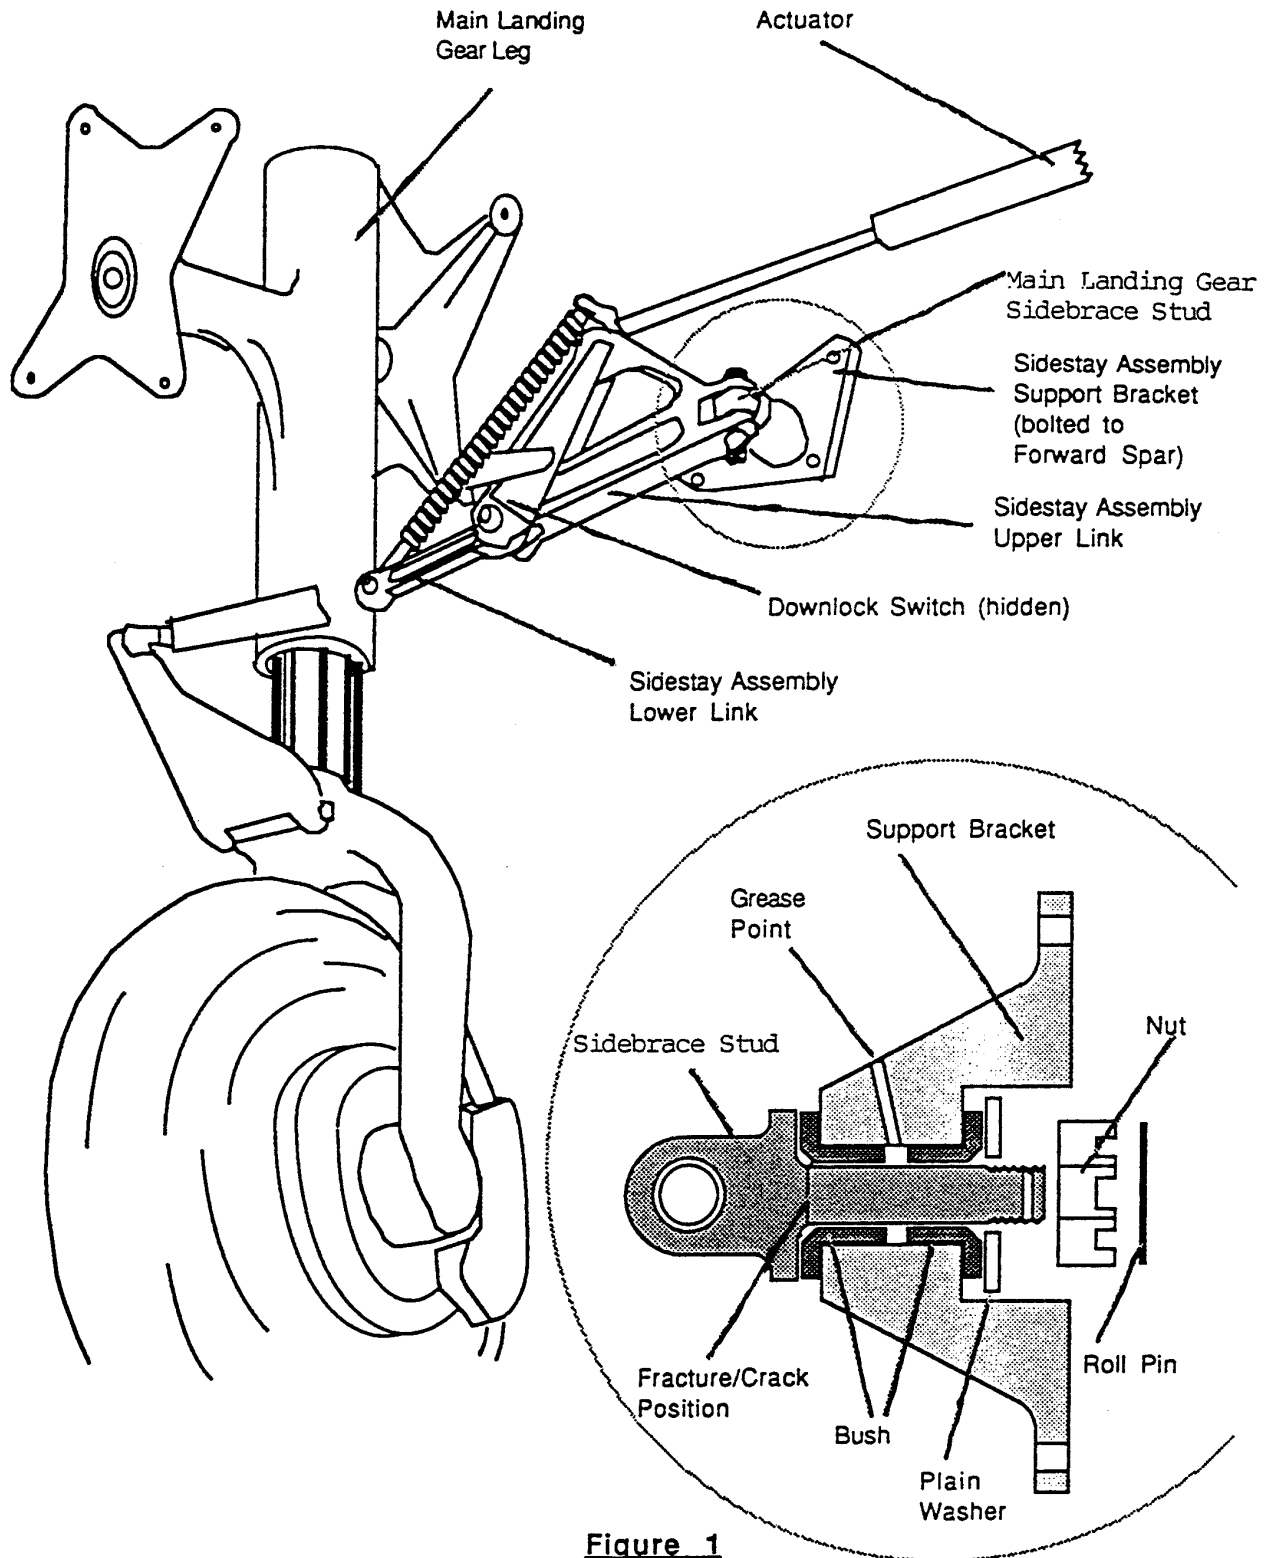
(a) Remove both the left and right main gear sidebrace studs from the airplane in accordance with the instructions contained in the Landing Gear section of the maintenance manual, and inspect each main gear sidebrace stud for cracks, using Type I (fluorescent) liquid penetrant or magnetic particle inspection methods. Figure 1 of this AD depicts the area of the sidebrace stud shank where the sidebrace stud is to be inspected.

Note: This figure is provided to depict the area of the sidebrace stud to be inspected. This is not intended to represent the configuration of all models affected.

(1) For any main gear sidebrace stud found cracked, prior to further flight, replace the cracked stud with an FAA-approved serviceable part (part numbers referenced in the table in paragraph (b) of this AD or FAA-approved equivalent part number) in accordance with the instructions contained in the Landing Gear section of the applicable maintenance manual, and accomplish one of the following, as applicable:
