[Docket No. 98-SW-24-AD; Amendment 39-10989; AD 98-12-30]

Airworthiness Directives; McDonnell Douglas Helicopter Systems Model MD-900 Helicopters

AD 98-12-30 McDonnell Douglas

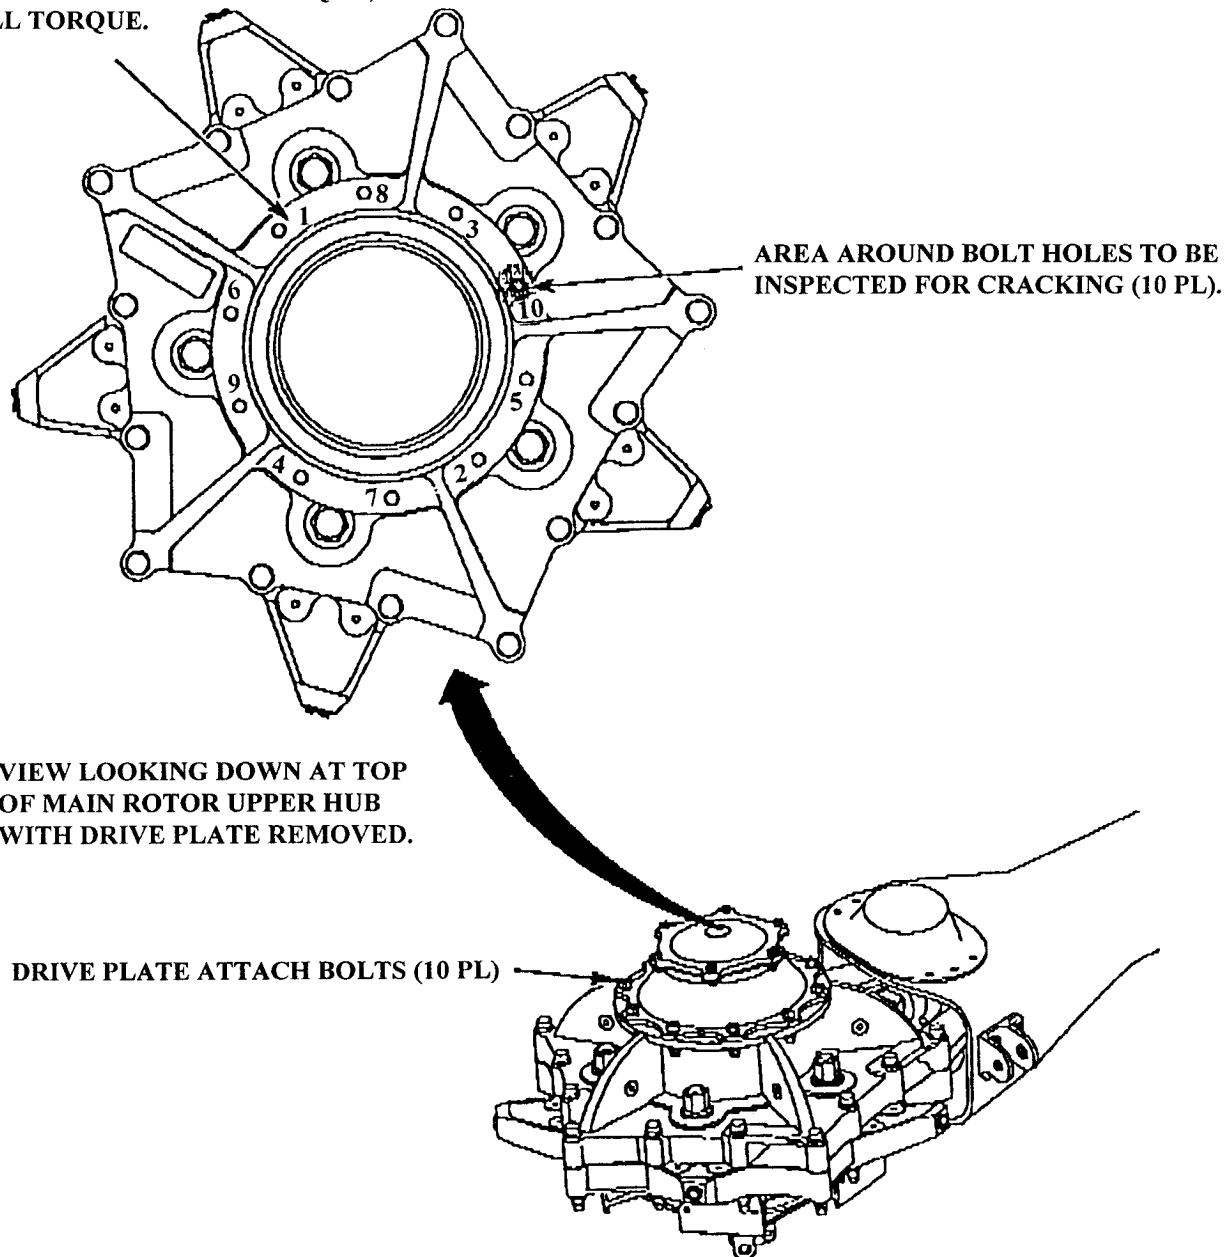
Figure 1. Main Rotor Upper Hub Assembly Inspection.

1. MAIN ROTOR DRIVE PLATE ATTACHMENT
HARDWARE TORQUE SEQUENCE.
2. NUMBERING MAY START AT ANY HOLE.
3. TORQUE NUTS TO 1/2 TOTAL TORQUE,
THEN FULL TORQUE.

(5) Using a 10-power or higher magnifying glass, inspect the area around the 10 bolt holes of the hub assembly for cracks. If a crack is found, replace the hub assembly with an airworthy hub assembly.

(2) Using an indelible marker, number the main rotor drive plate attachment fastener torque sequence on the drive plate (Figure 1).

(4) Using paint stripper (C313 or equivalent) and cleaning solvent (C420 or equivalent), remove the paint from the upper mating surface of the hub assembly to enable an accurate visual inspection of the drive plate attachment bolt hole (bolt hole) area for cracking (Figure 1). Ensure the paint stripper and solvent DO NOT contaminate the upper bearing and upper grease seal areas.

(7) Reinstall the main rotor drive plate using 10 new sets of replacement attachment hardware. Torque the nuts to 160-180 in.-lbs. above locknut locking/run-on torque in the sequence shown (Figure 1). Record in the rotorcraft log book the locknut locking/run-on torque for each nut.
