NBSIR 77-1241

Seismic Detection of Motor Vehicles

**Institute for Materials Research
National Bureau of Standards
Washington, D.C. 20234**

**U.S. Department of Transportation
Federal Highway Administration
Offices of Research and Development
Washington, D.C. 20234**

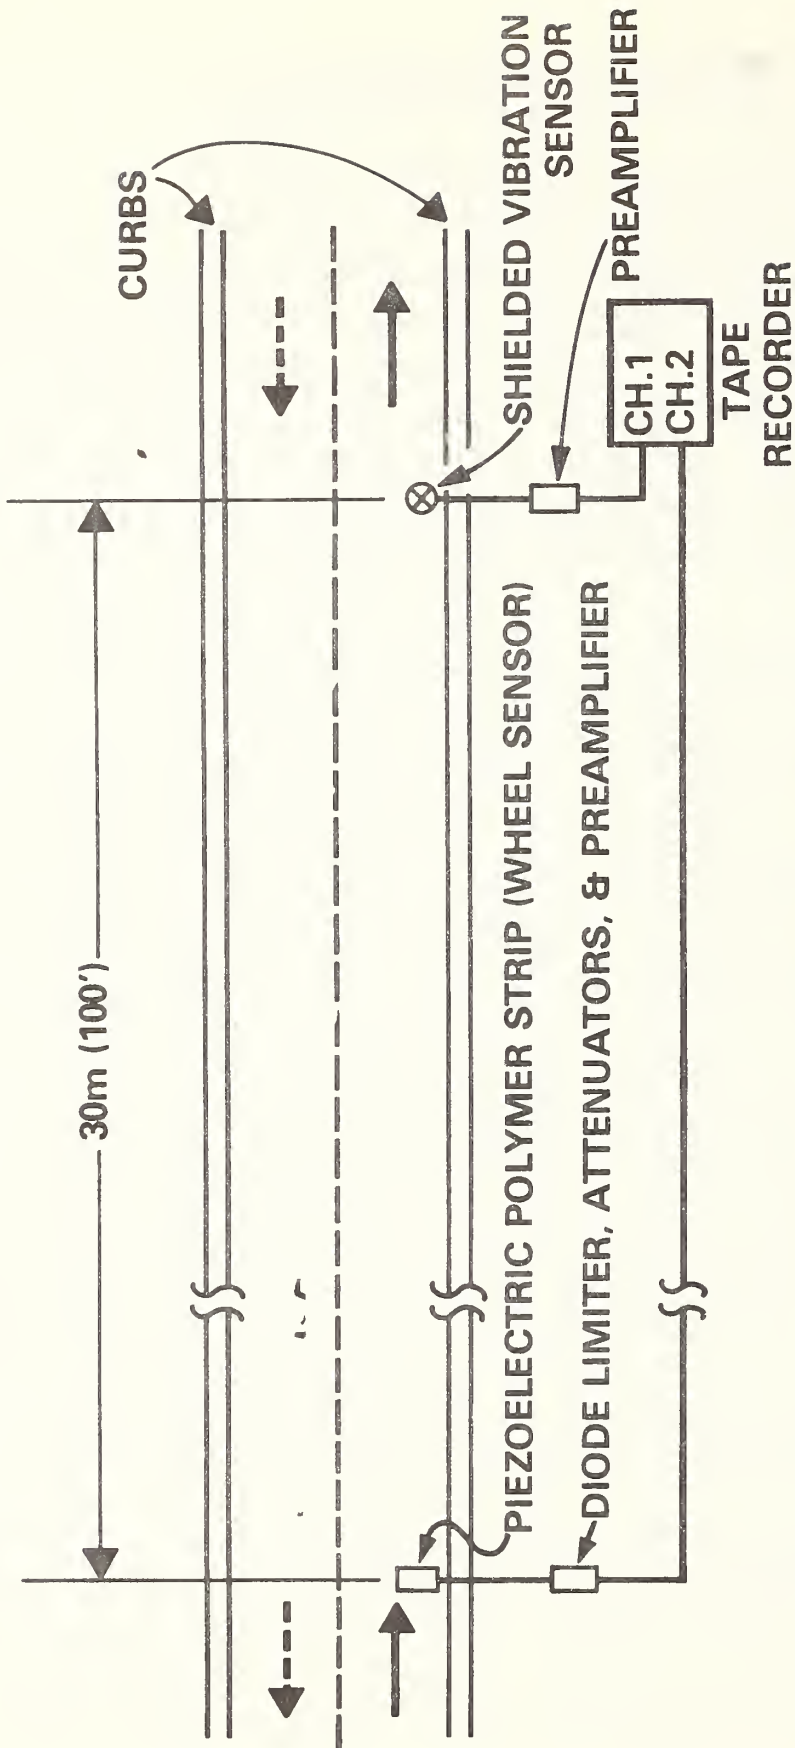
FIGURE 1. Set-up for single-vehicle (time-domain) road vibration measurements. Right wheels of vehicle (going from left to right in figure) passing over piezoelectric polymer strip generated a distinctive pair of narrow pulses, thereby recording when vehicle was 30 m (100') from sensor, and also permitting an estimation of average vehicle speed (see figure 2).

The right front and right rear wheels of a vehicle passing over the piezoelectric strip generated two very sharp pulses. (Diode limiters and cascaded attenuators were used to protect the preamplifier.) As may be seen from the lower traces in figure 2, these pulses are quite distinctive. The important thing to note in these oscillograms is that the road vibrations, shown in the top traces, exhibit an amplitude distinctly above the noise levels (approximated at the far left of the top trace) in the region where the wheel-spikes occur, thus demonstrating that the vehicle was detectable at the 30 metre distance.

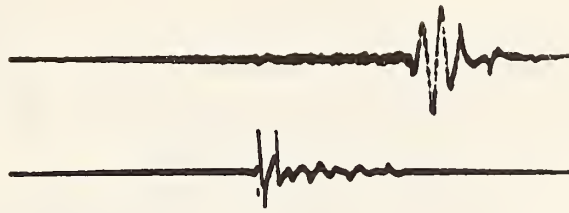
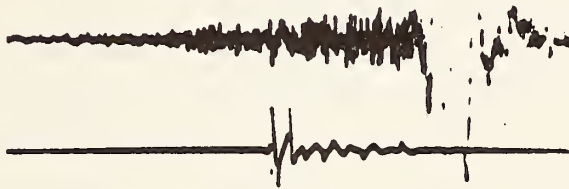
(a) Low gain for ceramic sensor output (top trace) shows passby transient at its highest amplitude.

(b) High gain for ceramic sensor output shows that transient is above noise level (left-most part of top trace) when vehicle is more than 30 metres from ceramic sensor, indicated by pair of narrow wheel spikes in the output of the piezoelectric polymer strip at this distance (bottom trace).

FIGURE 2. Typical time domain recording of single vehicle passby on undivided AC* secondary road (on NBS grounds). Top trace in each photo is output of shielded ceramic sensor; bottom trace is output of piezoelectric polymer strip 30 metres from ceramic sensor passed over by right wheels of vehicle. Vertical scaling is arbitrary; horizontal scale is 0-10 seconds (1 second per major horizontal division) due to 10:1 increase in tape speed on playback. Estimated speed of vehicle is 33 km/h (21 mph).

From an analysis of the oscillograms of 13 single-vehicle passbys, it was estimated that in 9 of these the signal was perceptibly above the noise level just before the front wheels of the vehicle passed over the piezoelectric polymer strip. Average vehicle speeds over the 30 metre distance were estimated from the separation between the leading (front wheel) voltage spike and the apparent peak of the vibration transient envelope detected by the ceramic sensor. (A second piezoelectric polymer strip could have been used to more precisely mark the moment the vehicle passed opposite the ceramic sensor.) Average vehicle speeds ranged from an estimated 16 to 18 km/h (10 to 11 mph) (which produced a poorly defined transient envelope) to 73 km/h (45 mph) for two vehicles. Average speed for the 13 vehicles was 44 km/h (27 mph). Four vehicles had an average speed over 50 km/h (30 mph), all of which were judged easily detectable at 30 metres or more. Of the four vehicles judged not detectable (or questionable), two were the slowest. Of the seven vehicles with speeds of 33 km/h (21 mph) or over but less than 50 km/h (30 mph), five were judged detectable

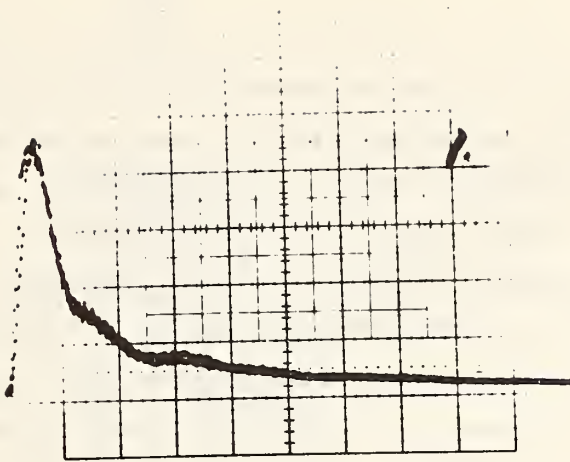
FIGURE 3. Average spectra, 0-50 Hz (5 Hz per major horizontal division). Noise match between channels. With no sensor at the input of either channel, the channel noise levels were matched to the degree shown. The sensor impedance is assumed to be sufficiently high at these frequencies as to have negligible effect. On this and all following spectrograms, the vertical deflection is linear with voltage; vertical scaling is arbitrary, but signal processing is identical for both channels. Horizontal scaling is linear with frequency. All spectra shown are average, covering very many individual spectra and many vehicle passbys.

The next stage was to attempt a frequency analysis of the signal in order to determine the passband requirements for a seismic switch. After considerable effort had been expended in capturing passby transients in the spectrum analyzer and matching their spectra with time-domain oscillograms, it was found that the observed spectral structure was poorly defined, and was not reproducible from one passby to another. Most importantly, it was not feasible to obtain a spectrum from only that part of the transient when the vehicle was at a distance from the sensor. It was found, however, that distinctive and reproducible vehicle vibration spectra could be built up to significant amplitude by spectrum averaging -- a valuable feature of the analyzer used. To separate useful signal (sensor output) from instrumentation noise, channel 2 of the recorder was used as a noise reference, matching that of channel 1, which was used for the sensor signal, as shown in figure 3 where the small separation between traces is due to slightly greater noise from the reference channel. Of four available preamplifiers, two were chosen which by adjustment of channel gain matching pots (provided in the preamplifier-to-recorder adaptors to compensate for microphone sensitivity differences) would allow the closest match of instrument noise between channels at the record-gain setting commonly used. Spectral analysis of the channel 2 "reference noise" was made from each length of tape from which a channel 1 signal analysis had been made. A dual averager memory in the spectrum analyzer allowed both spectra to be stored. They could then be photographed together by double exposure while being alternately displayed on an oscilloscope (the preferable method) or by a single long exposure with the analyzer alternating the two spectra in rapid sequence.

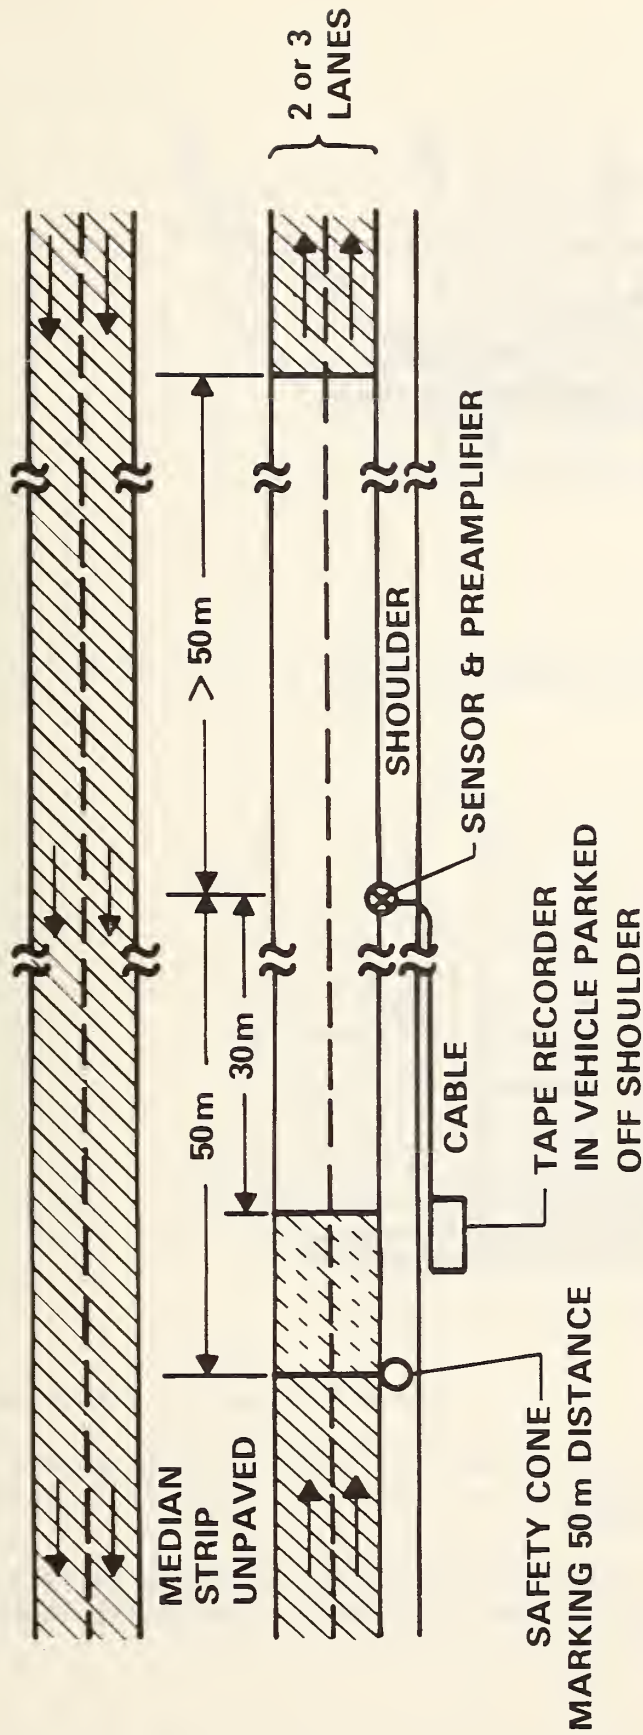
FIGURE 4. Set-up for multiple-vehicle (frequency domain) highway vibration measurements. For distant-spectra measurements (> 30 m or >50 m), tape recorder was stopped when any vehicle was within the unshaded area. Opposite lane traffic (beyond median strip) was disregarded; it was essentially continuous during all recordings, as simultaneous breaks in traffic in both directions were exceedingly rare.

The procedure used for most road vibration recordings was to connect the sensor and its preamplifier to the recorder with the 30 m cable previously mentioned, the sensor being down-traffic from the recorder, as shown in figure 4. The recorder was manned inside a vehicle parked just off the shoulder pavement of the road, from which position the tape could be rapidly stopped as vehicles passed opposite the car (initially) or (later) as they passed a safety cone set on the outer edge stripe of the nearest lane 50 m from the sensor. The tape was not restarted until the vehicles were at least those distances past the sensor, and with no others within \pm 50 m of the sensor. Recordings were also made with the recorder in continuous operation. The sensor was bonded to the pavement directly on the outer edge stripe of the nearest lane, which is the nominal "edge" of the pavement of the road proper. (While usually paved, the shoulders of the highways used were at a somewhat lower level or were paved with somewhat different appearing material.)

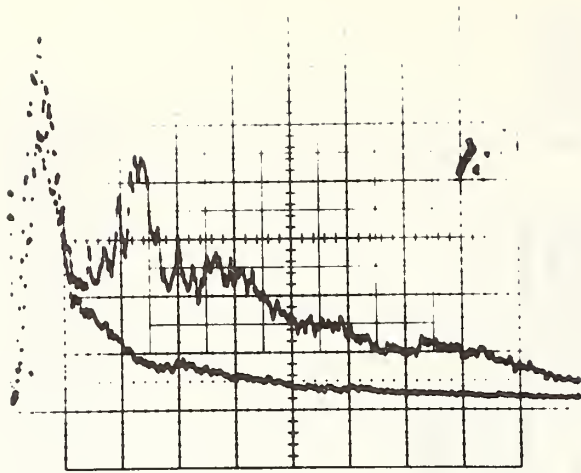
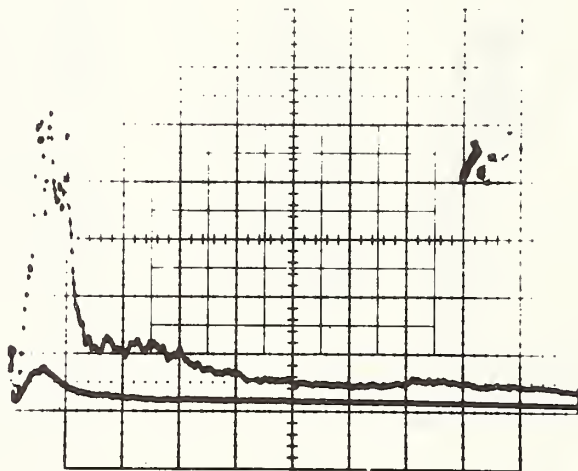
(a) Vehicles > 50 metres from sensor in either direction.

(b) Vehicles at all distances from sensor.

FIGURE 5. Average spectra, 0-50 Hz, from shielded ceramic sensor on divided segmented PCC* highway (MD-29). On these spectrograms, the bottom trace is the channel 2 reference noise.

Examples of the average frequency spectra obtained from highway pavements in various locations by the above technique are shown in figures 5 through 10. It may be seen from these spectra that the signal (represented by the gap between the upper and lower traces in figures 5 through 9) peaks in the vicinity of 15 Hz (12 to 17 Hz). Although differing in fine detail, the general shapes of the spectra from pavements of different material or construction are similar.

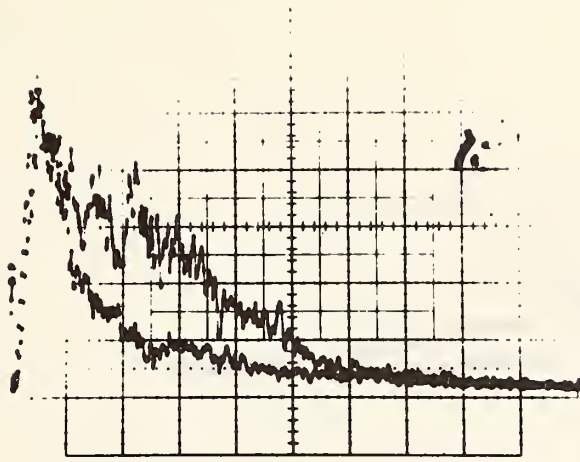
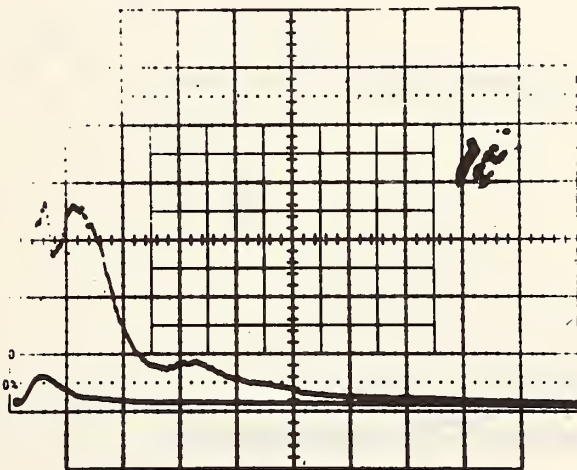
(a) Vehicles > 50 metres from sensor in either direction.

(b) Vehicles at all distances from sensor.

FIGURE 6. Average spectra, 0-50 Hz, from shielded ceramic sensor on divided unsegmented PCC* highway (I-95). On these spectrograms, the bottom trace is the channel 2 reference noise.

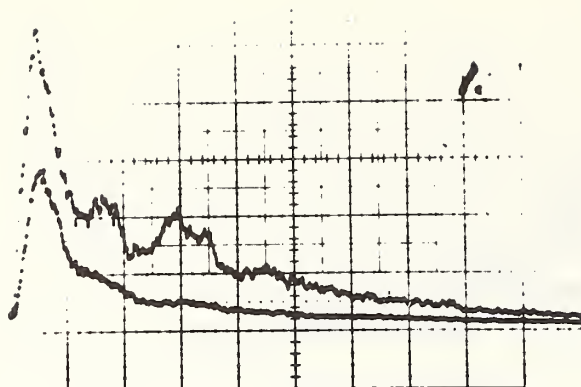
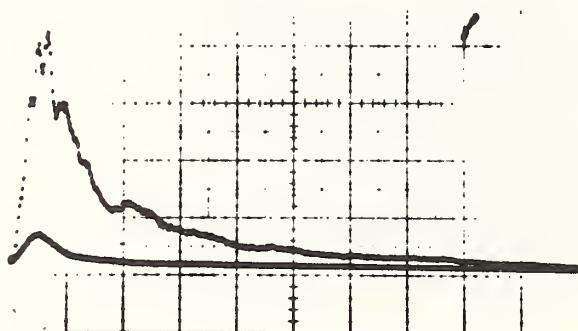
(a) Vehicles > 30 metres from sensor in either direction.

(b) Vehicles at all distances from sensor.

FIGURE 7. Average spectra, 0-50 Hz, from shielded ceramic sensor on divided AC* highway (I-270). On these spectrograms, the bottom trace is the channel 2 reference noise.

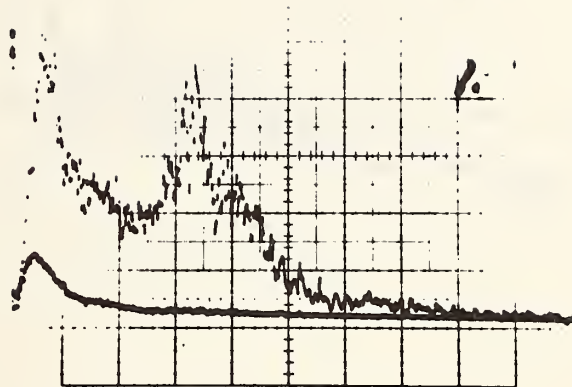
FIGURE 8. Average spectra, 0-50 Hz, from piezoelectric polymer sensor on segmented PCC* highway turnoff (unfinished extension of I-95). Vehicles > 30 metres from sensor in either direction. Rubber cement bond. On this spectrogram, the bottom trace is the channel 2 reference noise.

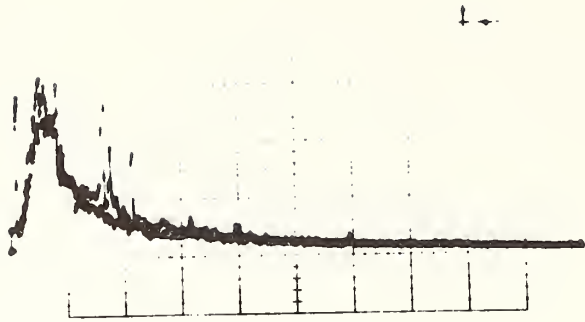
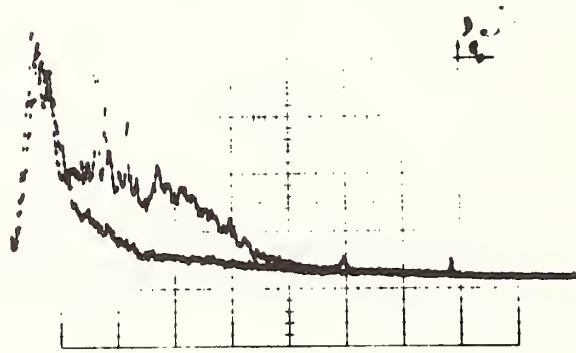
(a) No near vehicles in either direction, including opposite lane (on same pavement).

(b) Vehicles > 30 metres from sensor in either direction, including opposite lane.

FIGURE 9. Average spectra, 0-50 Hz, from shielded ceramic sensor on AC* secondary road (on NBS grounds). On these spectrograms, the bottom trace is the channel 2 reference noise.

The discrete spectral-lines in figure 9 demonstrate the possibility of false alarms due to seismic sources other than traffic or wind. Figure 10 indicates a high probability that the seismic switch would be activated by opposite-lane vehicles unless the threshold level for triggering was so high that the sensitivity to oncoming near-lane vehicles would be poor.

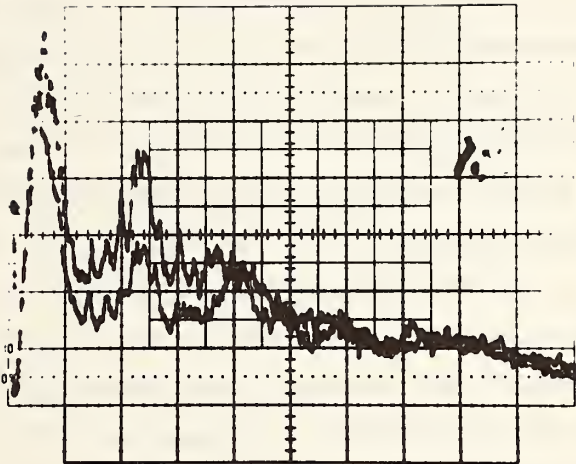
FIGURE 10. Average spectra, 0-50 Hz, from shielded ceramic sensor on divided segmented PCC* highway (MD-29). Top trace: vehicles > 50 metres from sensor in either direction; bottom trace: no close vehicles in either direction (except those in opposite lanes, in both cases, and for all other highway spectra).

Using the combination of a ceramic sensor (bonded to the asphalt pavement and shielded as it was during the vibration studies) and the electronic switch with the characteristics described above, set up as shown in figure 12, triggering could be made to reliably occur for single vehicles at or beyond the 50 m distance, a large percentage of which had speeds obviously below 50 km/h (30 mph). After a proper threshold level was established, there were almost no vehicle passbys that failed to trigger at this distance, none that failed to trigger at close to this distance, and very few false alarms. These tests were all made on the NBS grounds, and therefore did not indicate what the false alarm rate would be due to opposite-lane vehicles separated from the sensor by a median strip; that such false alarms can be expected to be quite high, however, is indicated by figure 10, but time did not permit verification of this.

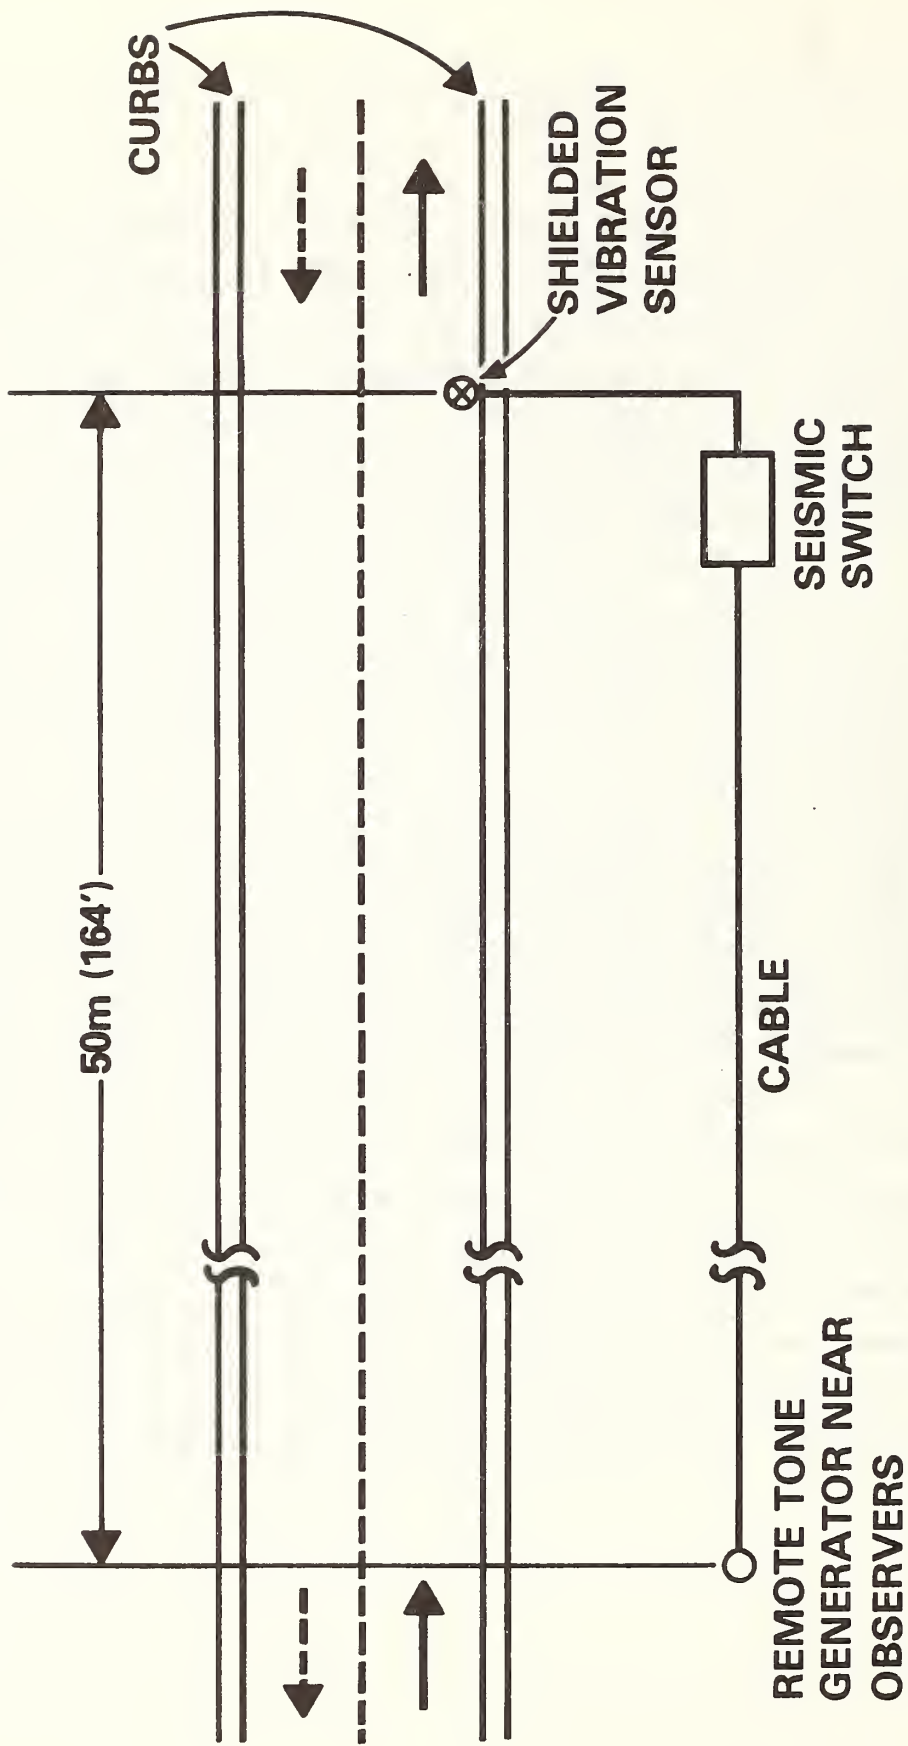
FIGURE 12. Set-up for testing seismic switch. Test utilized single-vehicle passbys (going from left to right in figure).

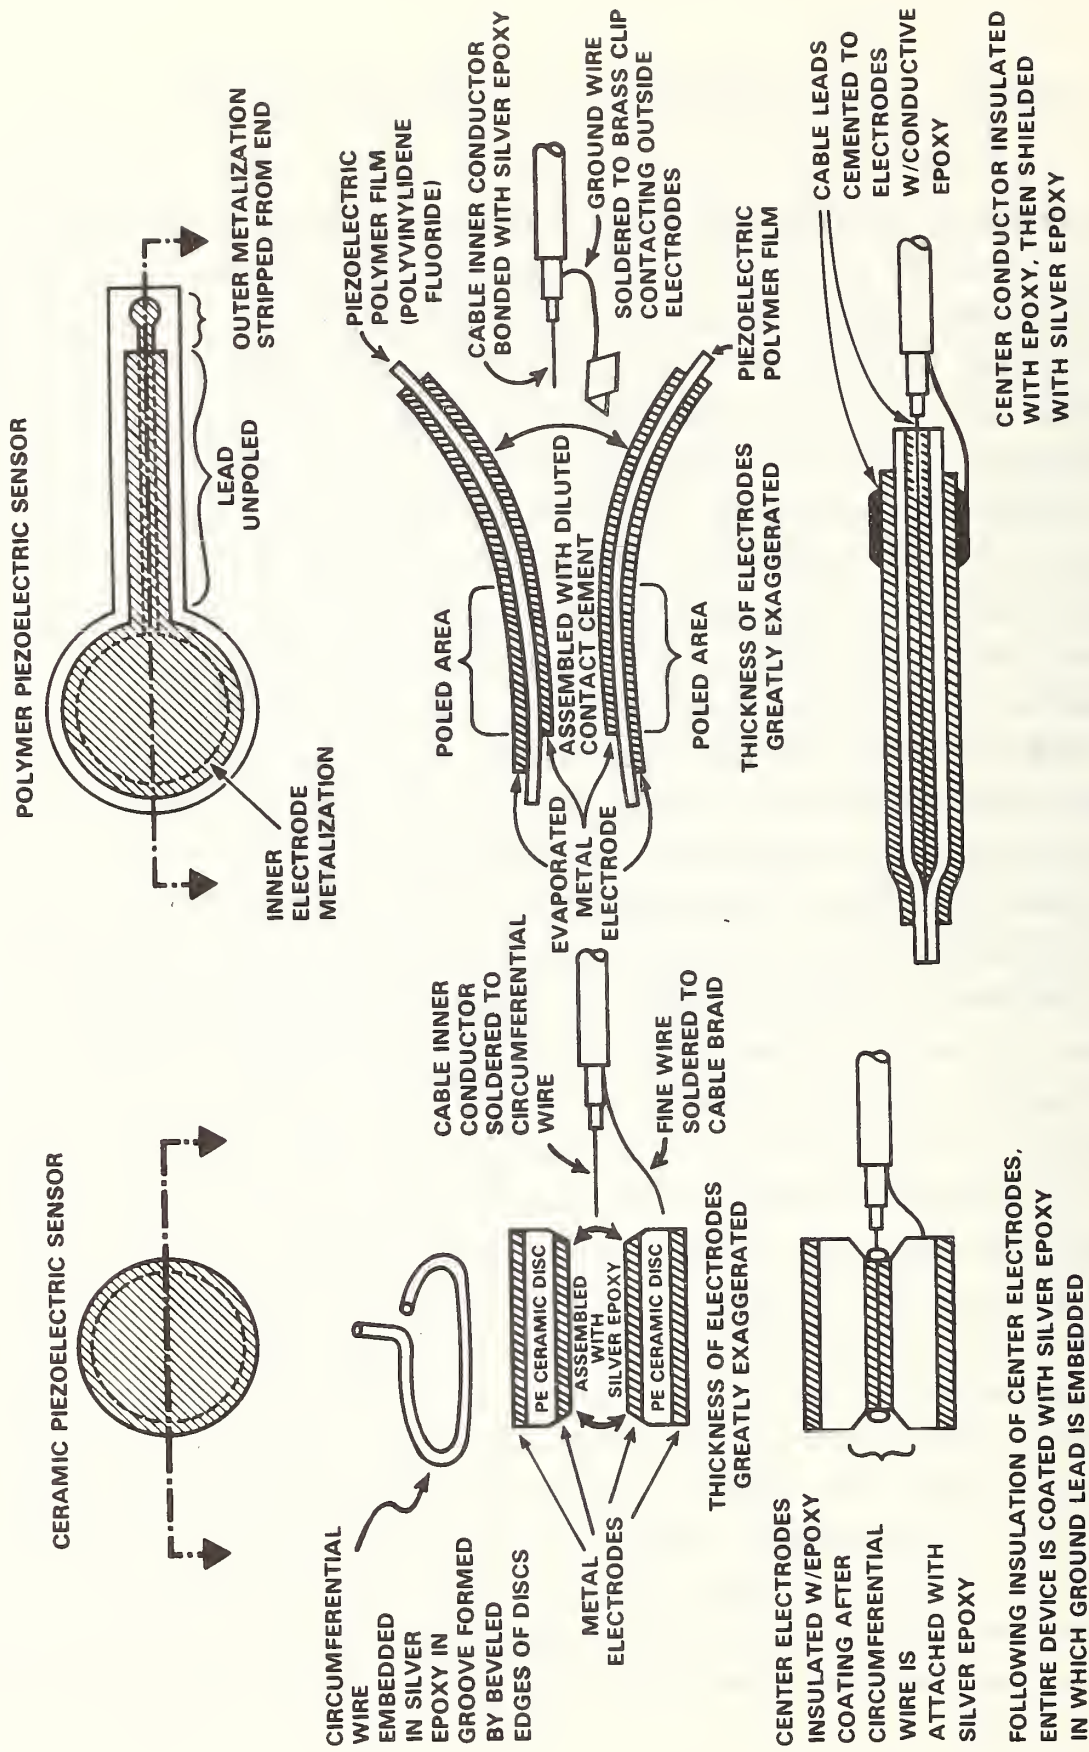
FIGURE A-1. Construction of piezoelectric sensors. Electrodes (metalization) shown shaded.

The piezoelectrics used in this investigation were lead zirconate titanate, a crystalline ceramic, and poly(vinylidene fluoride), a flexible plastic. The piezoelectric ceramic was obtained commercially as electroded and poled discs, so that it was only necessary to assemble a pair of discs together and attach a shielded cable, as shown in figure A-1. The electrically paralleled discs formed a fully shielded transducer since the grounded electrodes of the discs were on the outside and connected together at their edges by a layer of silver-filled conducting epoxy.

The piezoelectric polymers were electroded and poled at NBS using commercially available sheets of poly(vinylidene fluoride). They were assembled as self-shielding pairs, similar to the ceramic transducer. Details of a typical piezoelectric polymer fabrication procedure used at NBS have been given in a previous NBS report*.
